Construction Analysis

Dallas Semiconductor DS80C320 Microcontroller

Report Number: SCA 9702-525

ICE
INTEGRATED CIRCUIT ENGINEERING

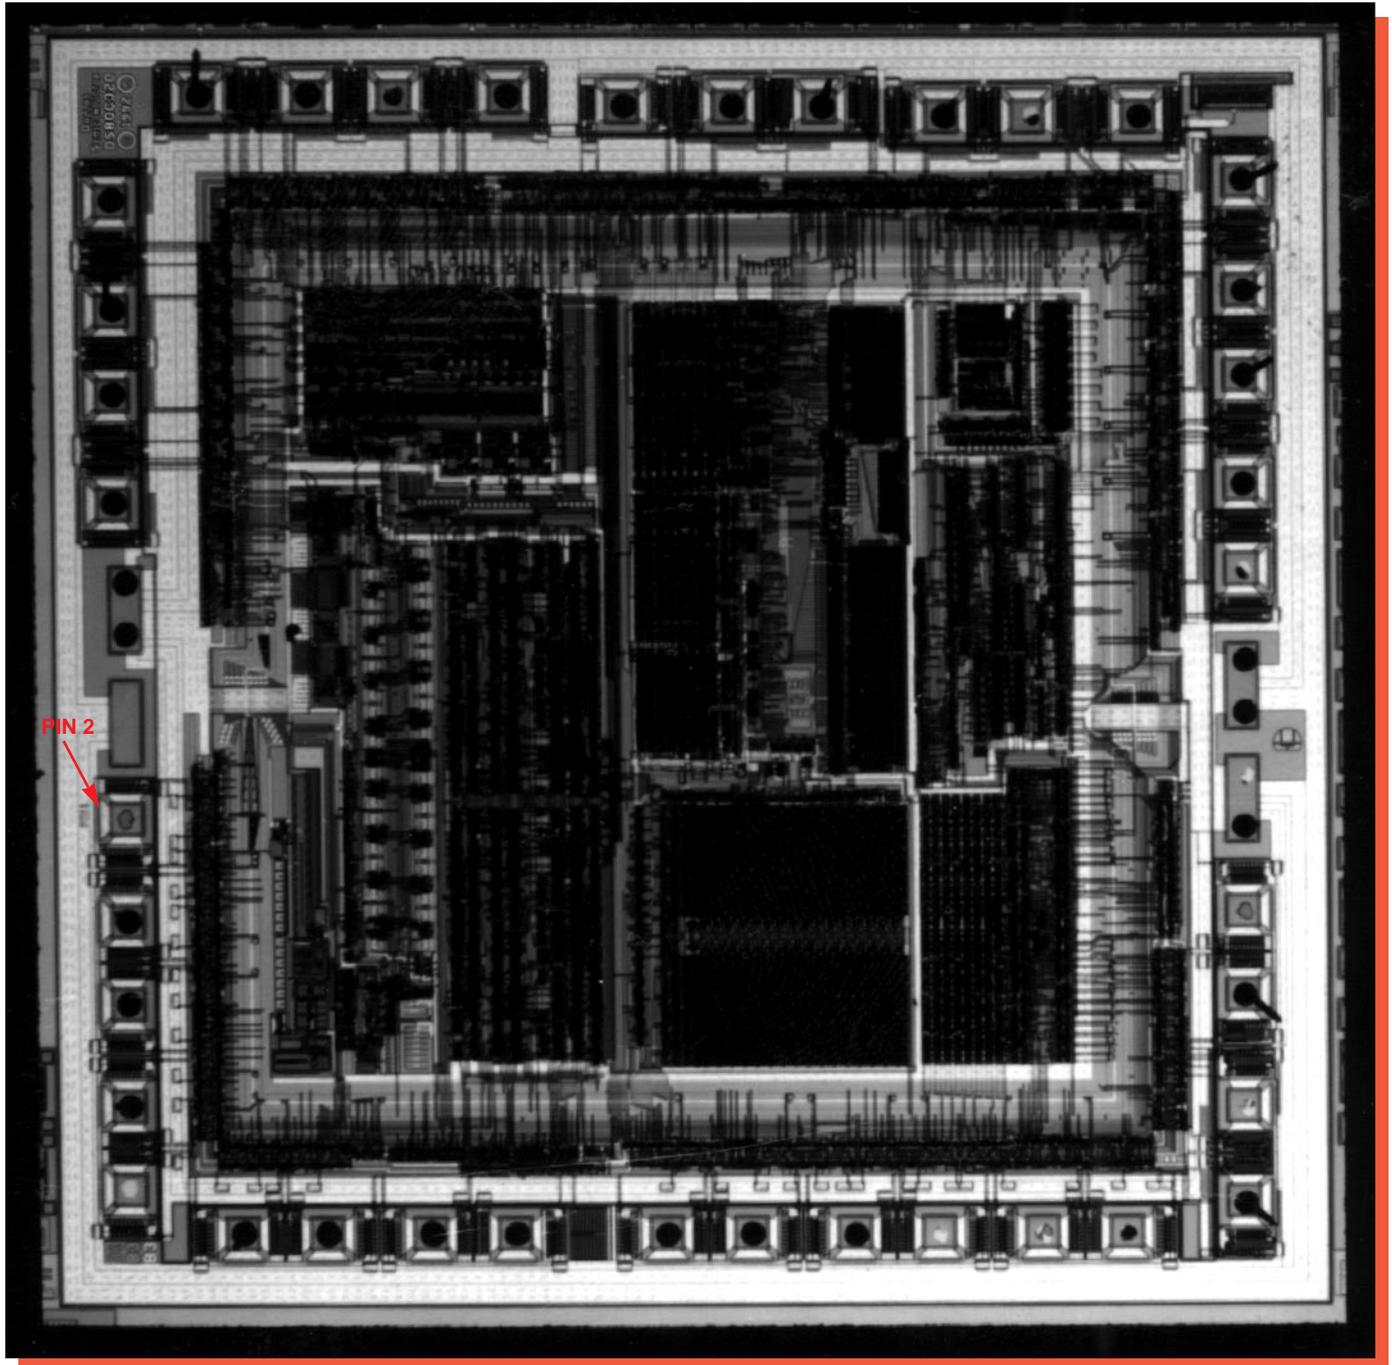
Figure 9. SEM views of typical wirebonds. 60°.

- Devices were packaged in 44-pin plastic leaded (PLCC) chip carriers.
- Overall package quality: Good. No significant defects were noted on the external or internal portions of the package. No cracks or voids were noted in the plastic.
- Leadframe: The leadframe was constructed of copper. External tinning consisted of tin-lead (SnPb) while internal plating consisted of silver (Ag). No gaps were noted at lead exits.
- Die dicing: Die separation was by sawing of normal quality. No large cracks or chips were present.
- Die attach: A silver epoxy of normal quality was used to attach the die to the header. No significant voids were noted in the die attach.
- Wirebonding was by the thermosonic ball bond method using 1.1 mil O.D. gold wire. Bonds were well formed and placement was good. Wirepull strengths were normal with no bond lifts (see page 10).

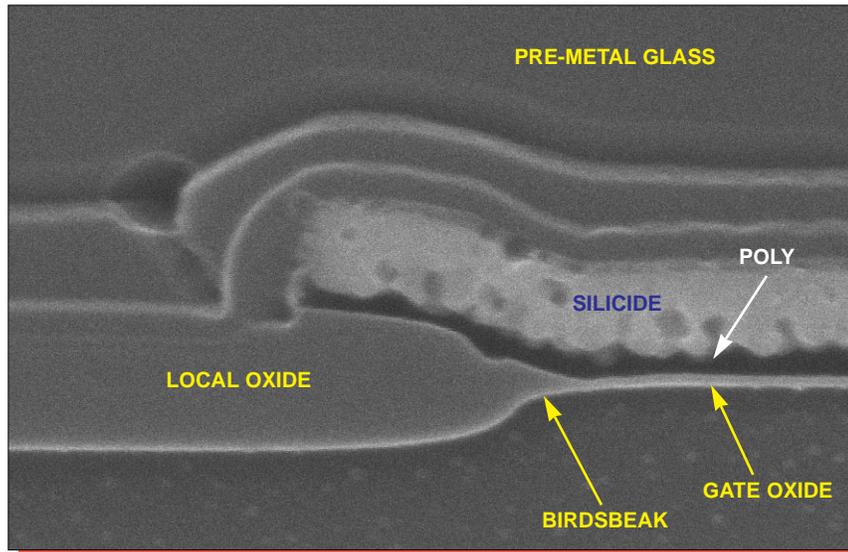
Figure 21 Topological SEM views of poly "links". 0°.

- Contact defects: None. No significant over-etching of the contacts was noted and no pitting or silicon mound growth was present.
- Polysilicon: A single layer of polycide (tungsten- silicide) was used to form all gates on the die and for interconnect (crossunders). Slots were noted within some of the large poly crossunders (Figures 32a and 32b). Direct poly-to-diffusion (buried) contacts were not used. Poly “links” are inactive and appear to have been a mask modification (Figure 21). Definition was by a dry etch of normal quality.

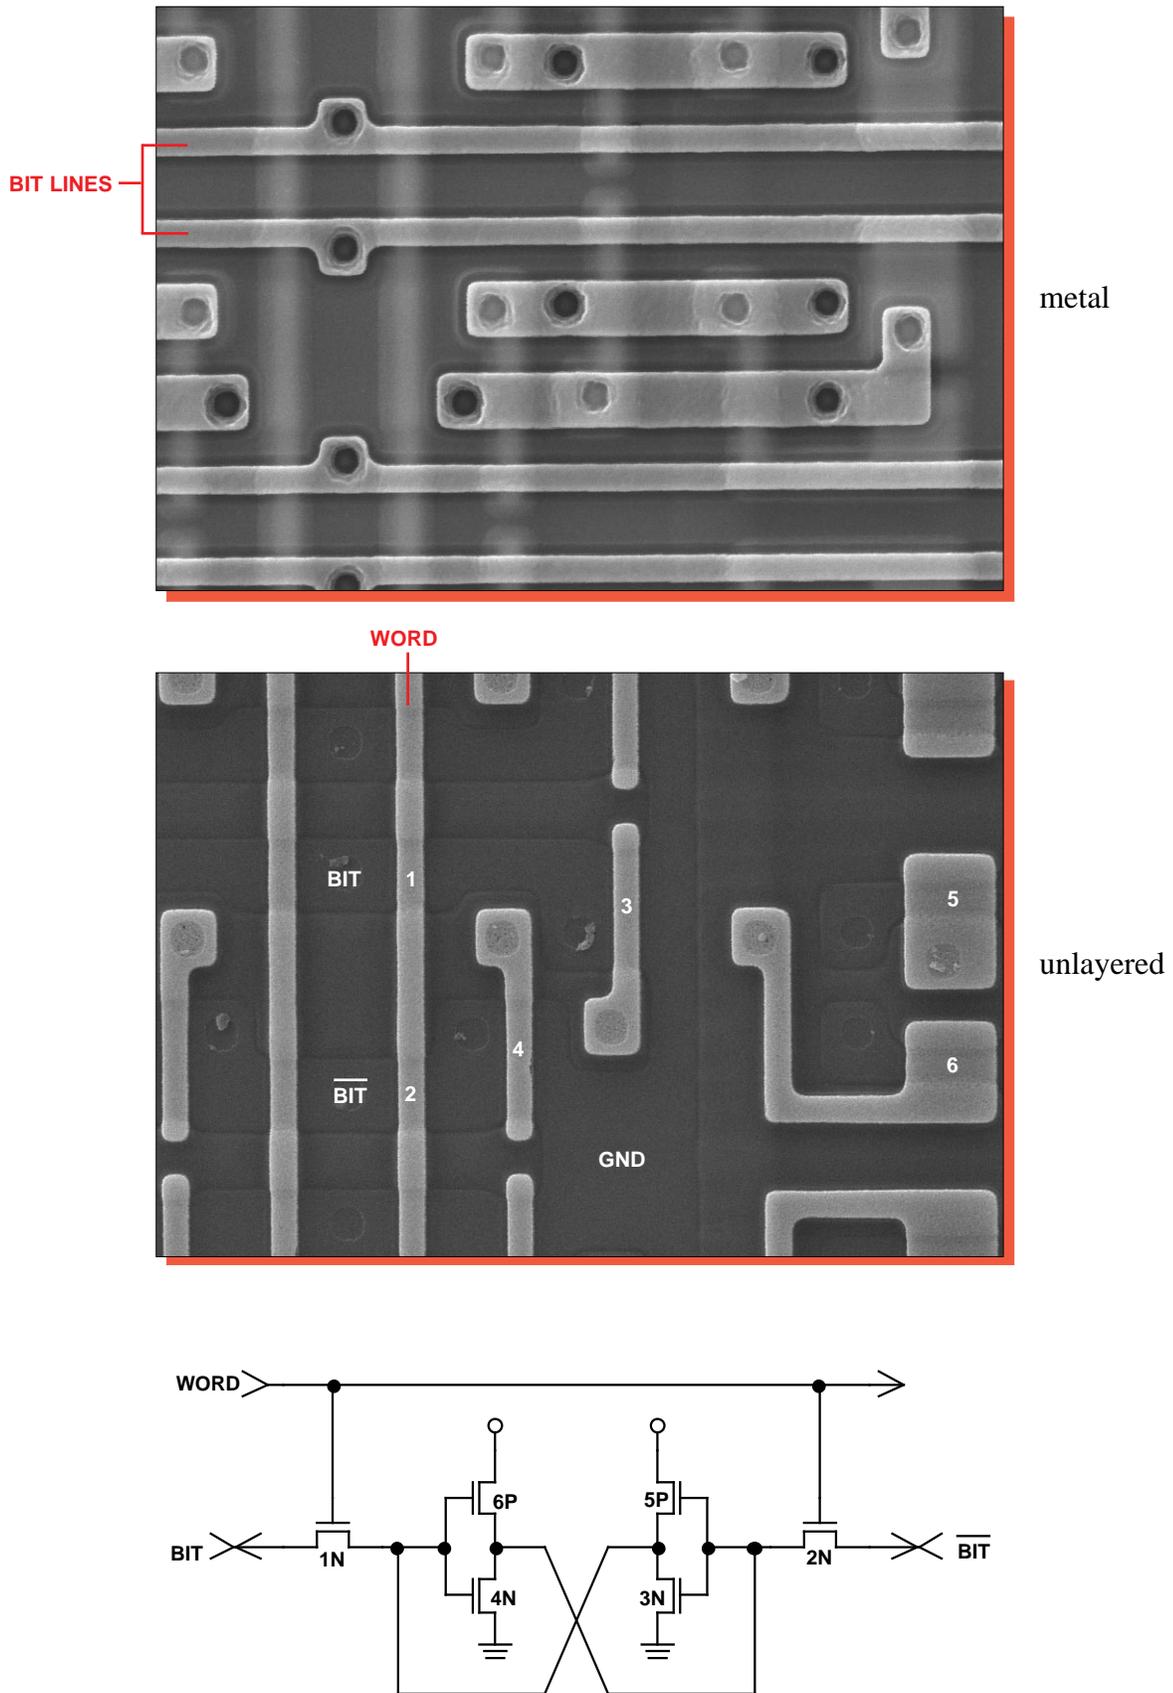
Figure 27. Detailed SEM views of the SRAM array. Mag. 4000x, 60°.

- SRAM array: Two blocks of SRAM memory were present. A 6T SRAM cell design was employed. Metal was used to form the bit lines. Poly was used to form the word/select lines, storage gate and pull-up devices. Cell pitch was relatively large 12.2 x 22.8 microns.

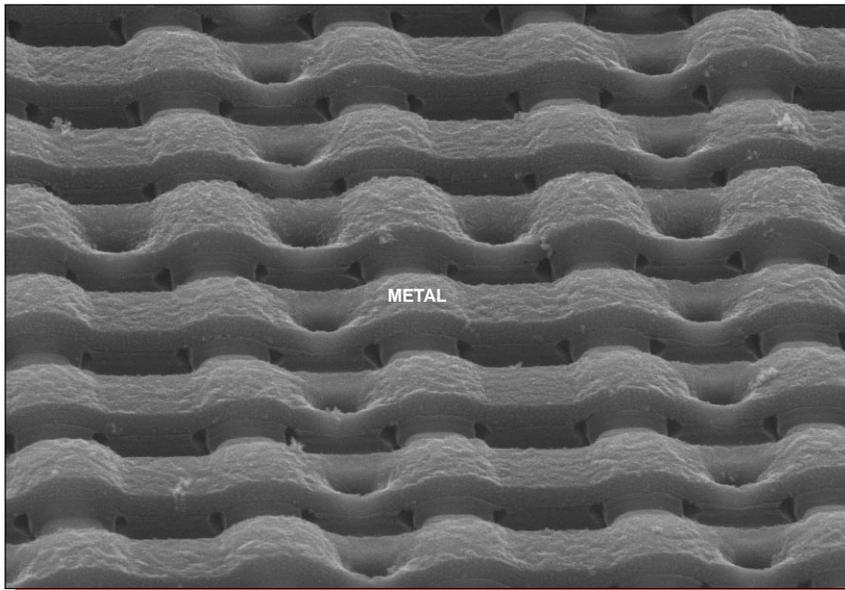
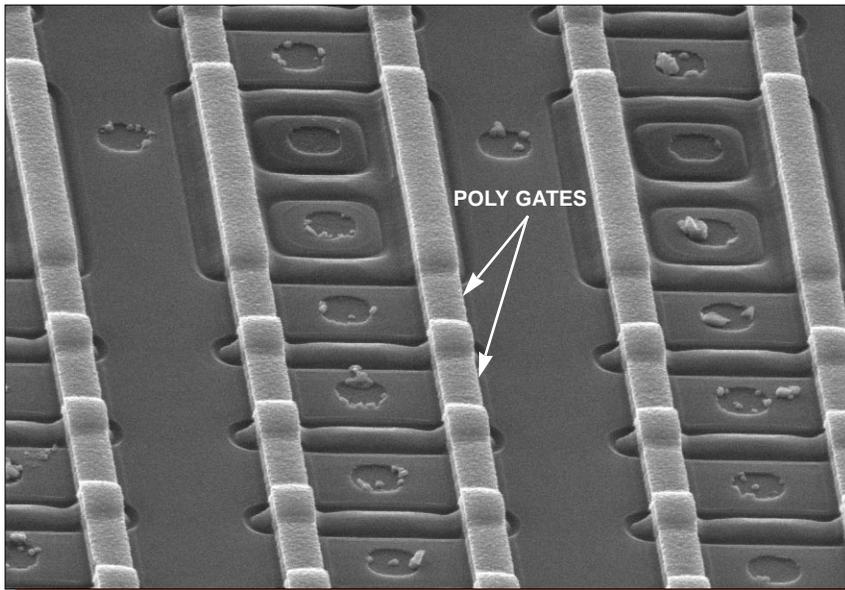
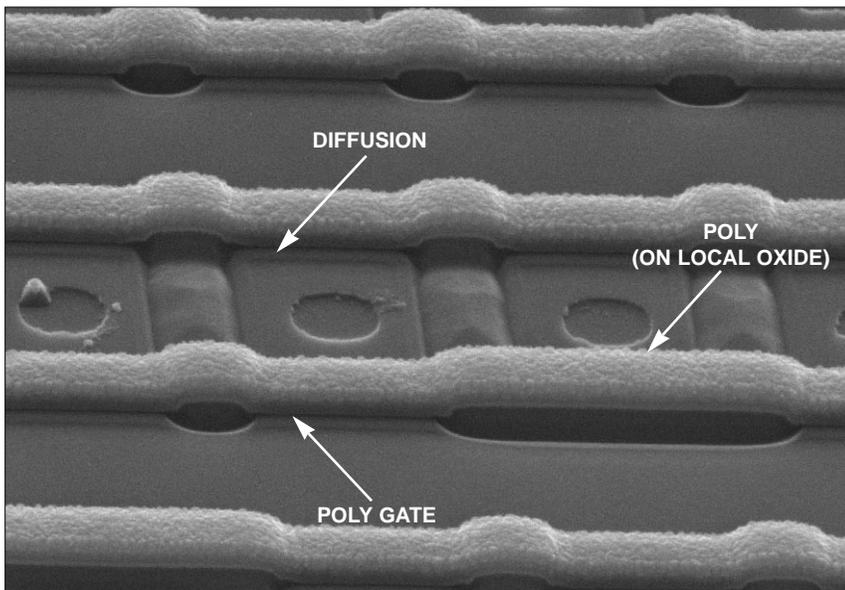
Figure 29. Topological SEM views of an MROM array on the DS80C320. Mag. 5000x, 0°.

- MROM arrays: Metal formed the bit lines and poly formed the word lines. The array was programmed at the field oxide (diffusion) level (see Figures 29 and 30).

- MROM array: Two separated blocks of MROM arrays were present on the device. Metal formed the bit lines and poly formed the word lines. No problems of any sort were noted in the SRAM nor MROM arrays. Both arrays were programmed at the field oxide (diffusion) level (see Figures 29 and 30).
