Construction Analysis

Xilinx XC4036EX FPGA

Report Number: SCA 9706-544

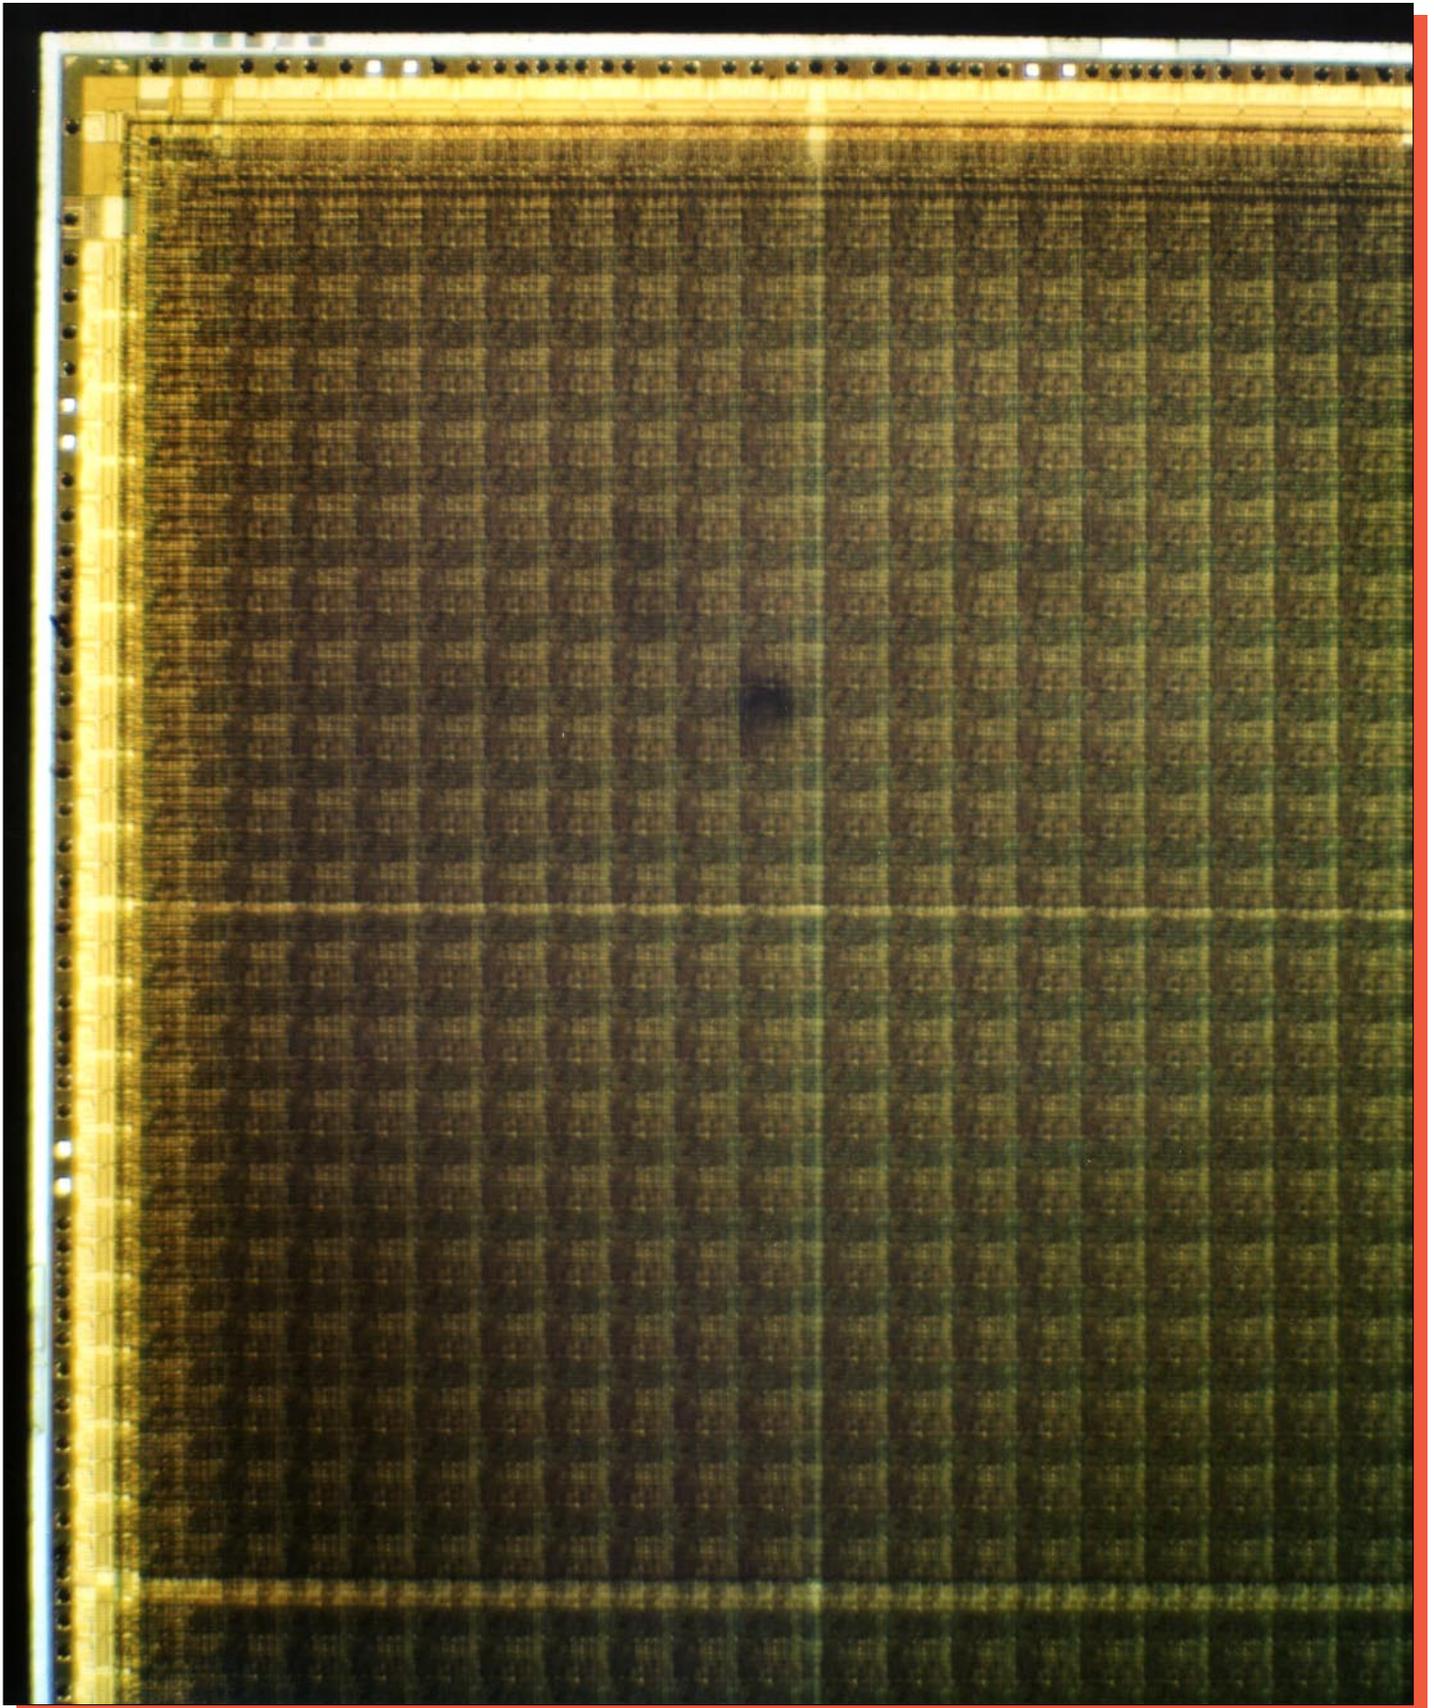
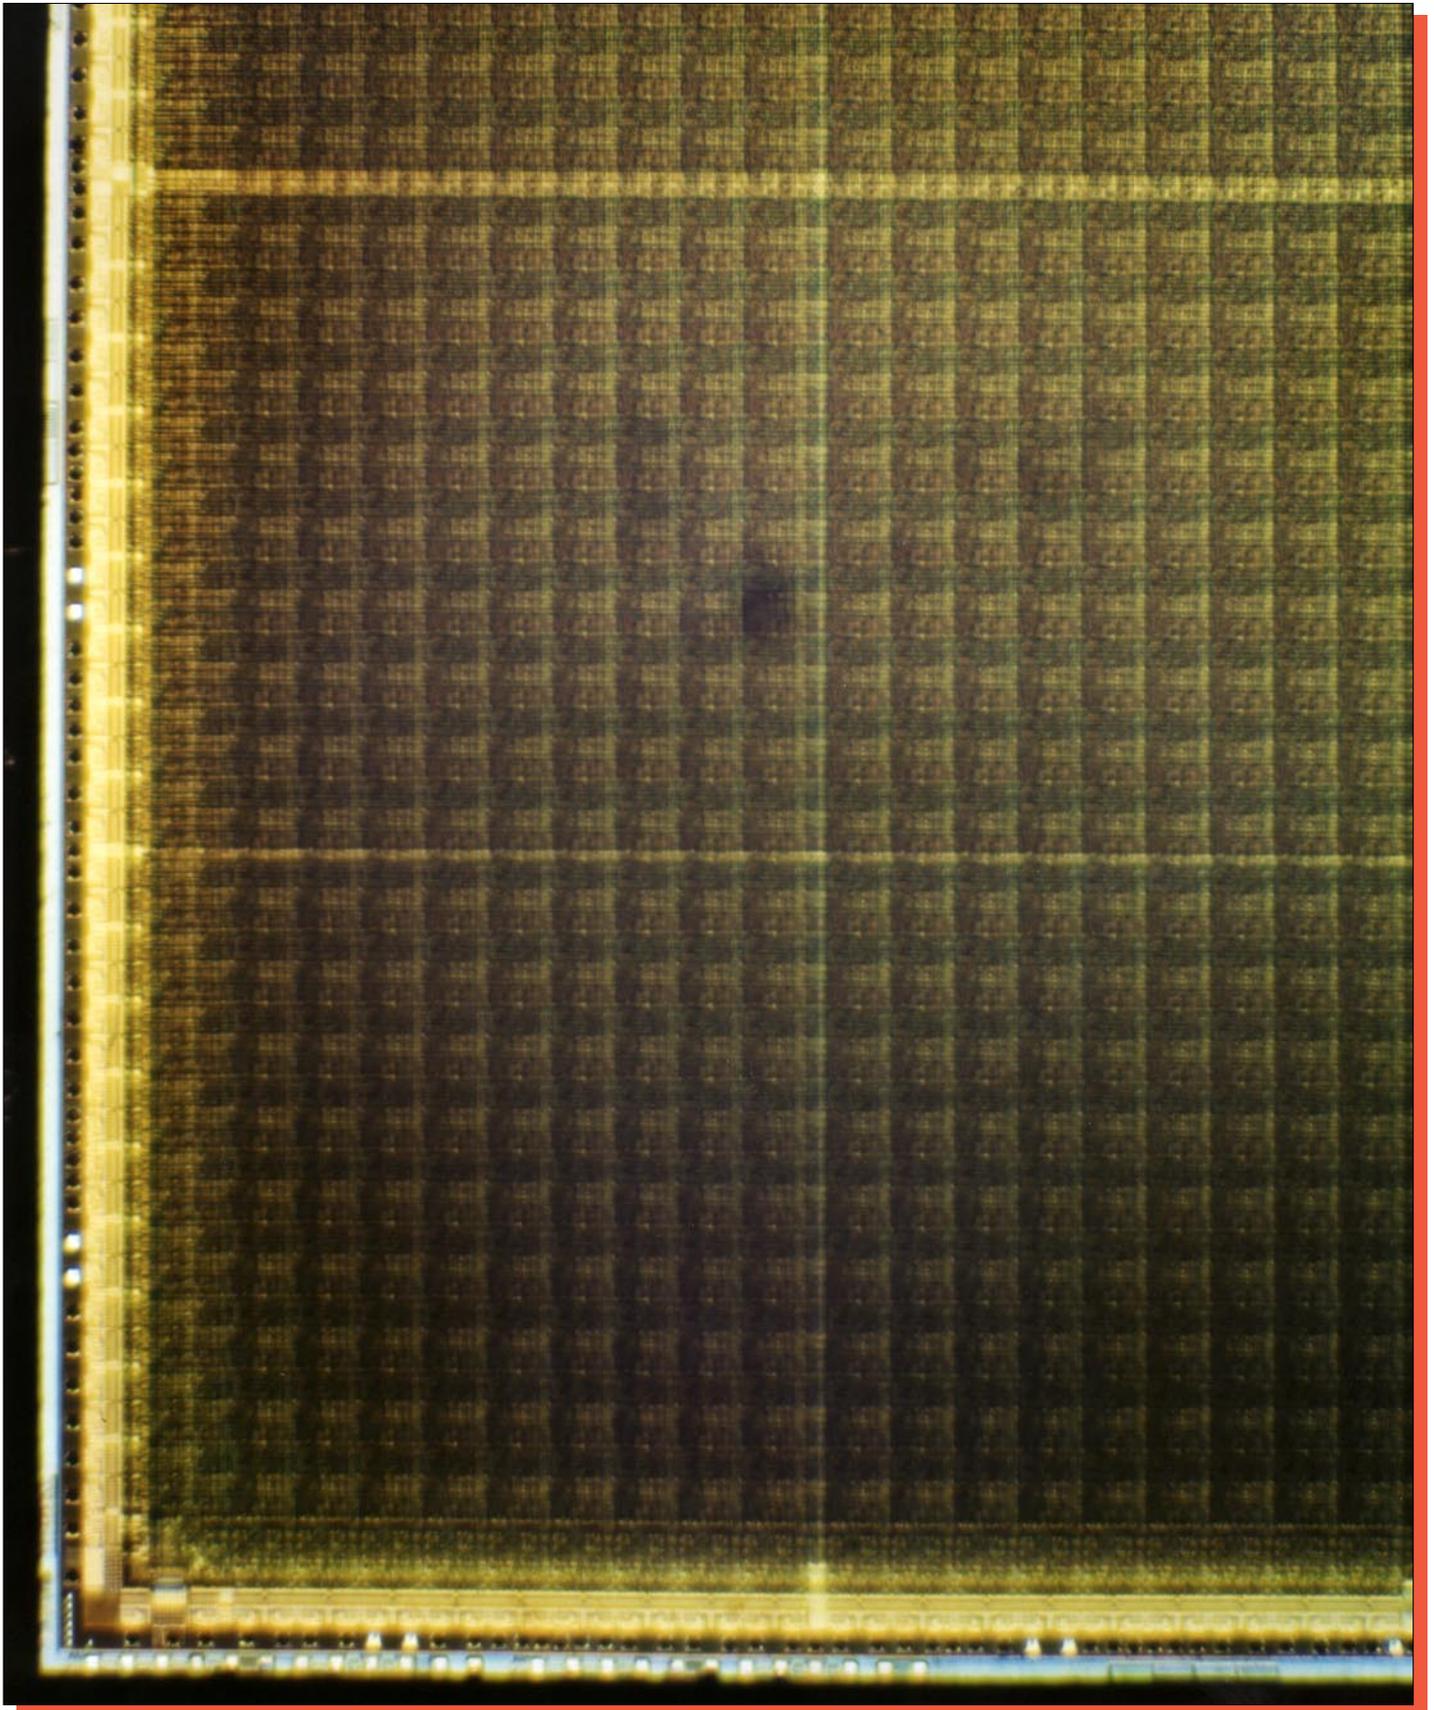
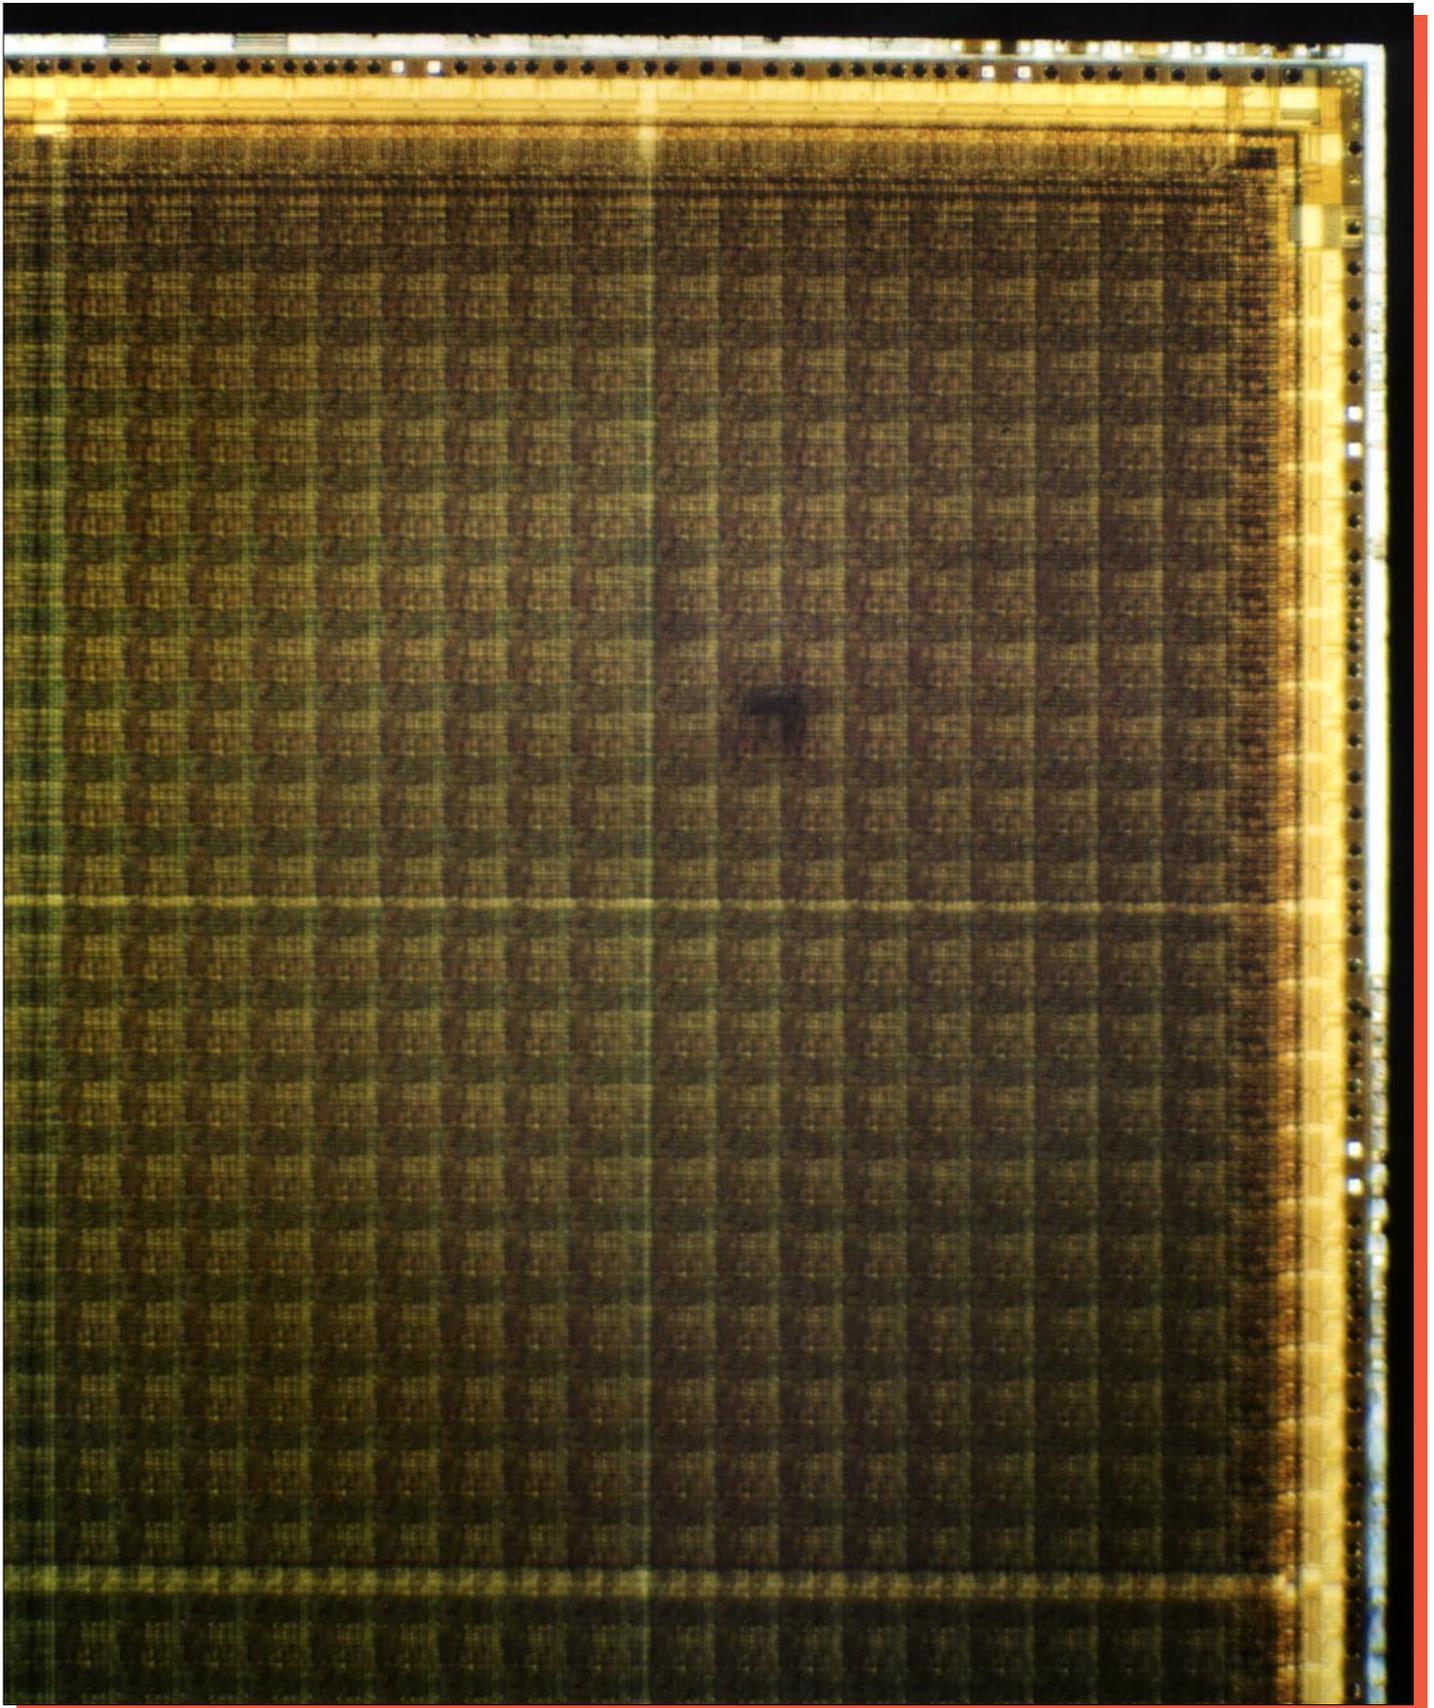
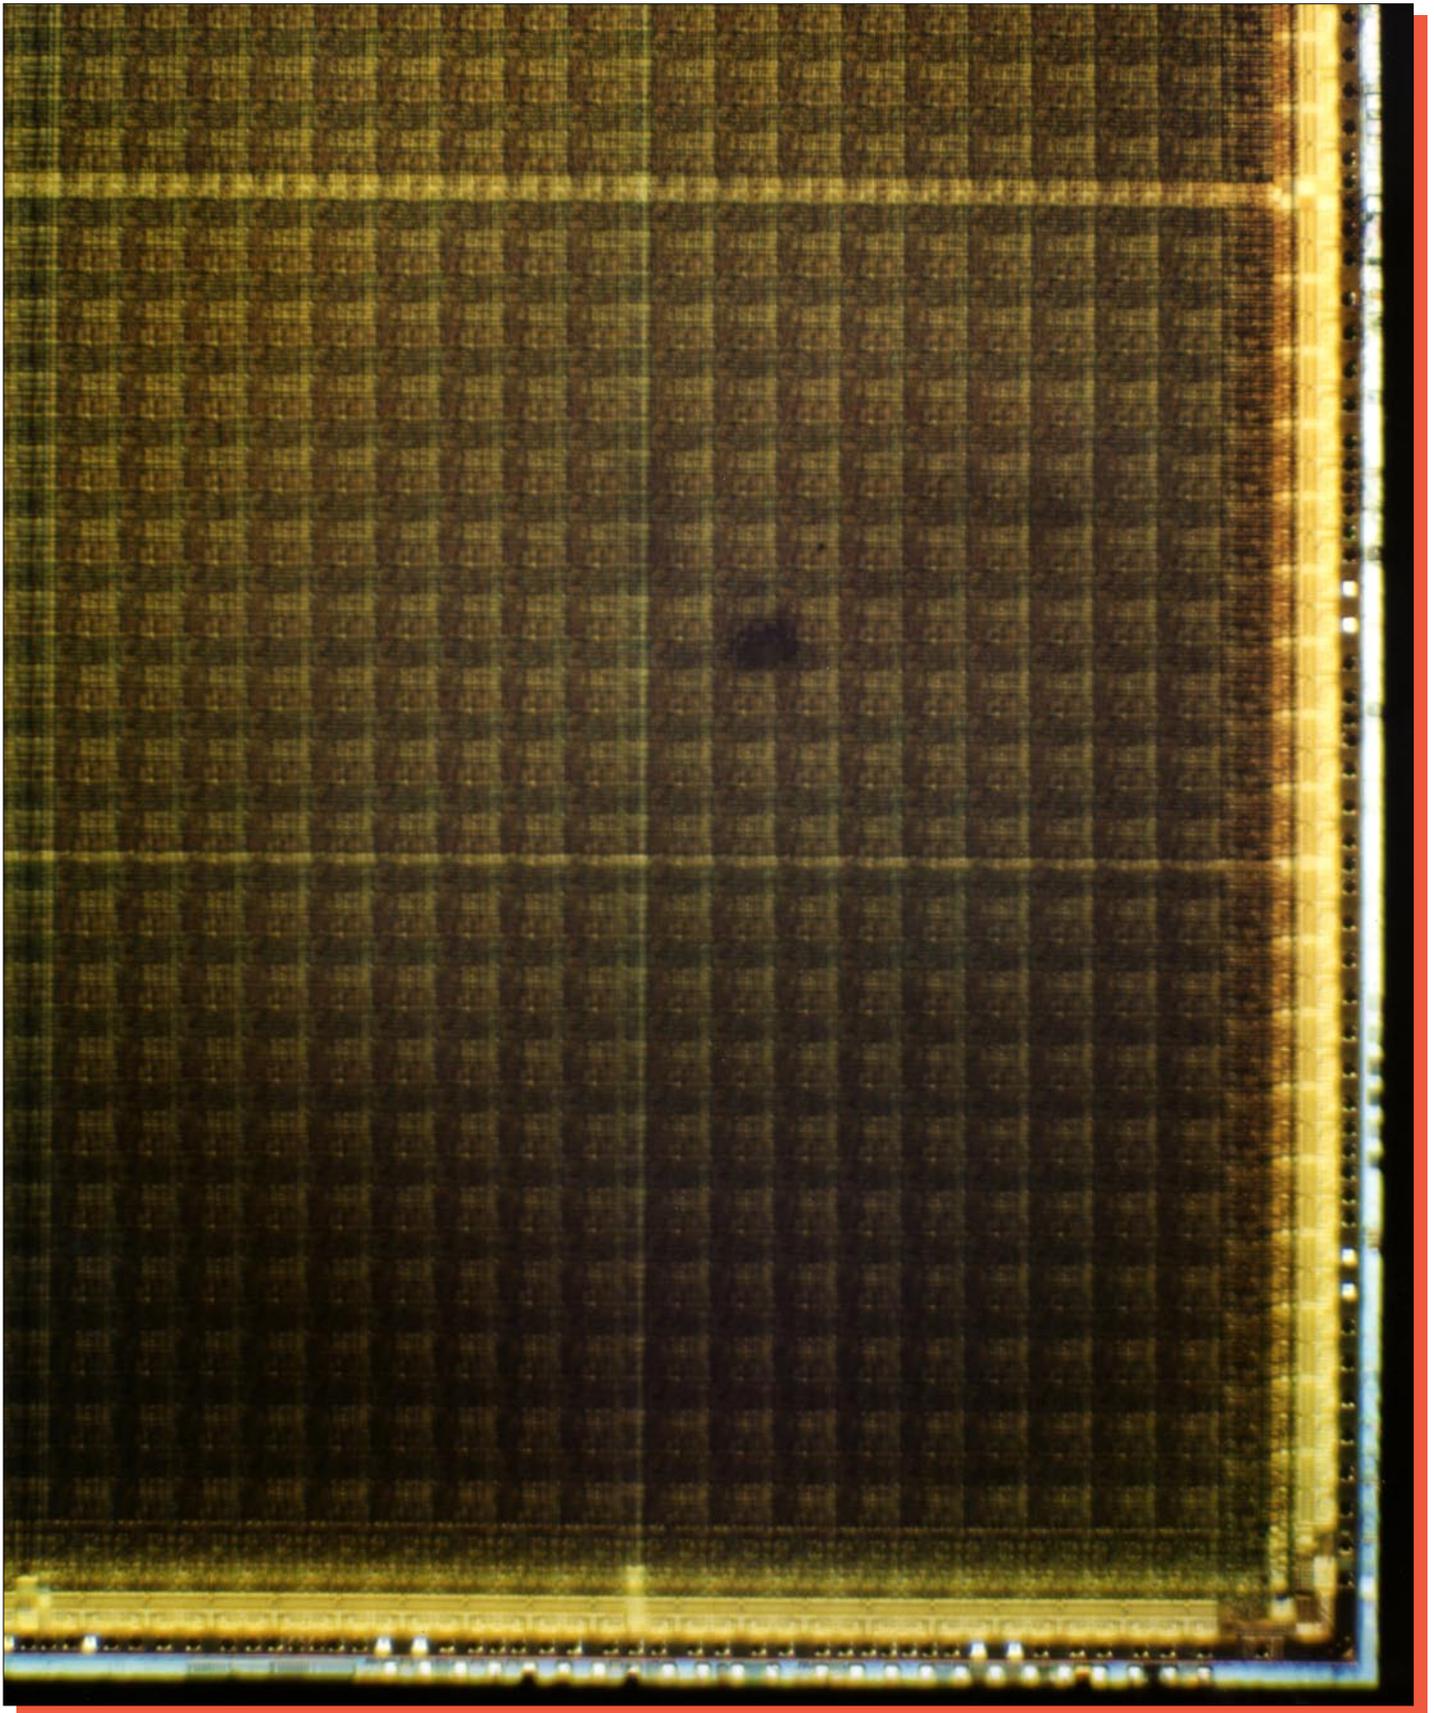
Figure 1. Portion of the whole die photograph of the Xilinx XC4036EX. Mag. 10x.

Figure 1a. Portion of the whole die photograph of the Xilinx XC4036EX. Mag. 10x.

Figure 1b. Portion of the whole die photograph of the Xilinx XC4036EX. Mag. 10x.

Figure 1c. Remaining portion of the whole die photograph of the Xilinx XC4036EX.
Mag. 10x.

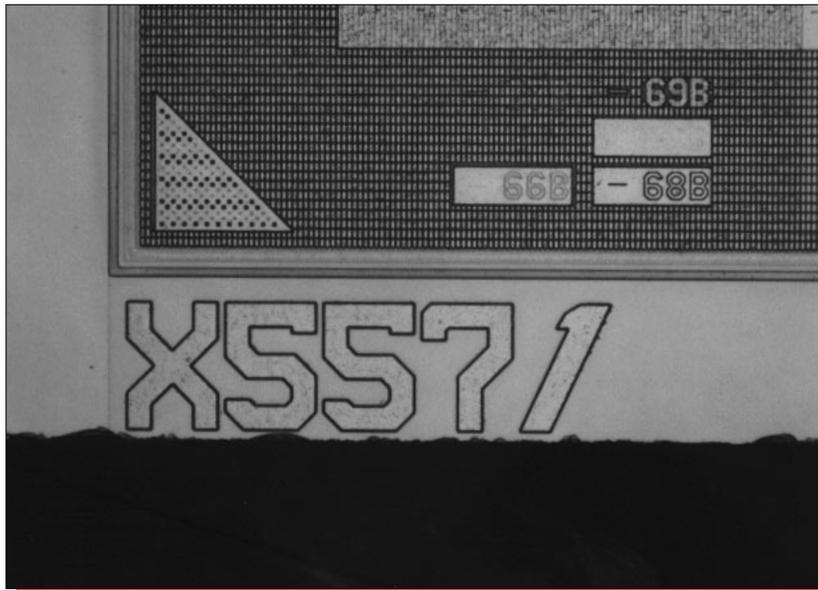
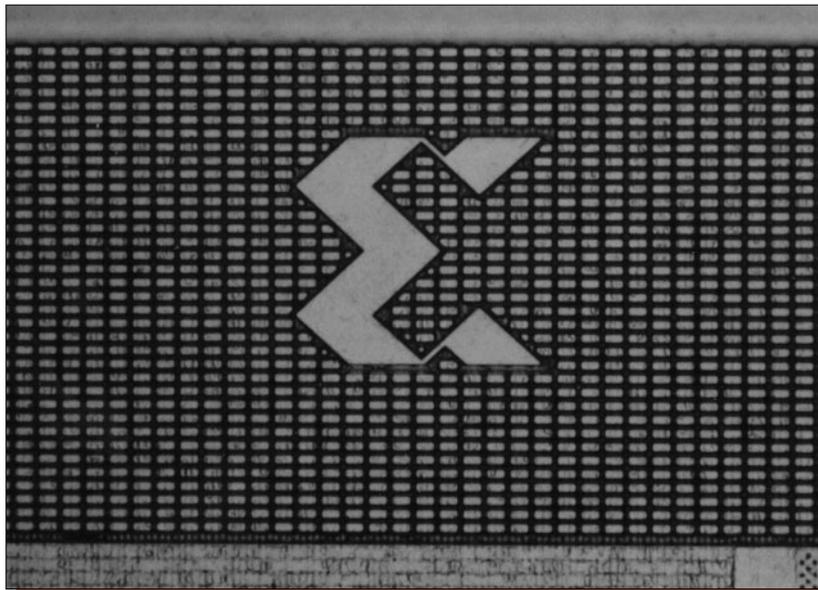
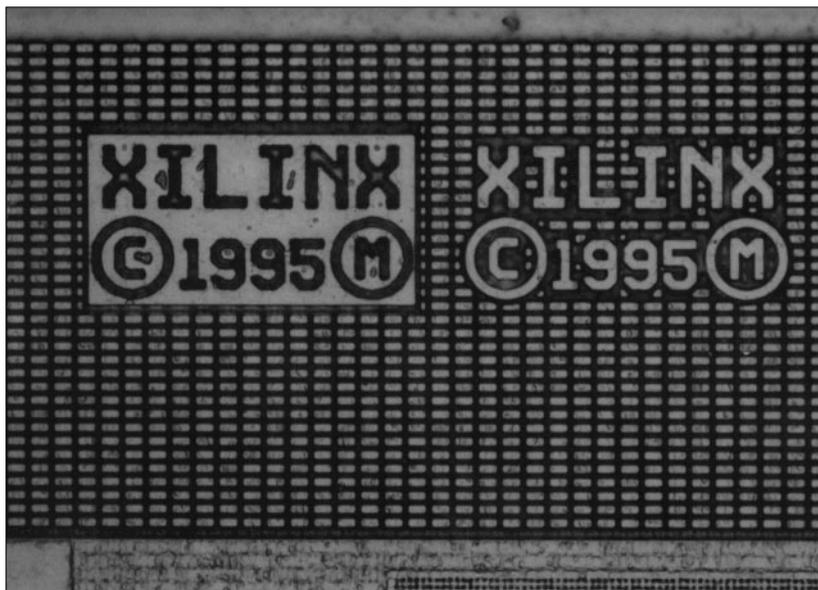
Figure 2. Markings from the die surface.

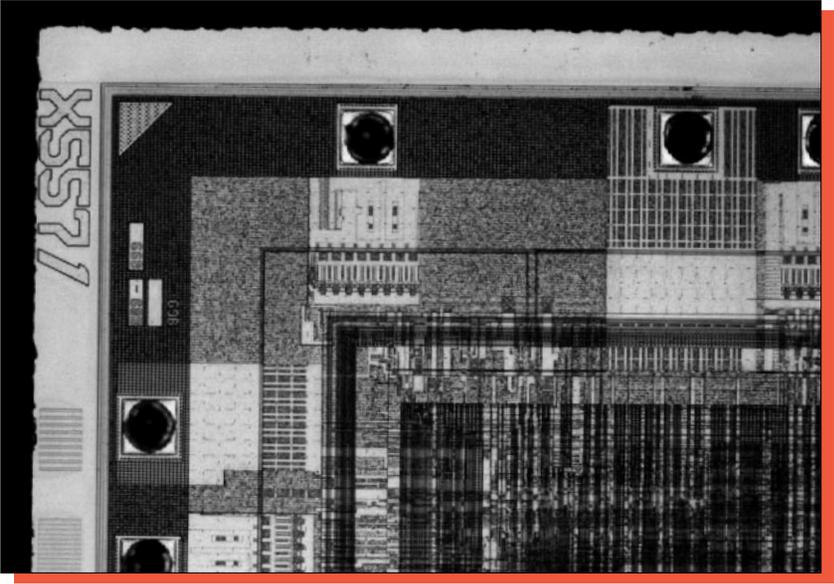
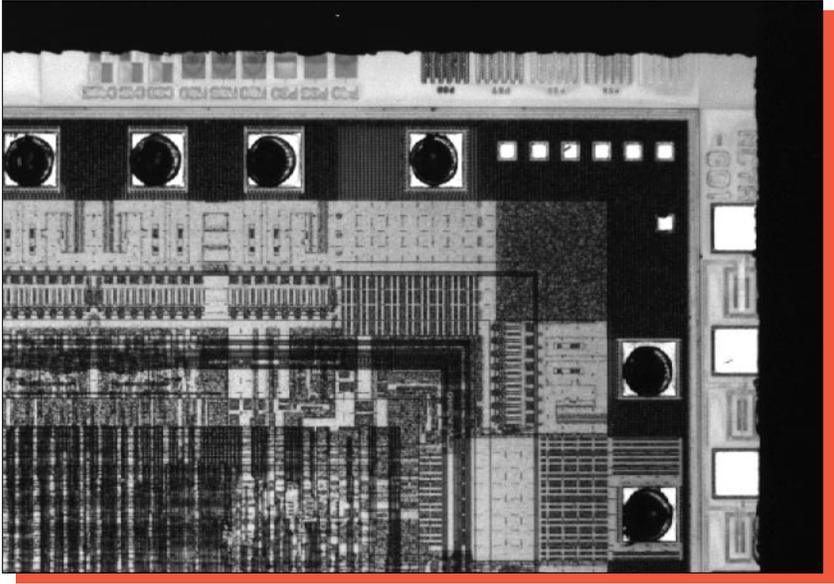
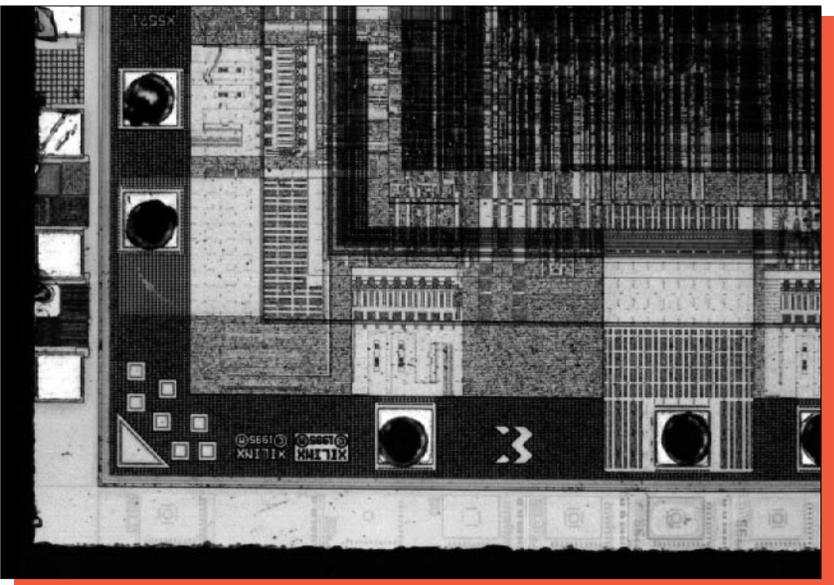
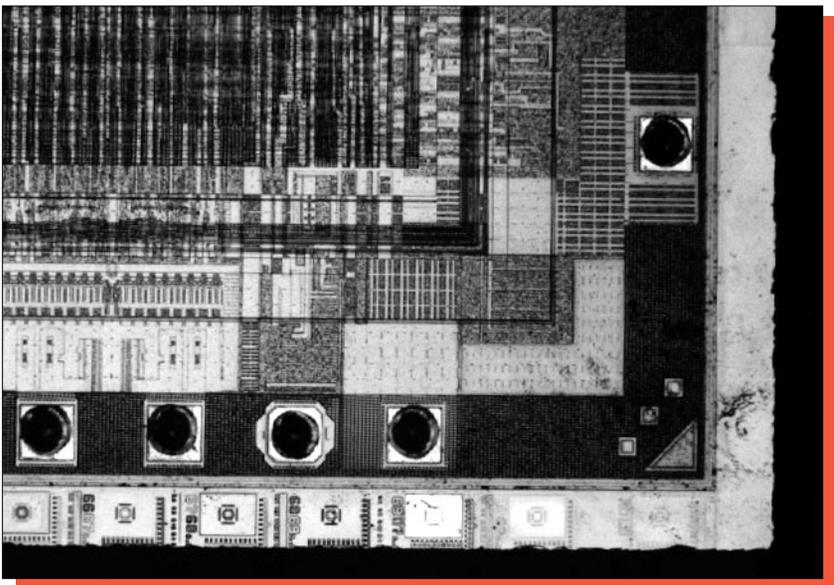
Figure 3. Optical views of the die corners. Mag. 80x.

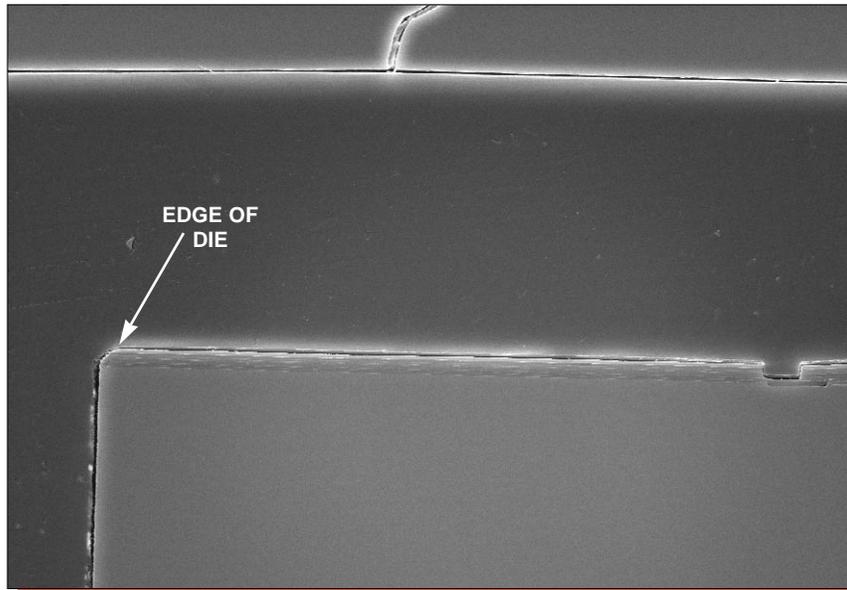
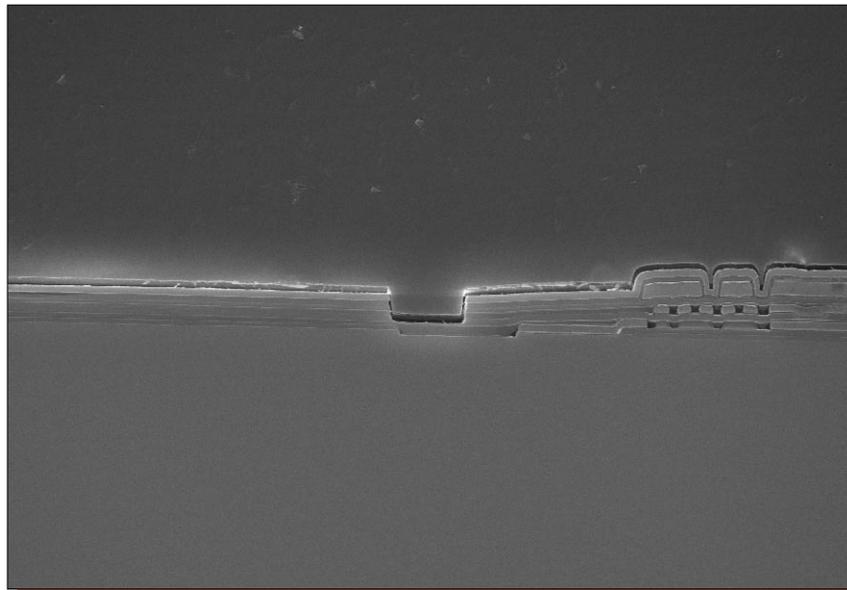
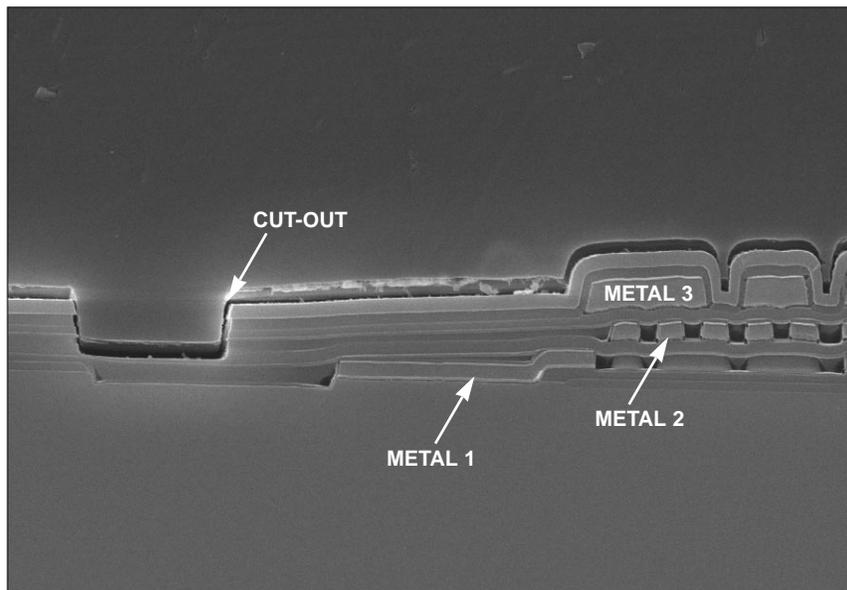
Figure 4. SEM section views of the edge seal.

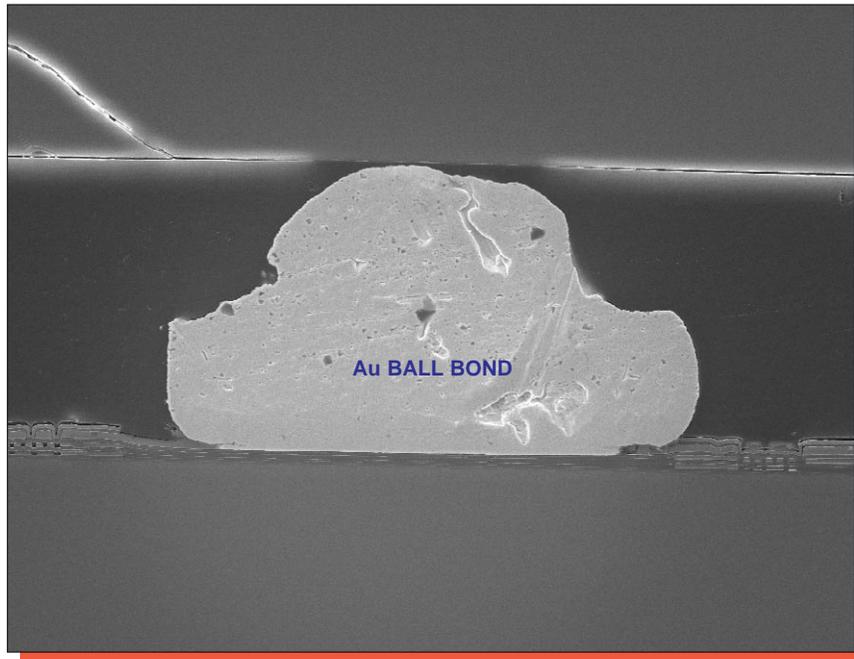
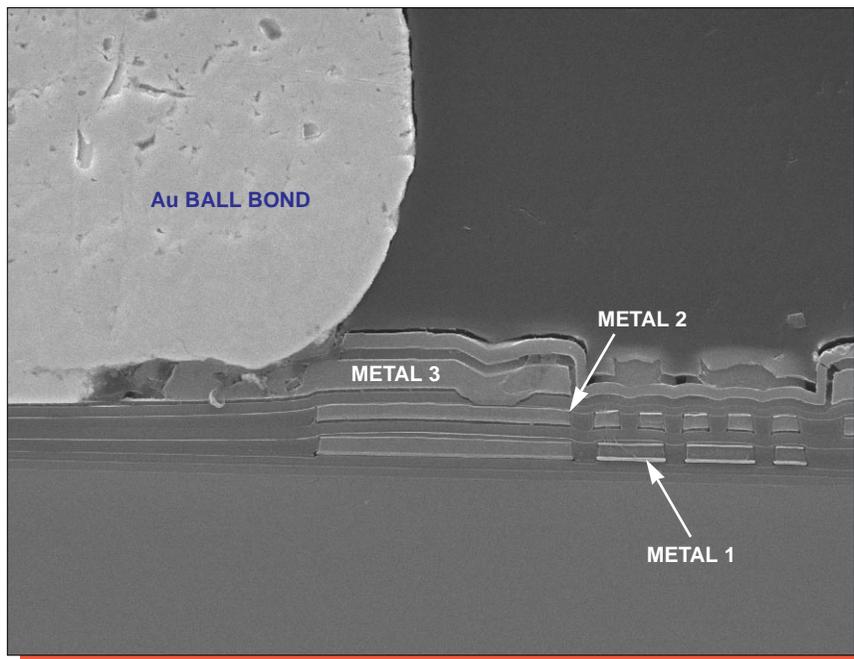
Figure 5. SEM section views of the bond pad structure.

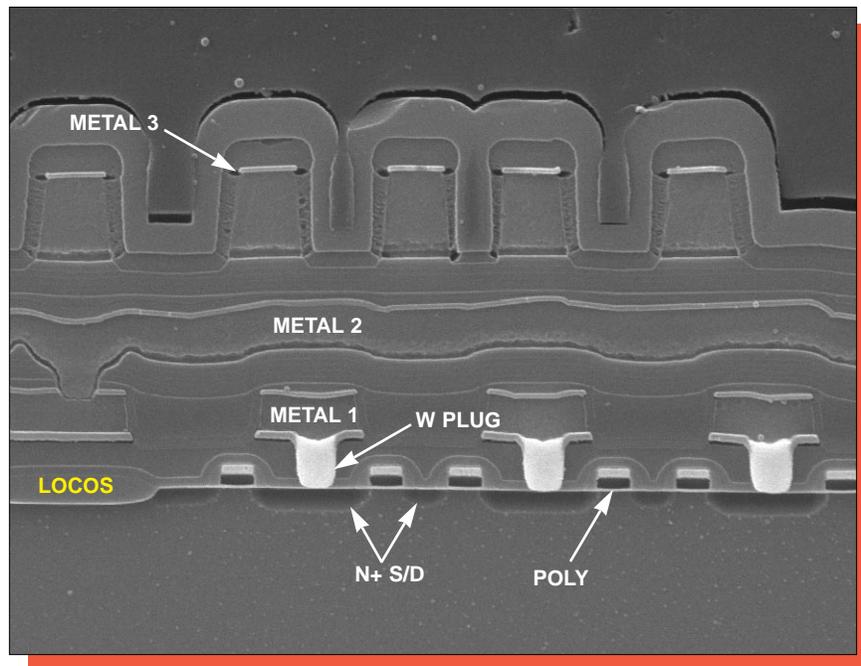
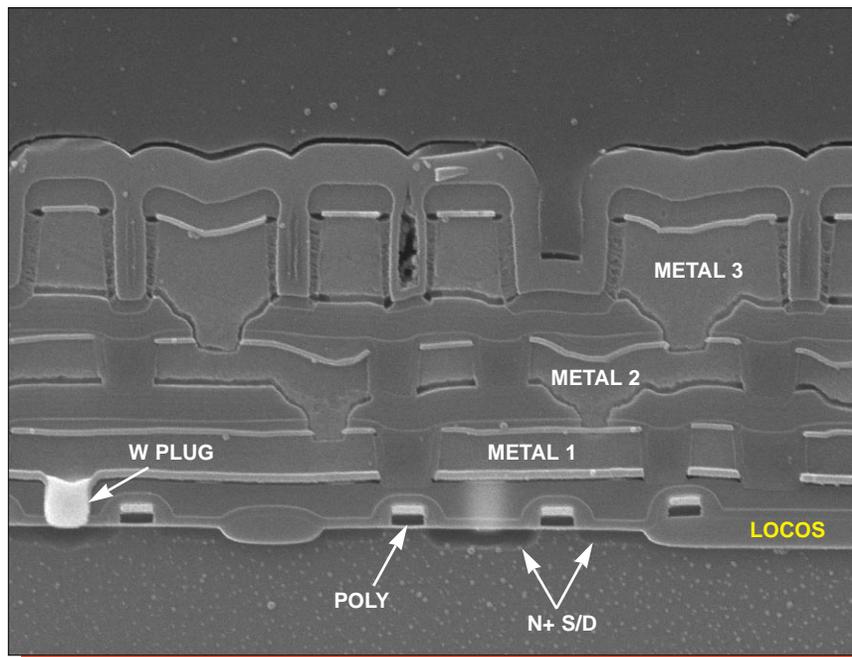
Figure 6. SEM section views of general structure (silicon etch). Mag. 10,000x.

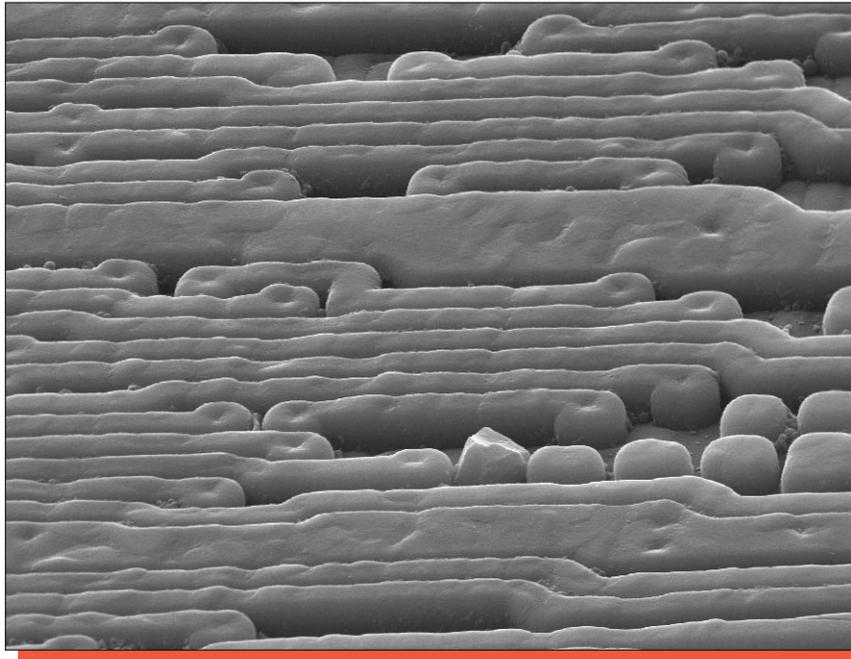
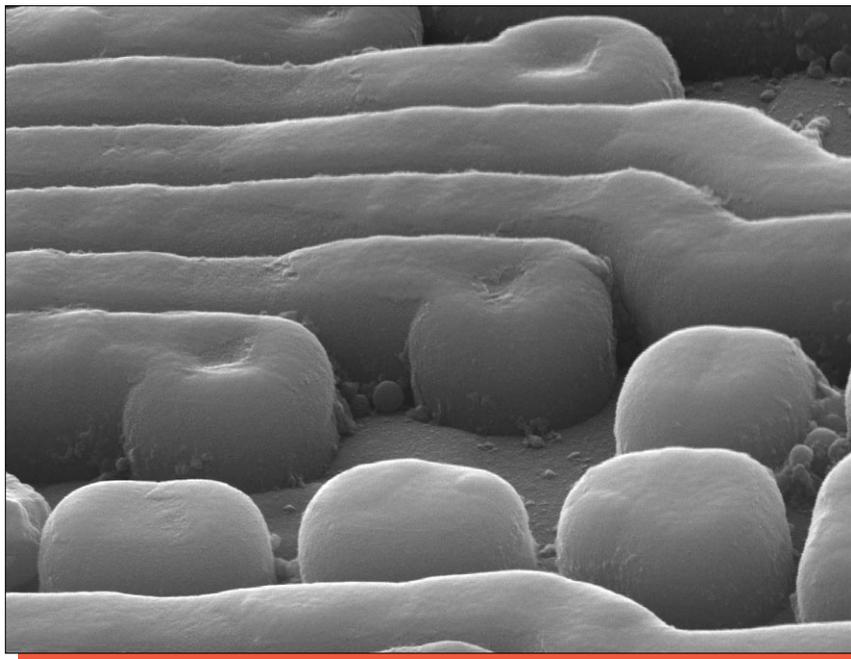
Figure 7. Perspective SEM views of the overlay passivation coverage. 60°.

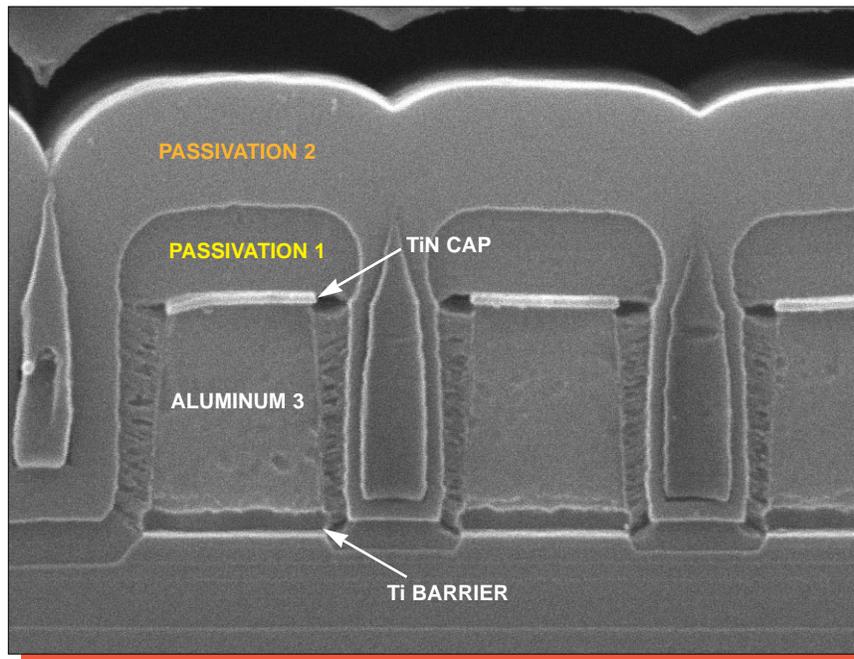
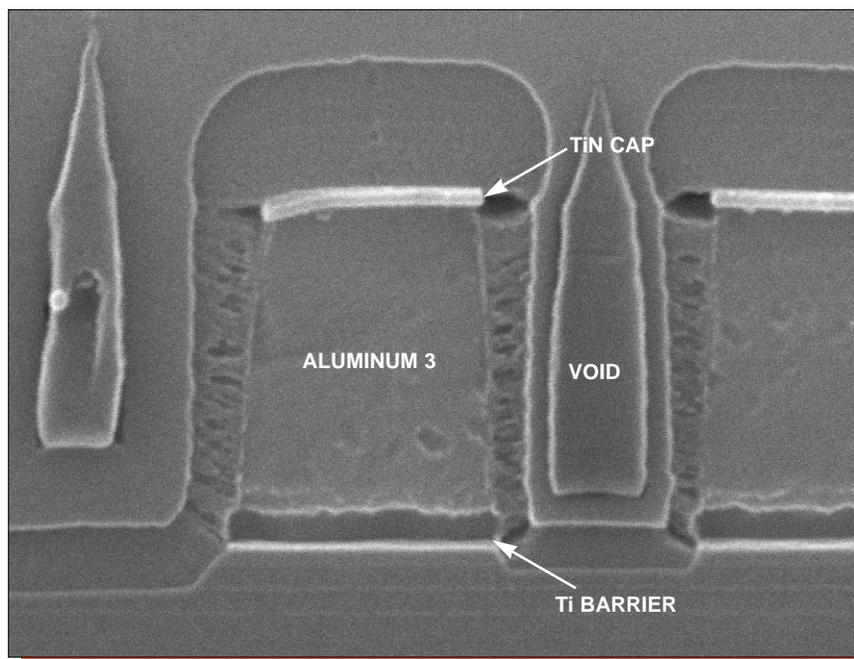
Figure 8. SEM section views of metal 3 line profiles.

- Metal patterning: All three metal levels were patterned by a dry etch of normal quality.
- Metal defects: No voiding, notching, or neckdown was noted in the metal 3 or metal 2. No silicon nodules were noted following removal of either metal layer. No problems were noted in any of the layers.

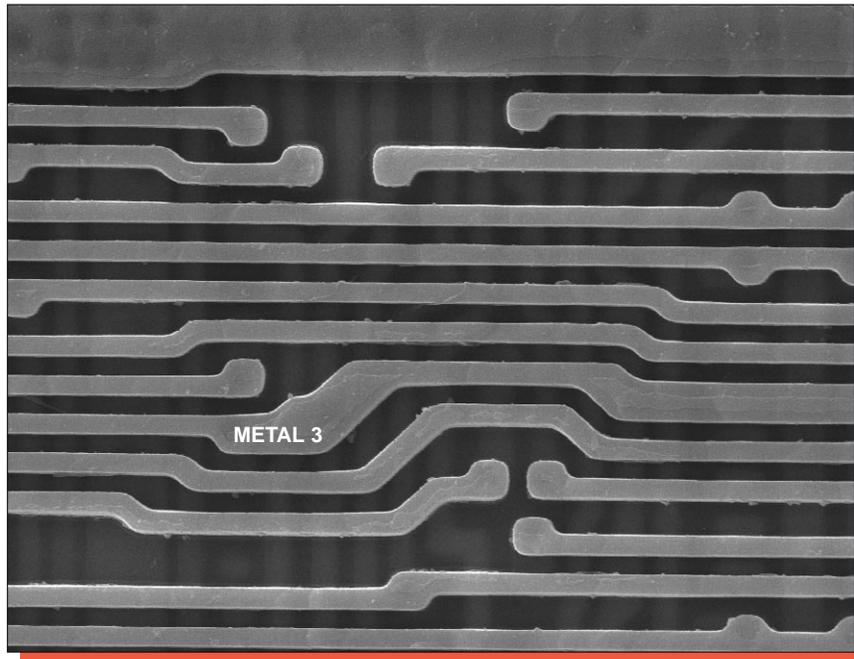
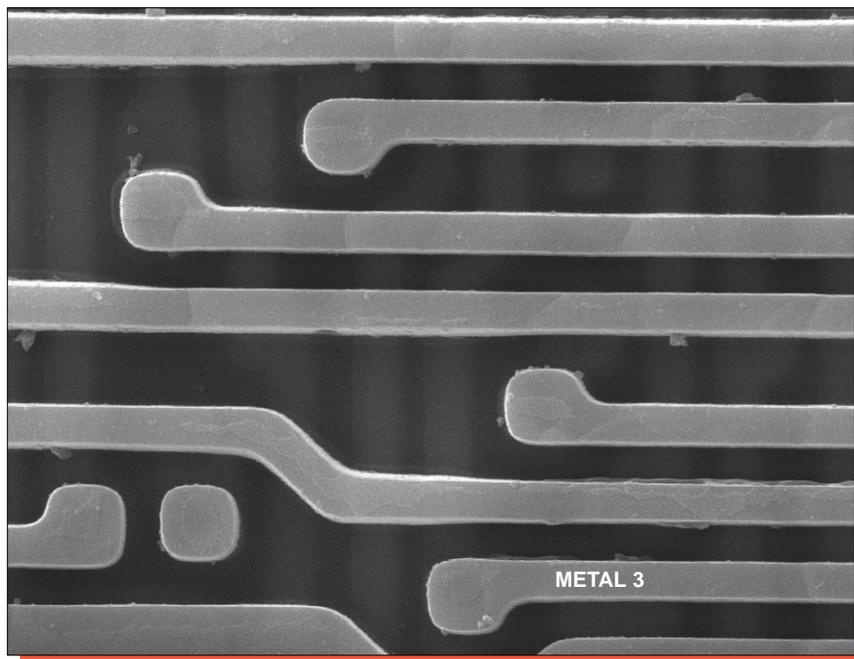
Figure 9. Topological SEM views of metal 3 patterning. 0°.

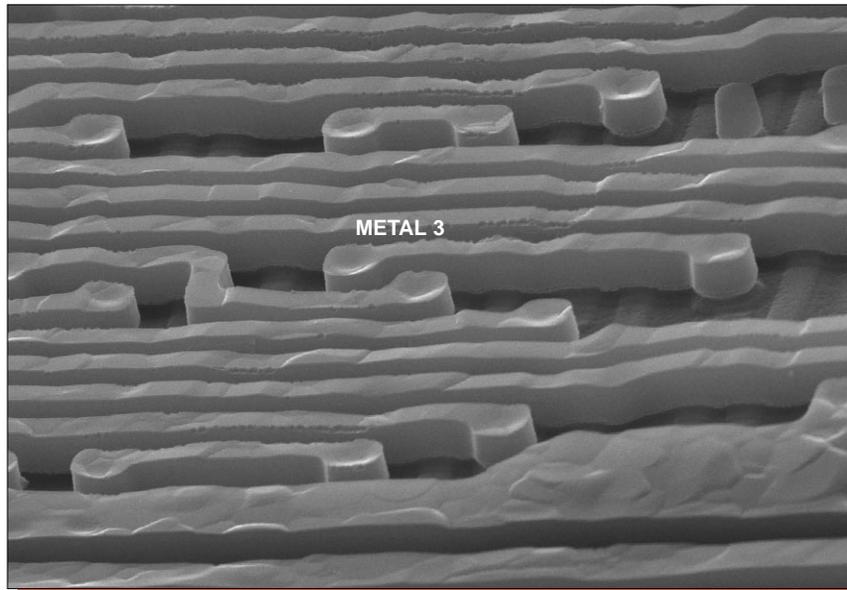
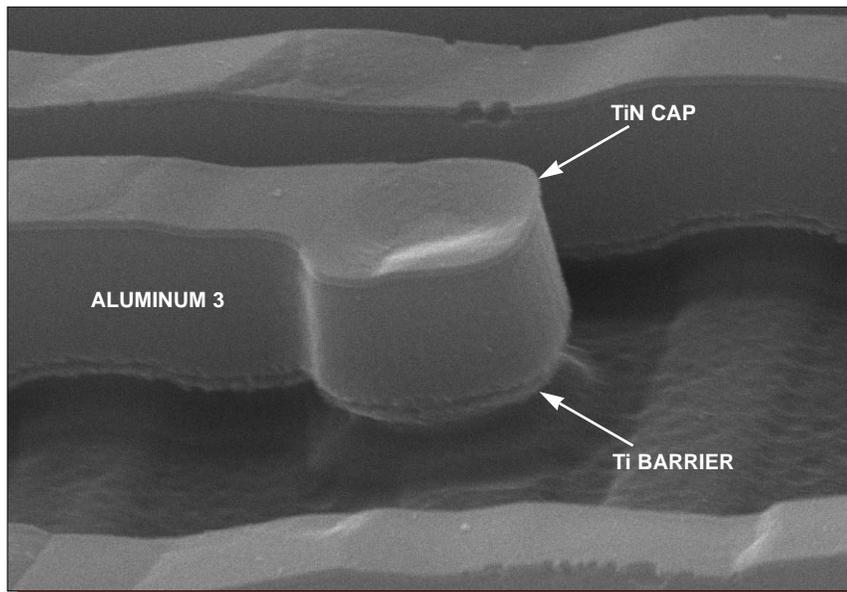
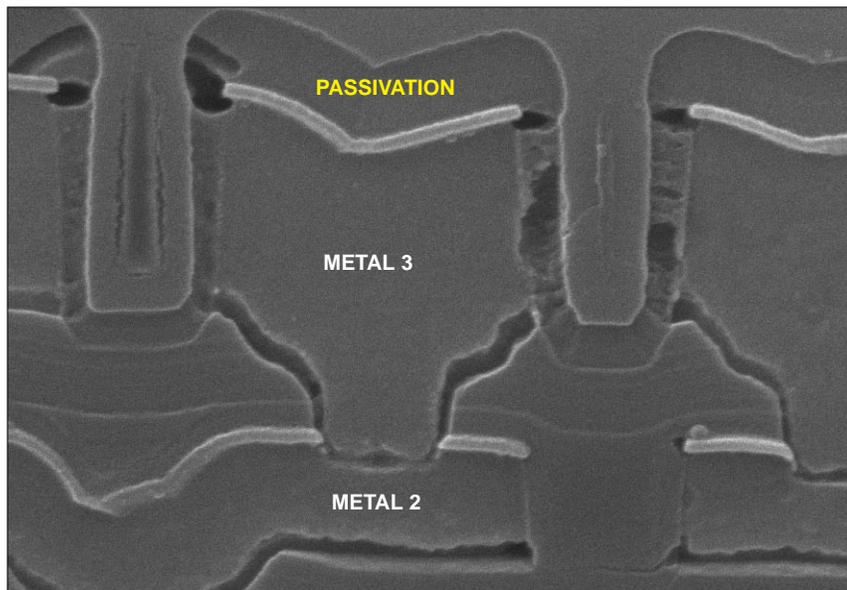
Figure 10. SEM views of metal 3 coverage and via.

- Metal step coverage: Vias under metal 3 and metal 2 were completely surrounded by metal. Metal 1 used plugs at contacts. Metal 3 and metal 2 had virtually no thinning due to the use of the aluminum filled vias. No thinning was present in metal 1 because of the use of tungsten (W) plugs at contacts.
