Construction Analysis

Xilinx XC4036EX FPGA

Report Number: SCA 9706-544

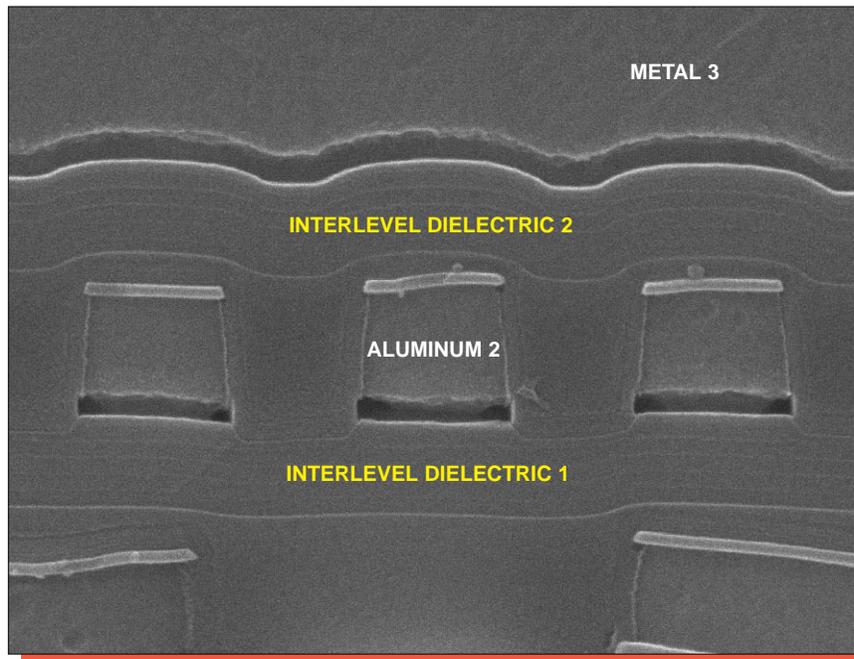
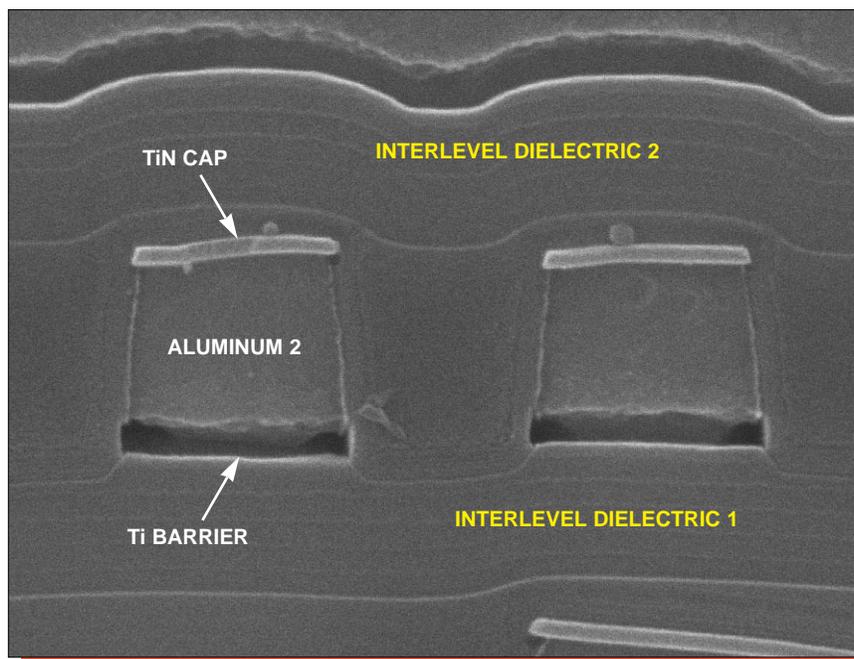
Figure 11. SEM section views of metal 2 line profiles.

- Metal patterning: All three metal levels were patterned by a dry etch of normal quality.
- Metal defects: No voiding, notching, or neckdown was noted in the metal 3 or metal 2. No silicon nodules were noted following removal of either metal layer. No problems were noted in any of the layers.

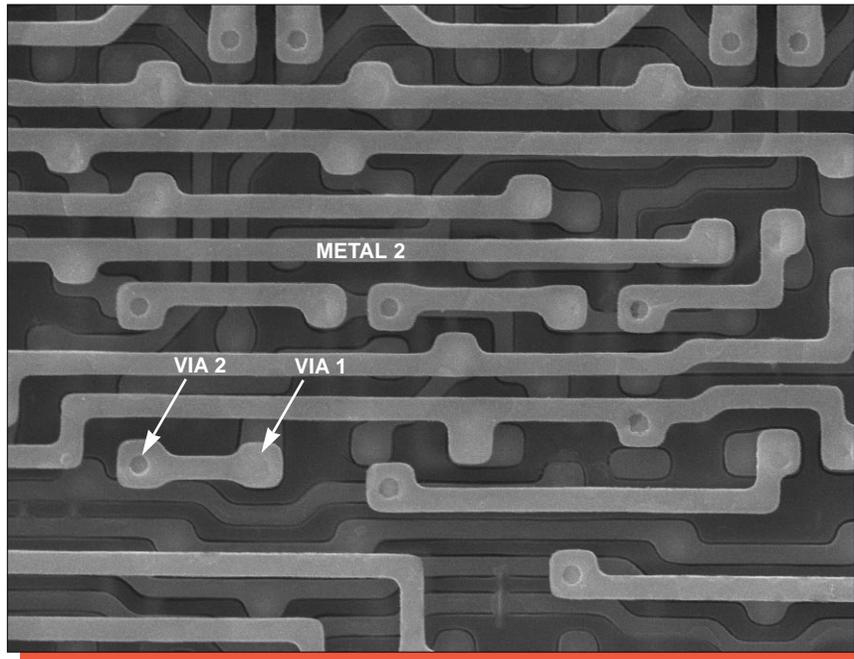
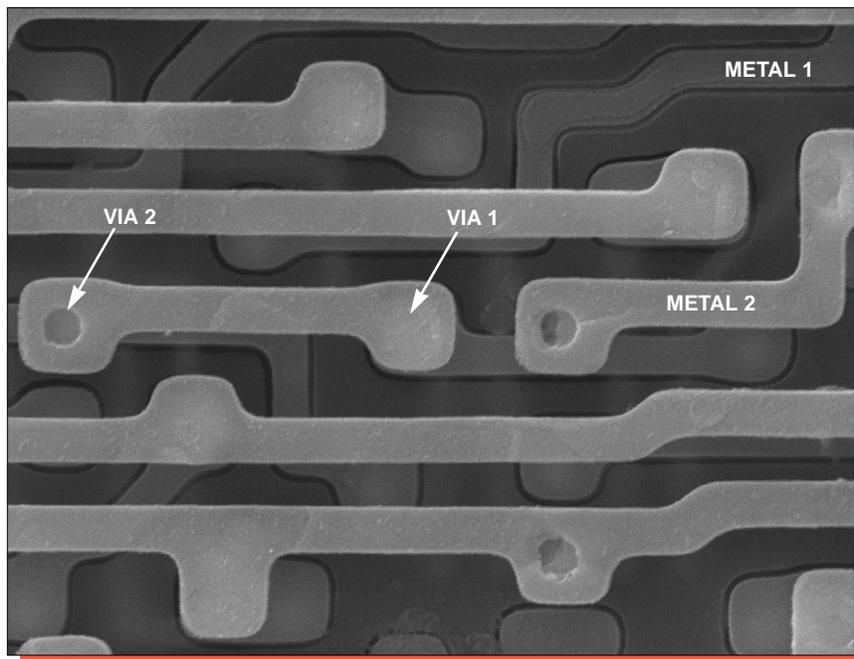
Figure 12. Topological SEM views of metal 2 patterning. 0°.

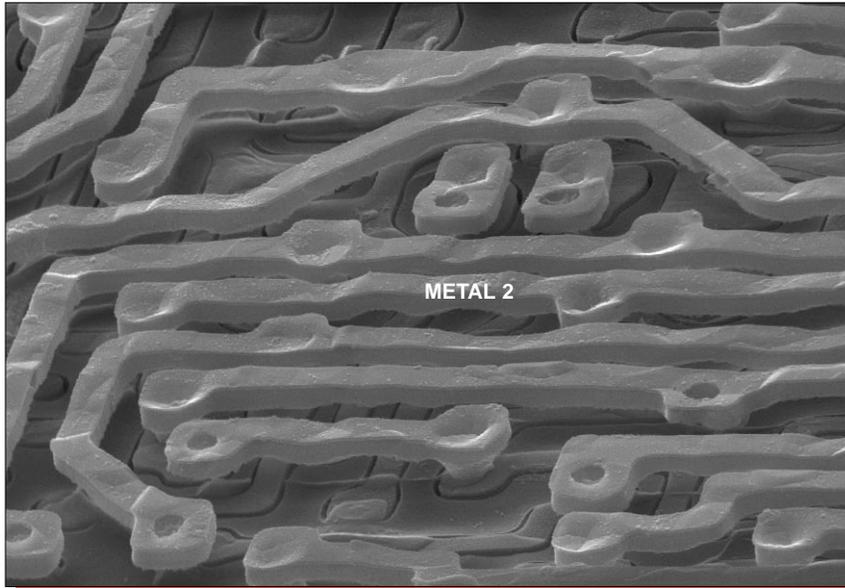
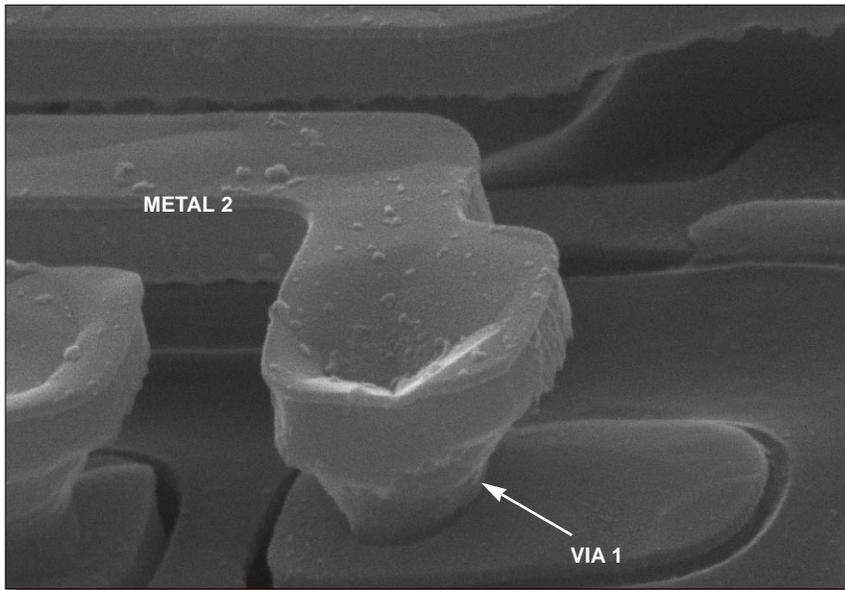
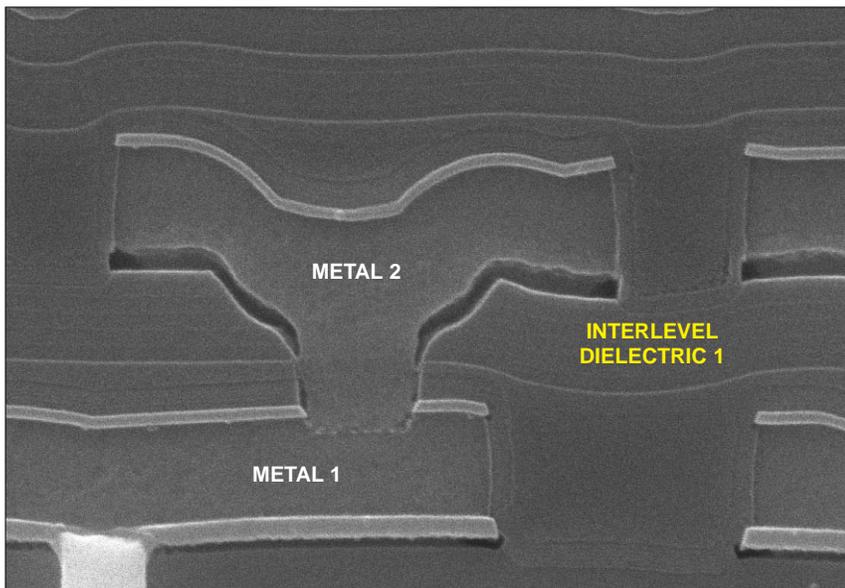
Figure 13. SEM views of metal 2 coverage and via.

- Metal step coverage: Vias under metal 3 and metal 2 were completely surrounded by metal. Metal 1 used plugs at contacts. Metal 3 and metal 2 had virtually no thinning due to the use of the aluminum filled vias. No thinning was present in metal 1 because of the use of tungsten (W) plugs at contacts.

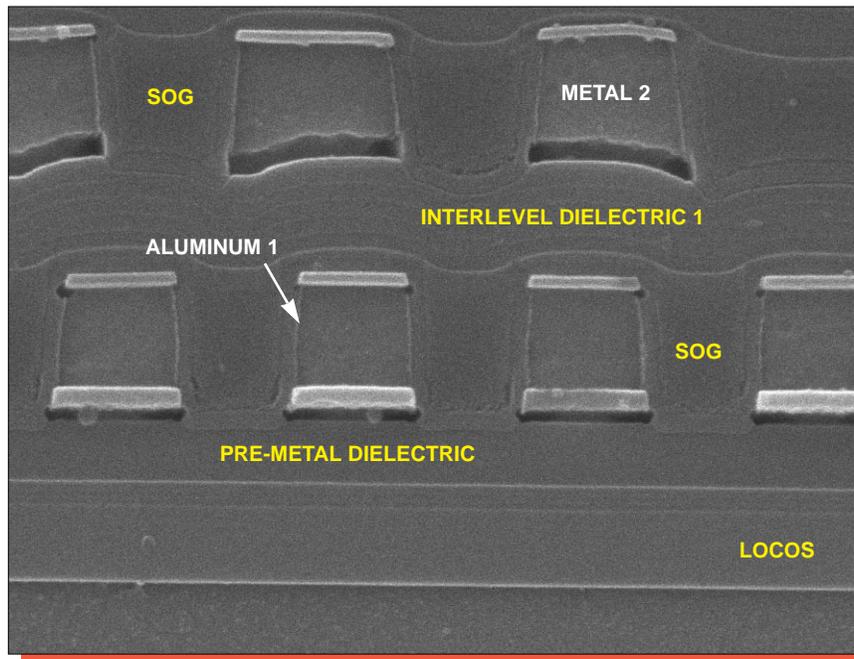
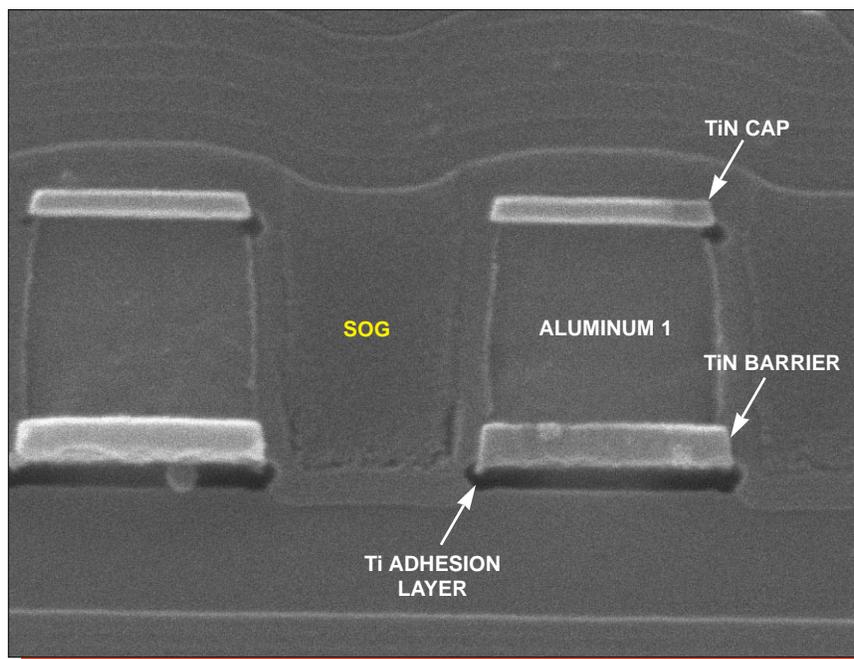
Figure 14. SEM section views of metal 1 line profiles.

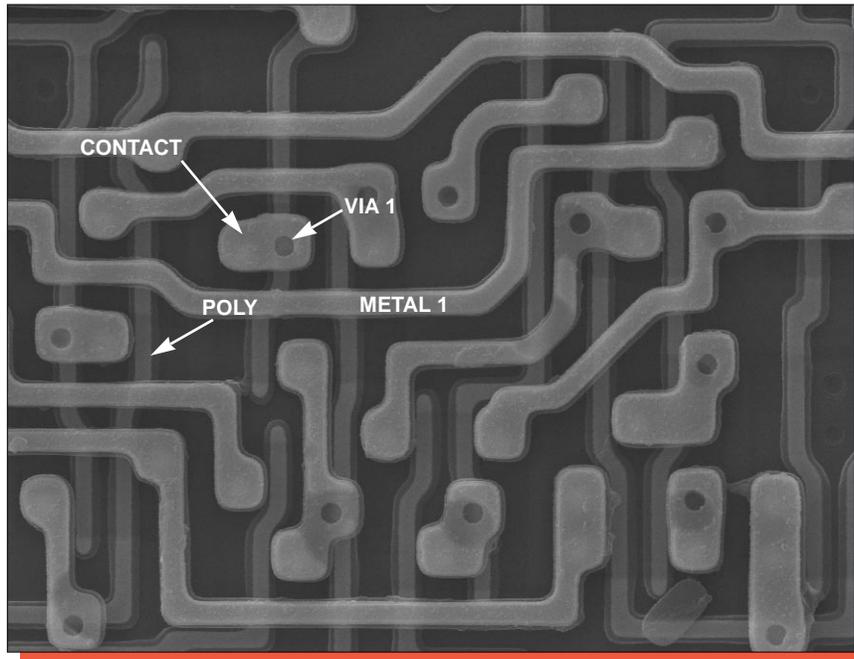
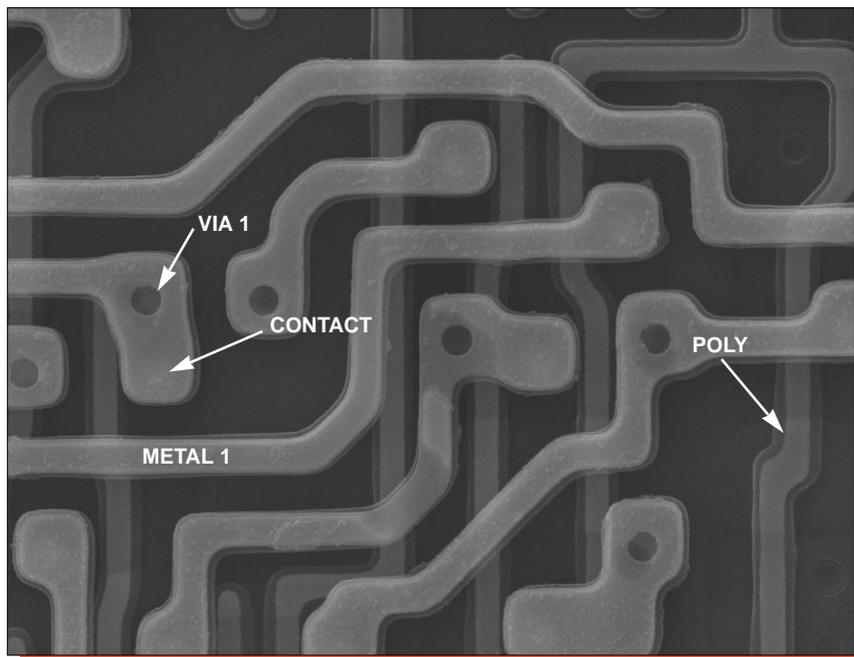
Figure 15. Topological SEM views of metal 1 patterning. 0°.

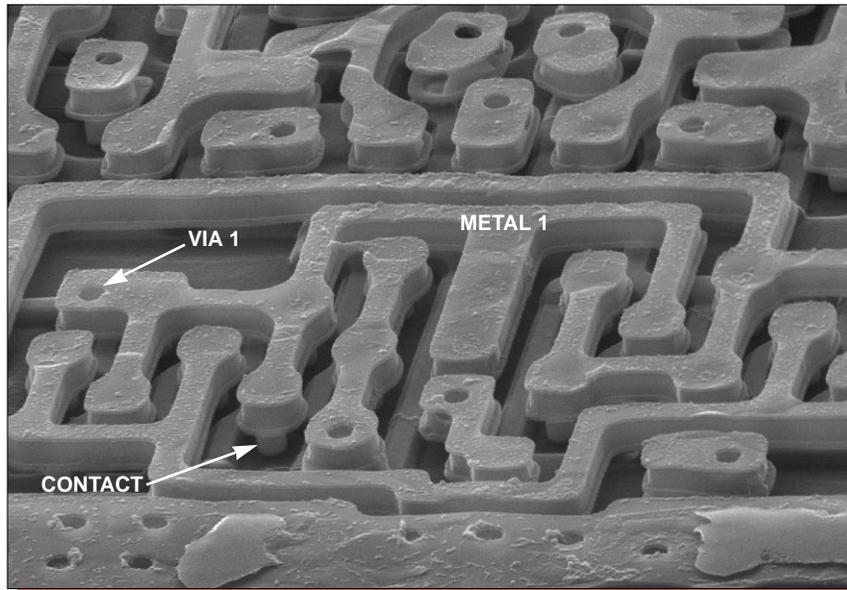
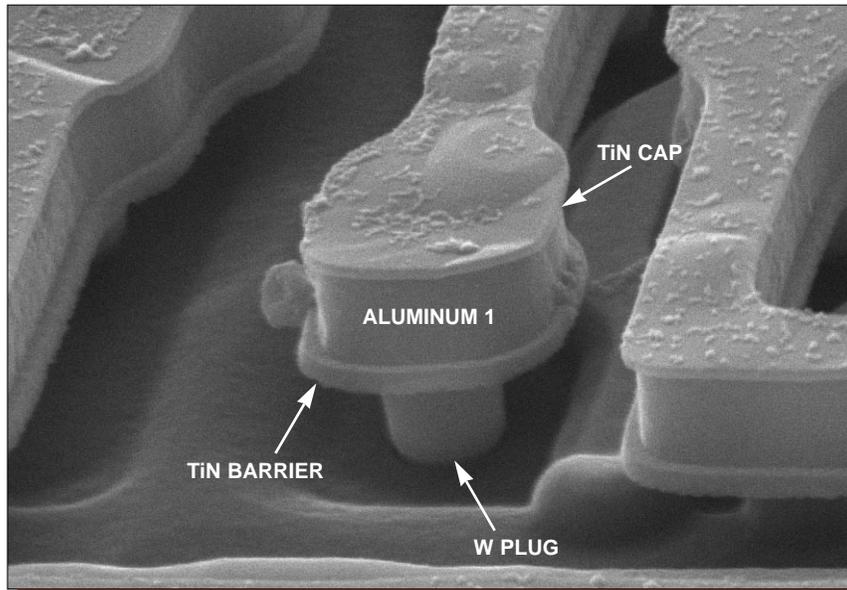
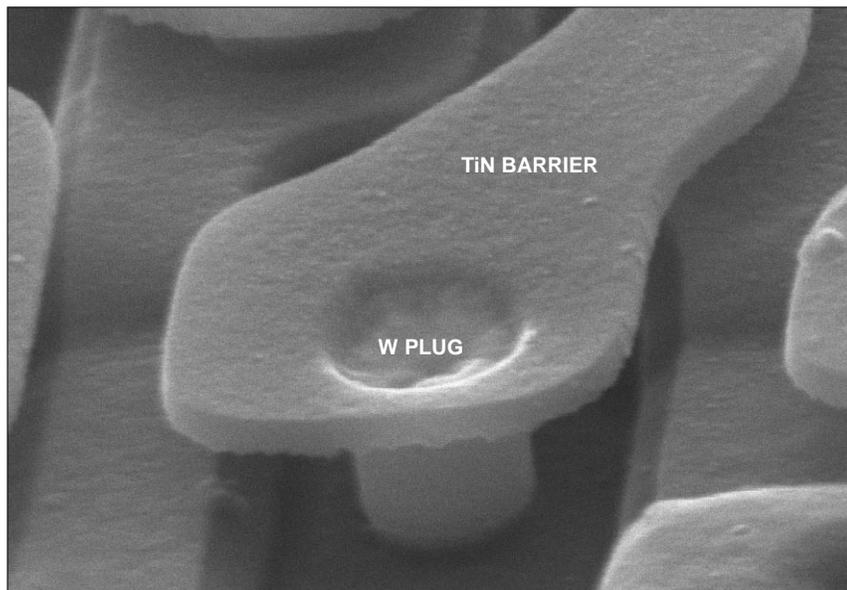
Figure 16. Perspective SEM views of metal 1 coverage and barrier. 60°.

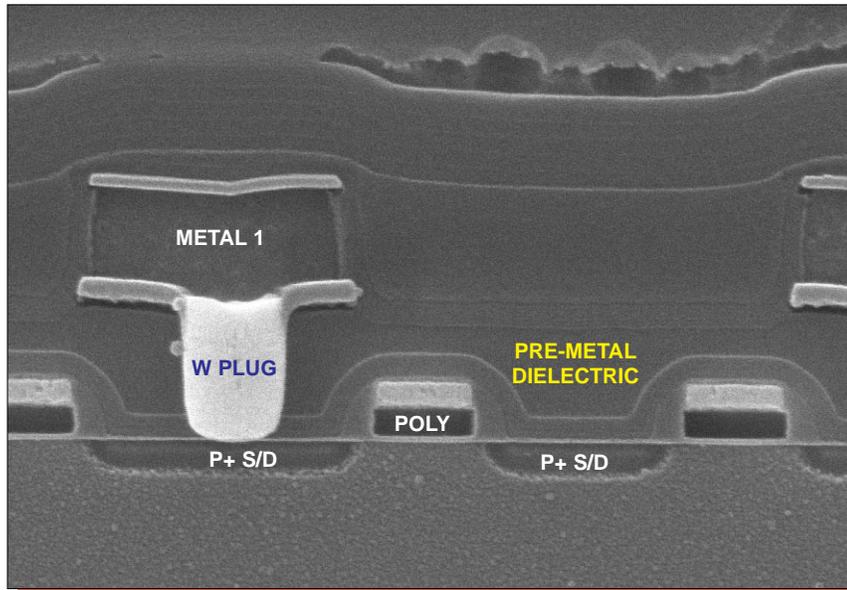
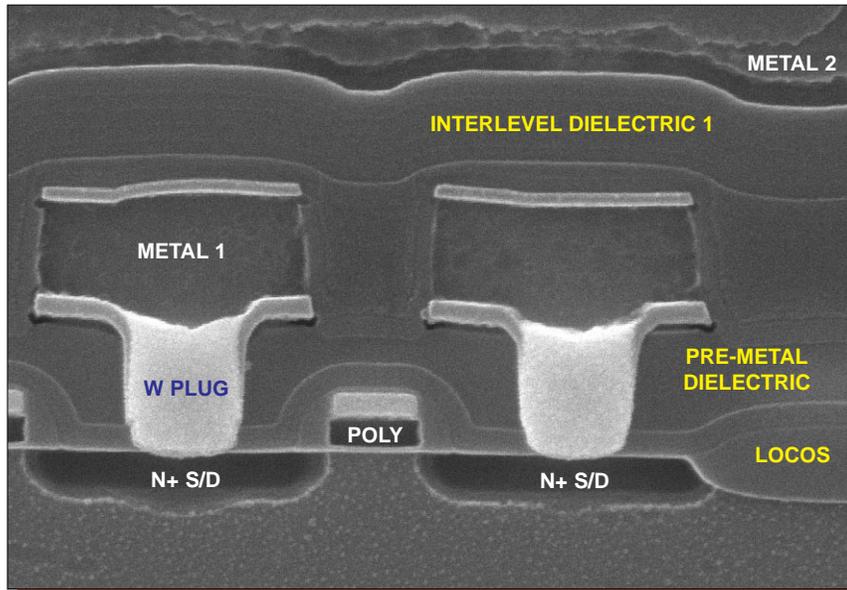
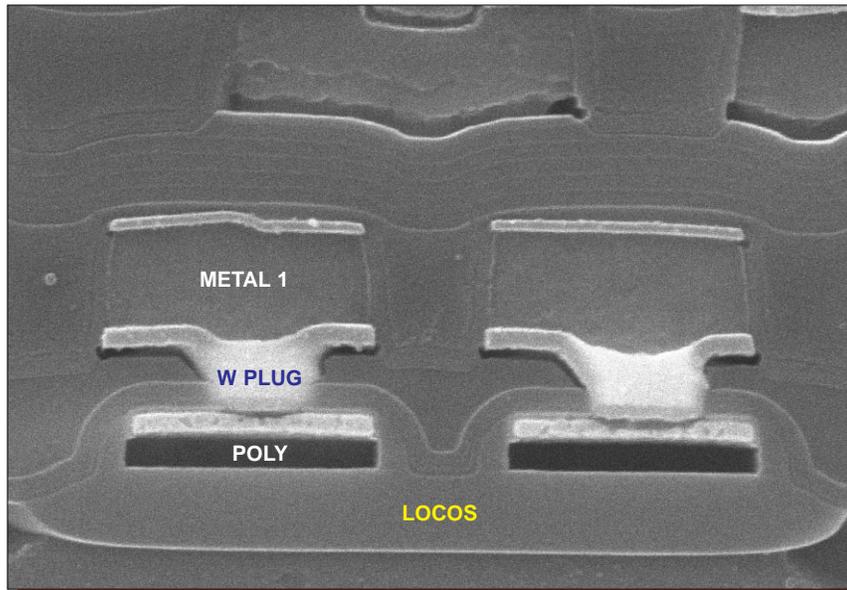
metal 1-to-P+

metal 1-to-N+

metal 1-to-poly

Figure 17. SEM section views of typical metal 1 contacts. Mag. 26,000x.

- Vias and contacts: Via cuts were defined by a two-step process. Vias appeared to have been patterned using a controlled overetch to just penetrate the titanium nitride cap to the aluminum underneath. Contacts used an apparent single etch step, lined with the titanium-nitride barrier and then filled with tungsten. No problems were found.

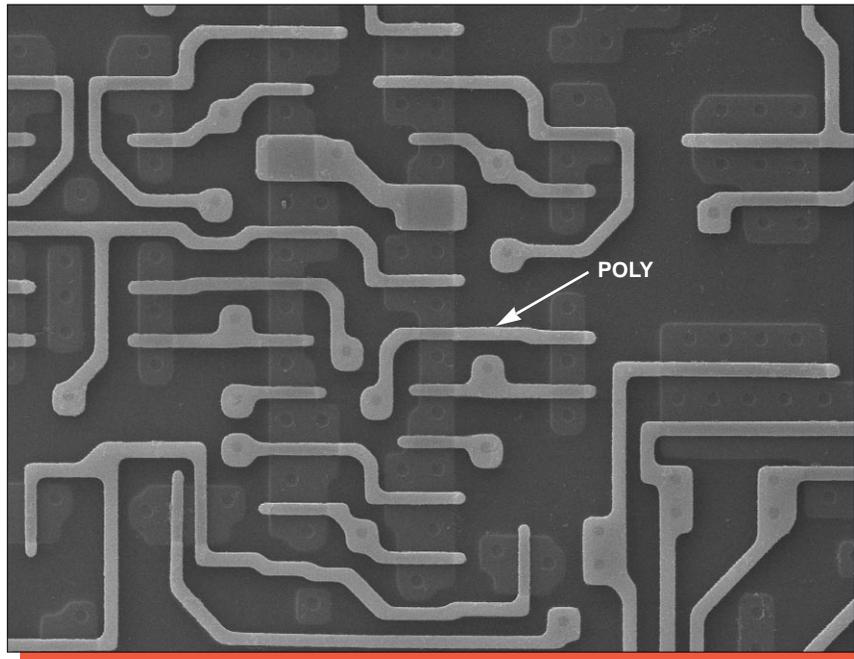
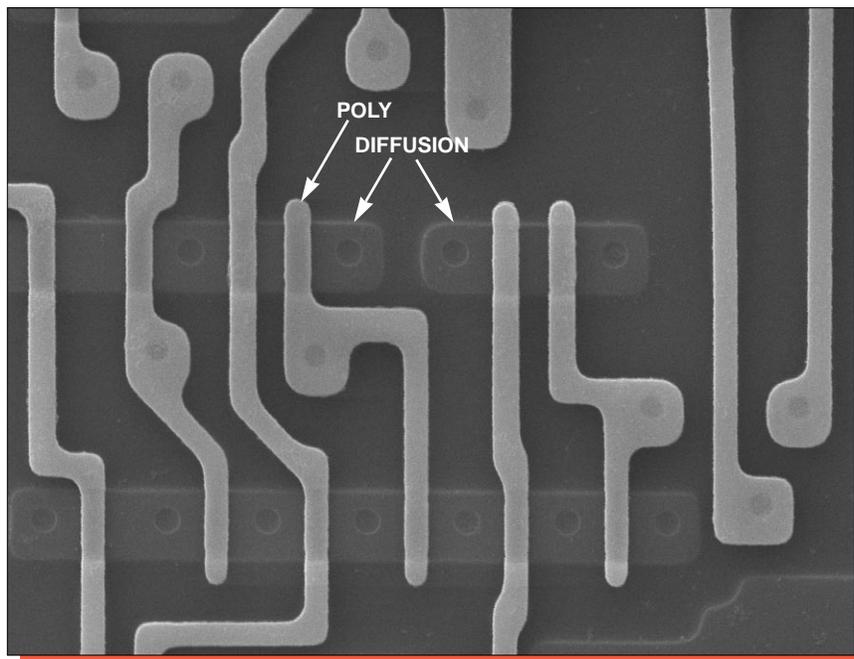
Figure 18. Topological SEM views of poly patterning. 0°.

- A single layer of polycide (poly and tungsten silicide) was used to form all gates on the die. Definition was by a dry-etch of normal quality.
- Standard implanted N+ and P+ diffusions formed the sources/drains of the CMOS transistors. The process used oxide sidewall spacers that were left in place. No problems were found.
- Local oxide (LOCOS) isolation was used. No step was present in the oxide at the well boundaries, nor did we find any other evidence of the use of P-wells.
- The memory cell array utilized a 5T SRAM cell design. Metal 3 was used to form the word lines. Metal 2 was used to form the bit lines and distribute GND and Vcc (via metal 1). Metal 1 provided cell interconnect. Poly was used to form all gates. Cell pitch was 8.7 x 9.5 microns. Process in the array appeared identical to the rest of the die.
- Redundancy fuses were not present on the die.

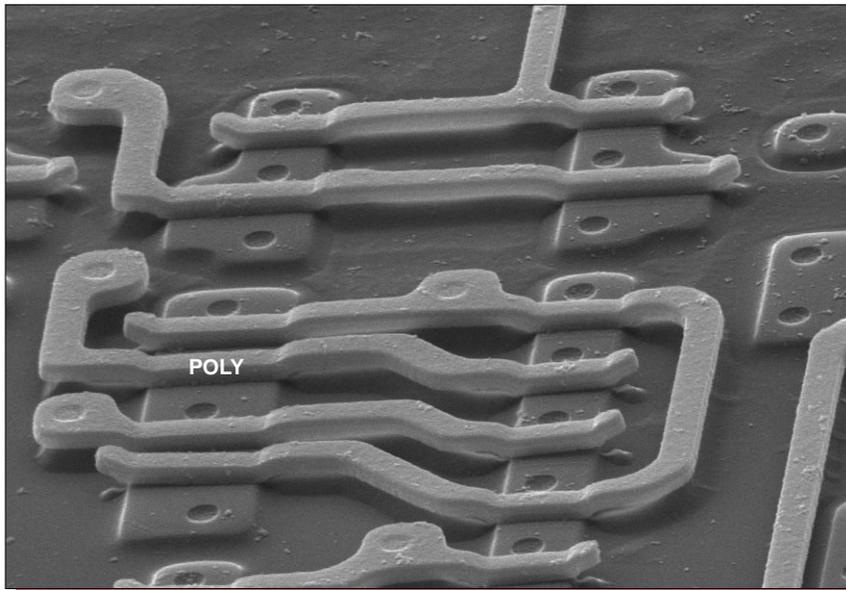
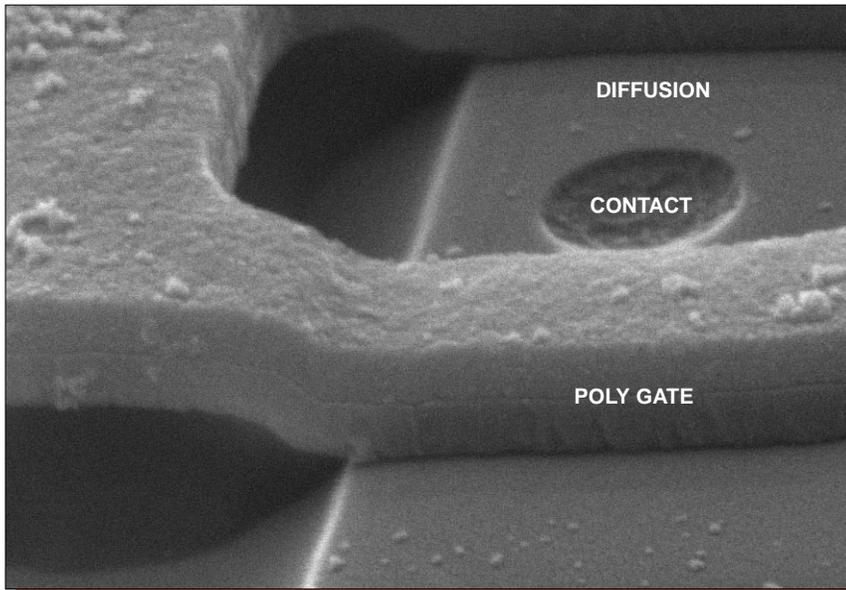
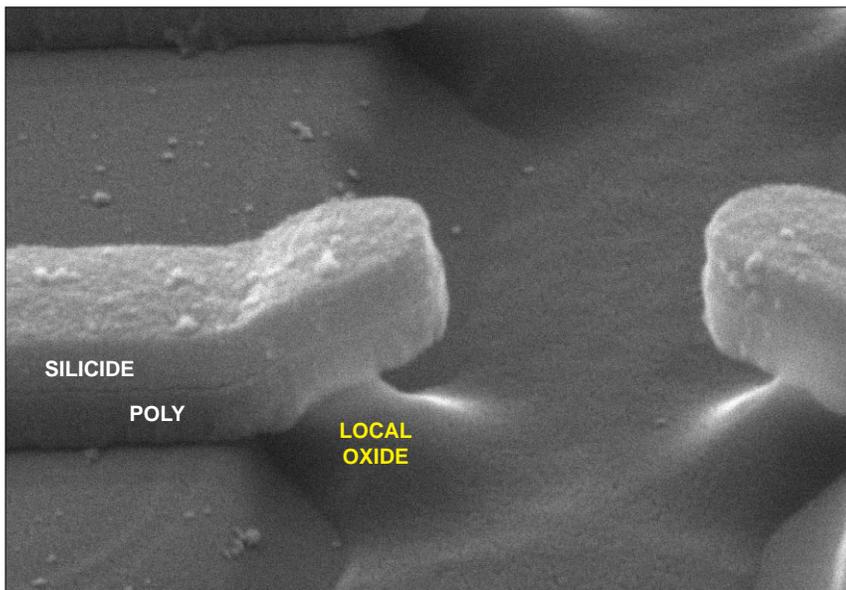
Figure 19. Perspective SEM views of poly coverage. 60°.

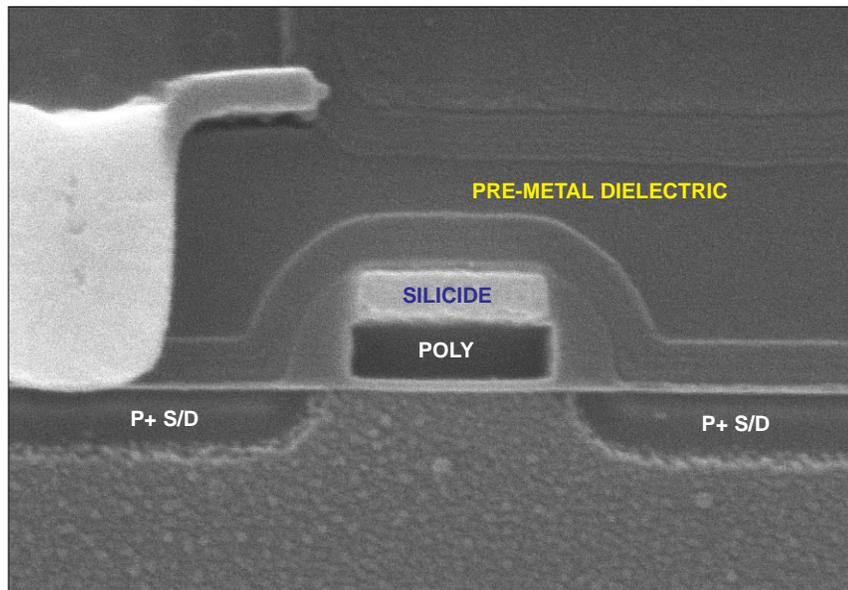
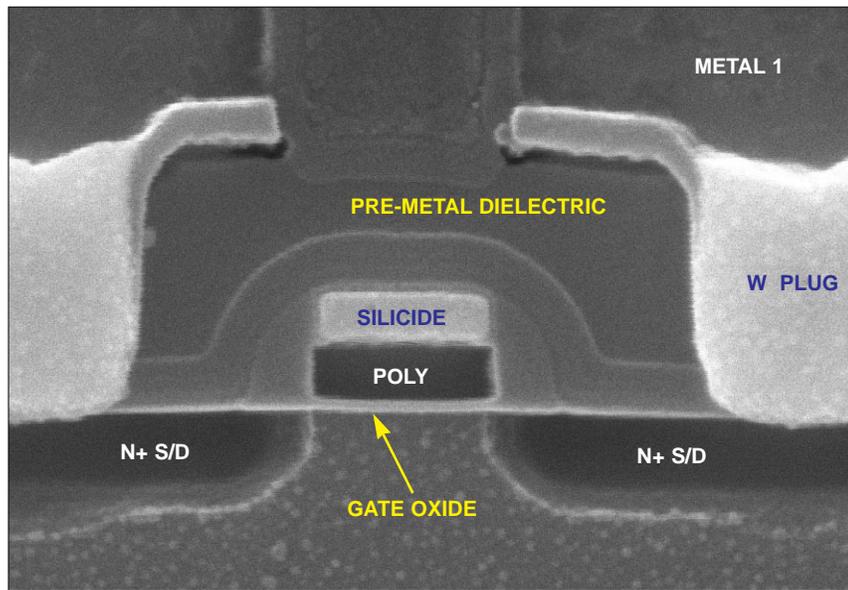
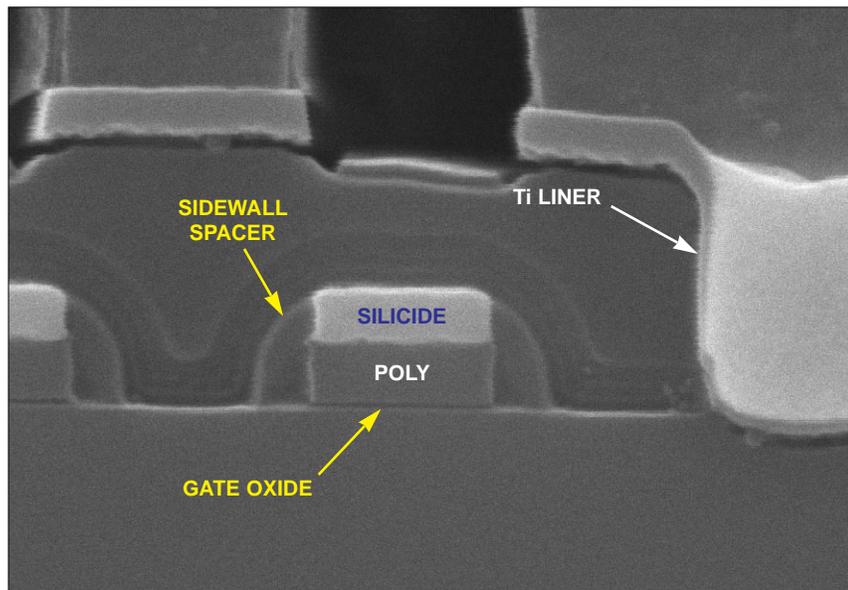
P-channel,
silicon etch

N-channel,
silicon etch

glass etch

Figure 20. SEM section views of typical transistors. Mag. 52,000x.

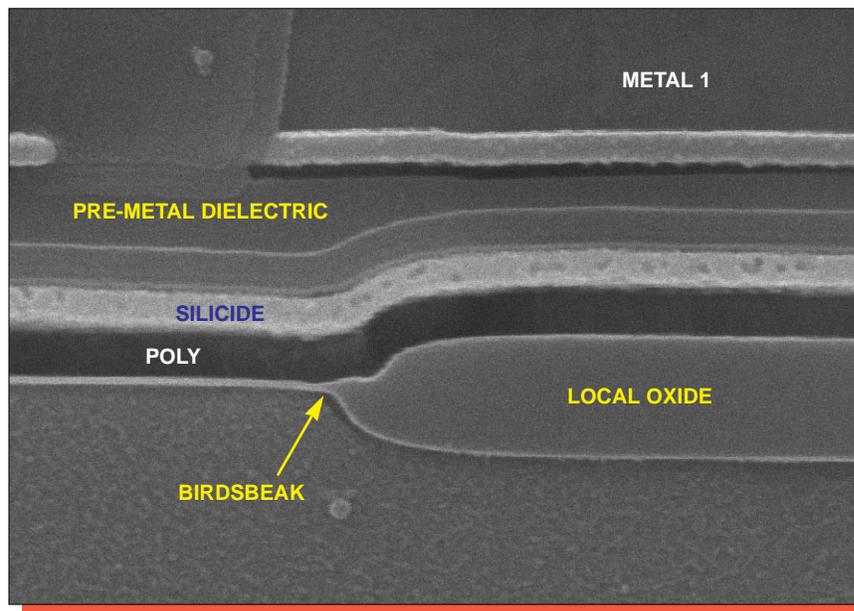
Figure 21. SEM section view of a local oxide birdsbeak. Mag. 40,000x.

- Implanted N+ and P+ diffusions formed the sources/drains of the CMOS transistors. The process used oxide sidewall spacers that were left in place.
- Local oxide (LOCOS) isolation. No step was present in the oxide at the edge of the well, and no other signs of the use of P-wells was found.

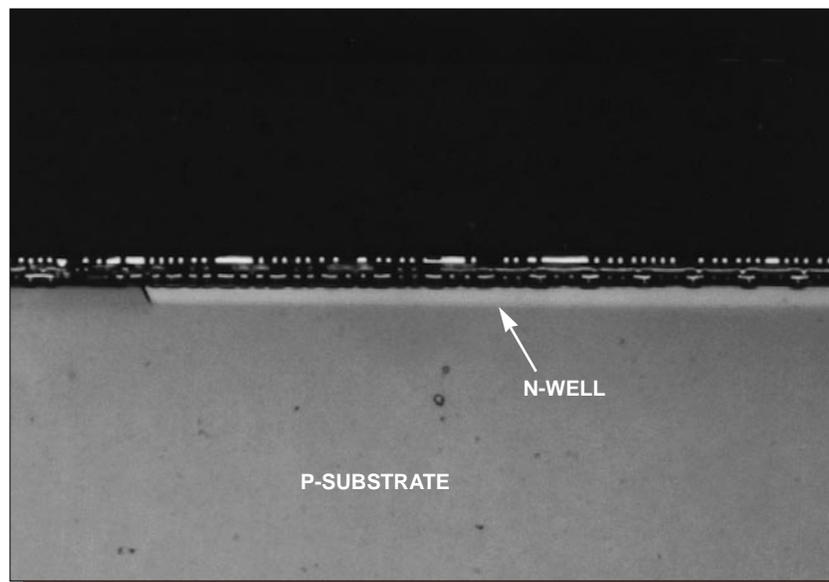
Figure 21a. Optical view of the well structure. Mag. 800x.

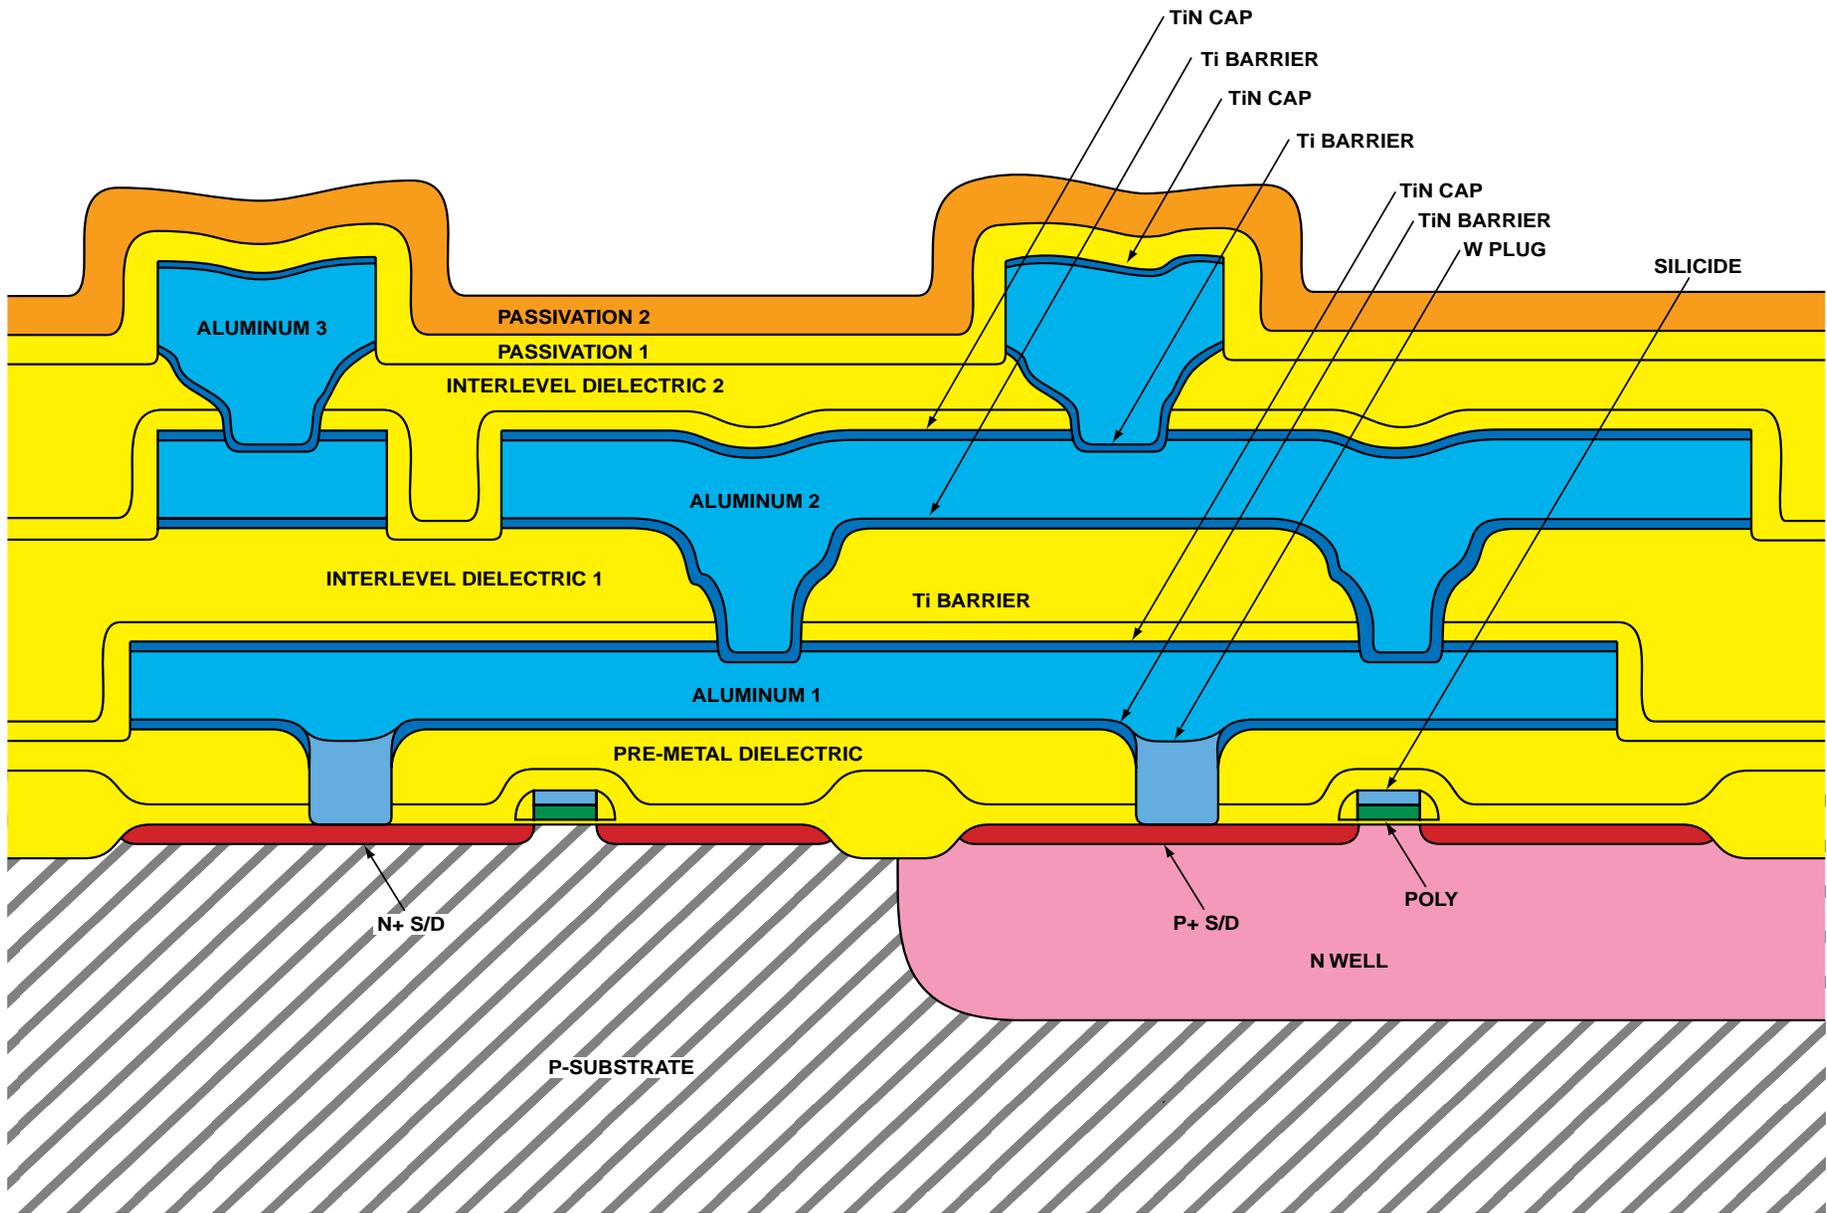
Orange = Nitride, Blue = Metal, Yellow = Oxide, Green = Poly,
 Red = Diffusion, and Gray = Substrate

Figure 22. Color cross section drawing illustrating device structure.

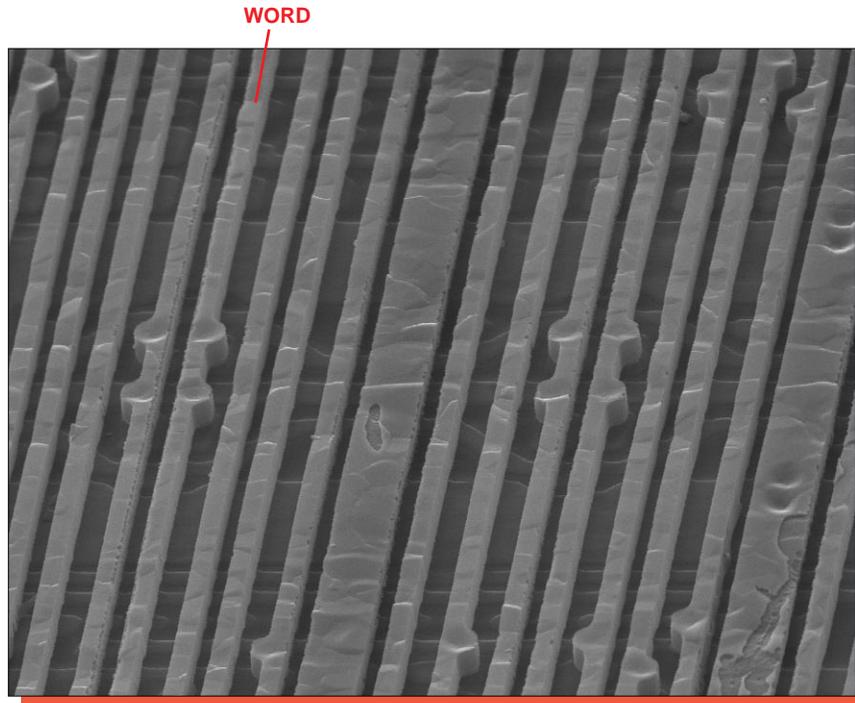
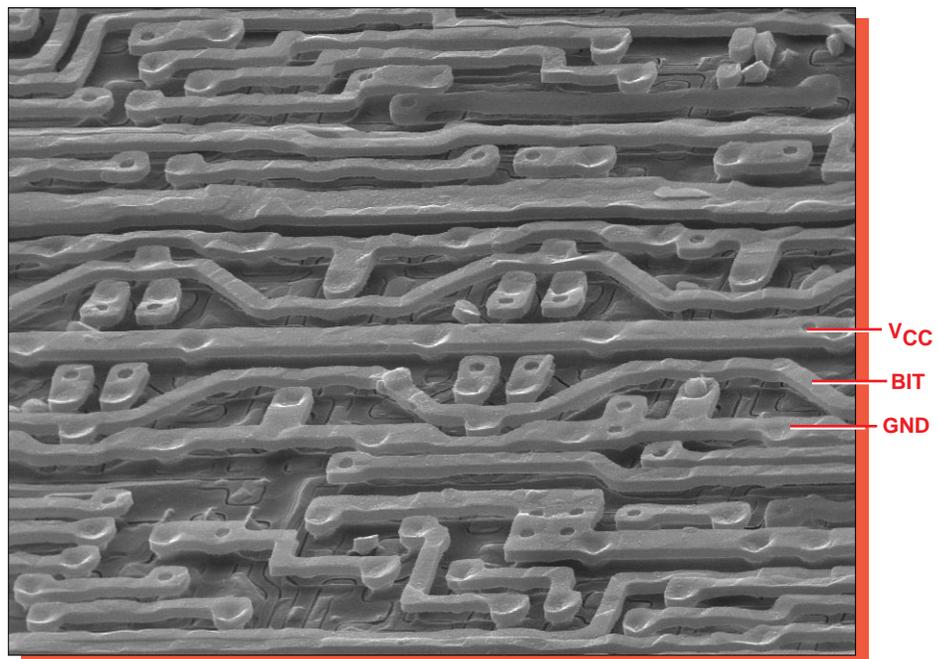
metal 3

metal 2

Figure 23. SEM views of the SRAM cell. Mag. 3200x, 60°.

- The memory cell array utilized a 5T SRAM cell design. Metal 3 was used to form the word lines. Metal 2 was used to form the bit lines and distribute GND and Vcc (via metal 1). Metal 1 provided cell interconnect. Poly was used to form all gates. Variations in the metal interconnect layout were observed.

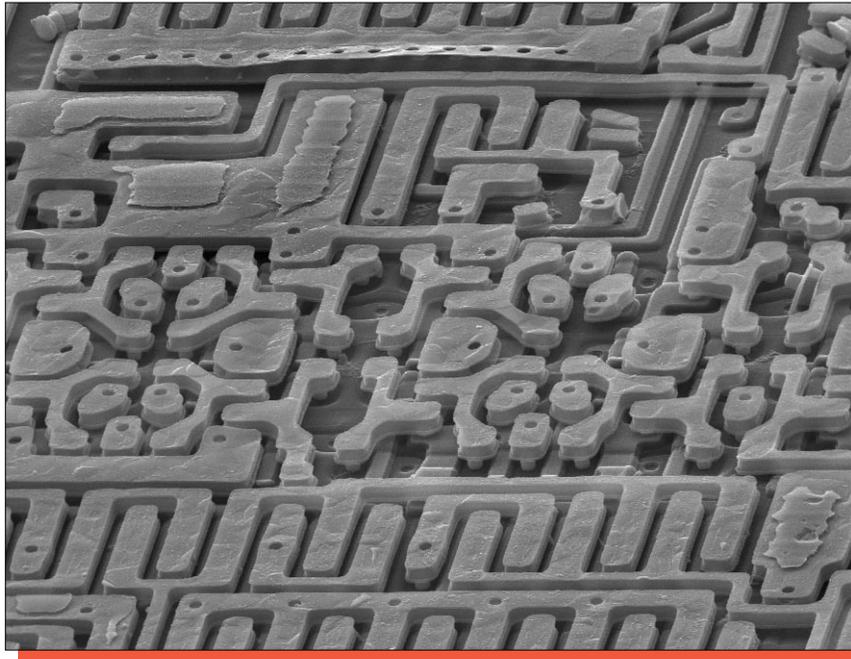
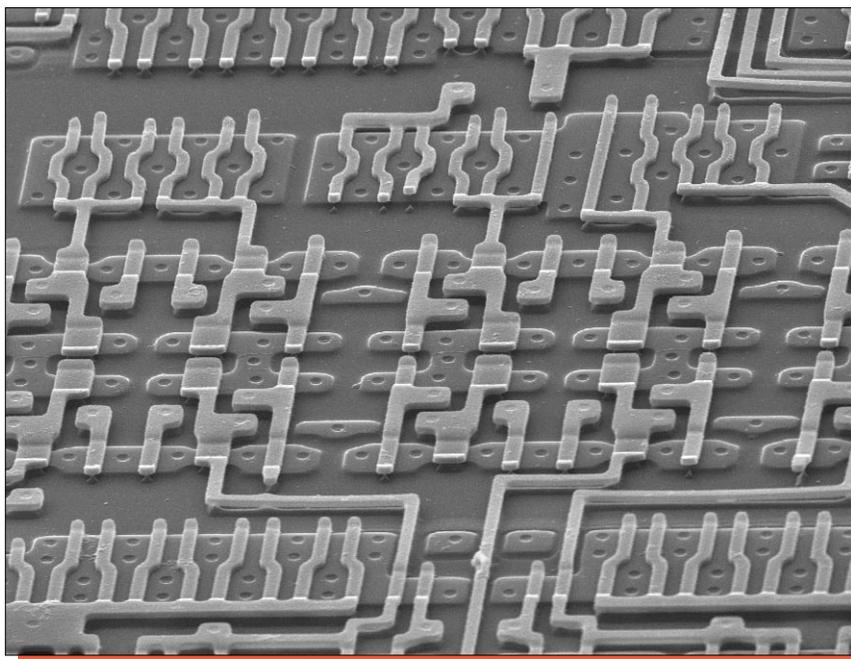
metal 1

poly

Figure 24. SEM views of the SRAM cell. Mag. 3200x, 60°.

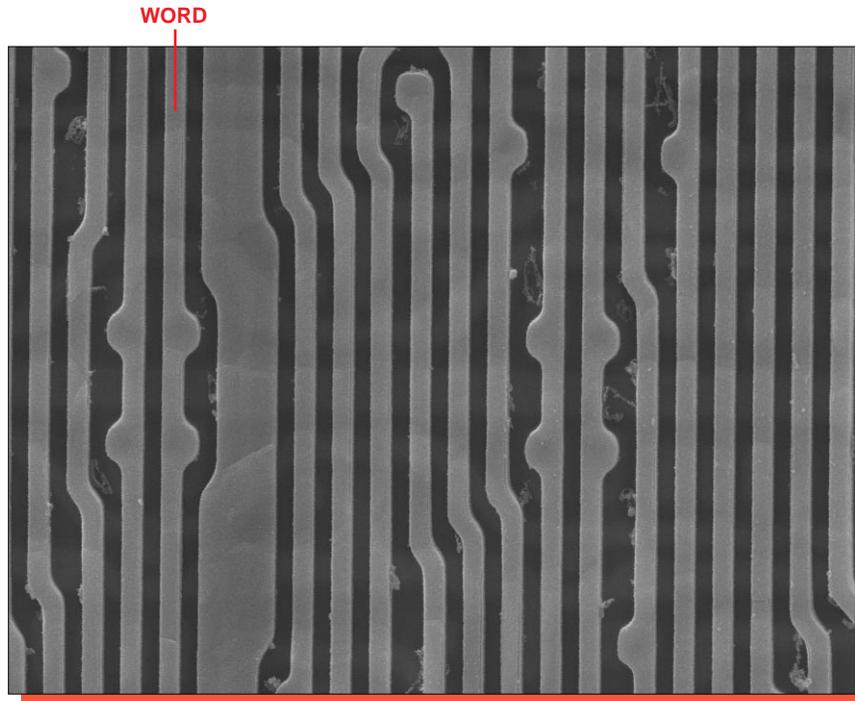
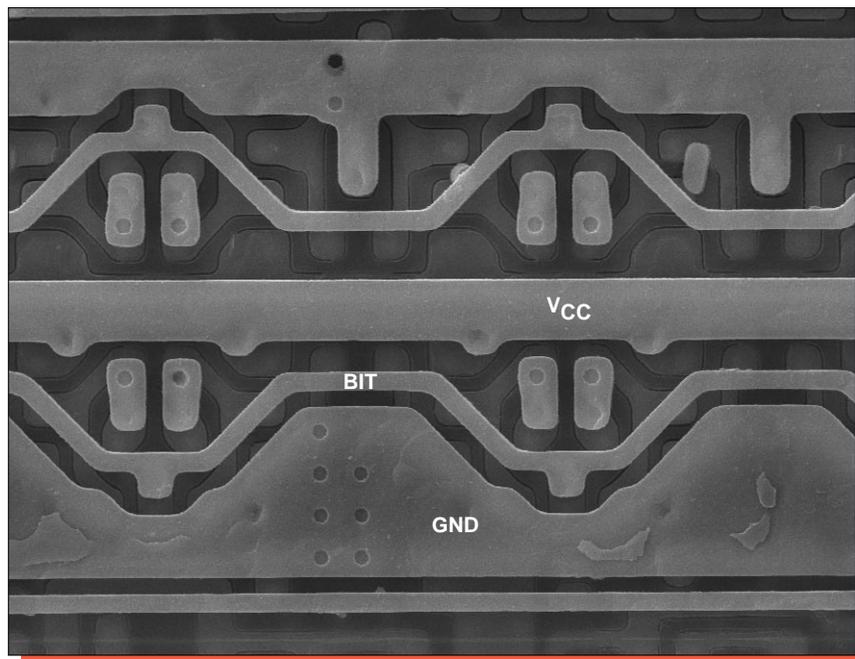
metal 3

metal 2

Figure 25. Topological SEM views of the SRAM cell. Mag. 3200x, 0°.

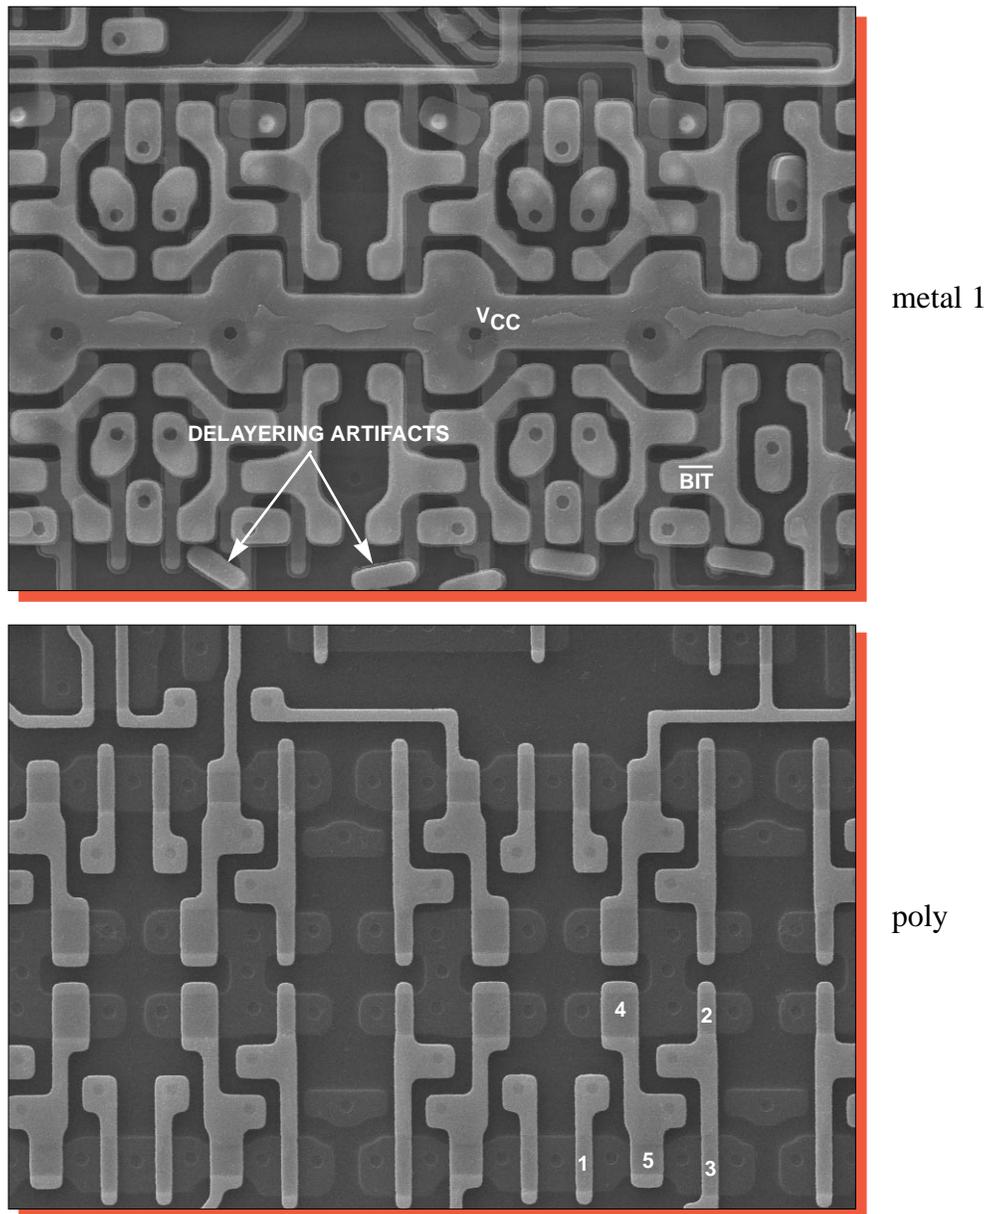
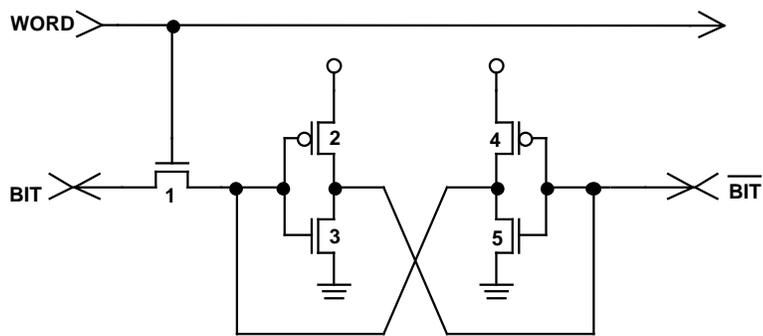
Figure 26. Topological views and schematic of the SRAM cell. Mag. 3200x, 0°.
