Construction Analysis

Xilinx XC4036EX FPGA

Report Number: SCA 9706-544

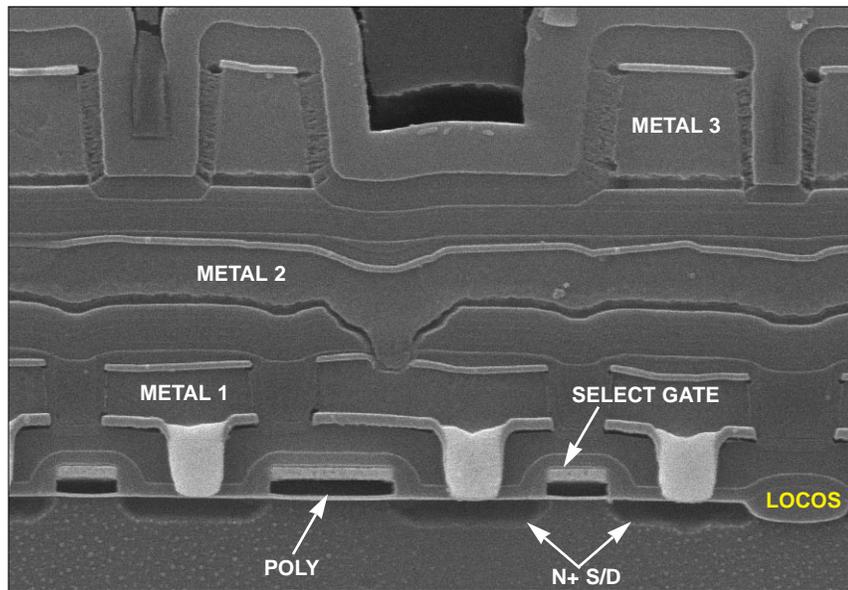
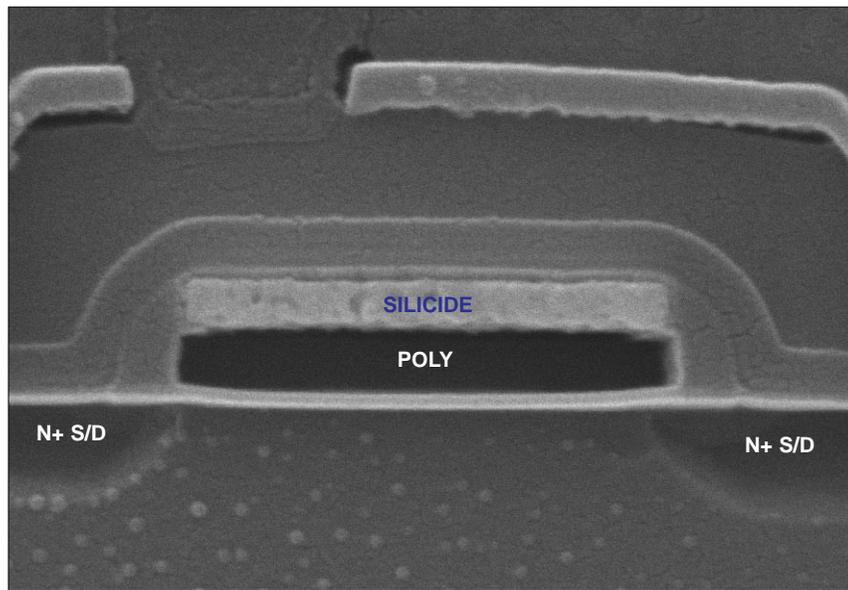
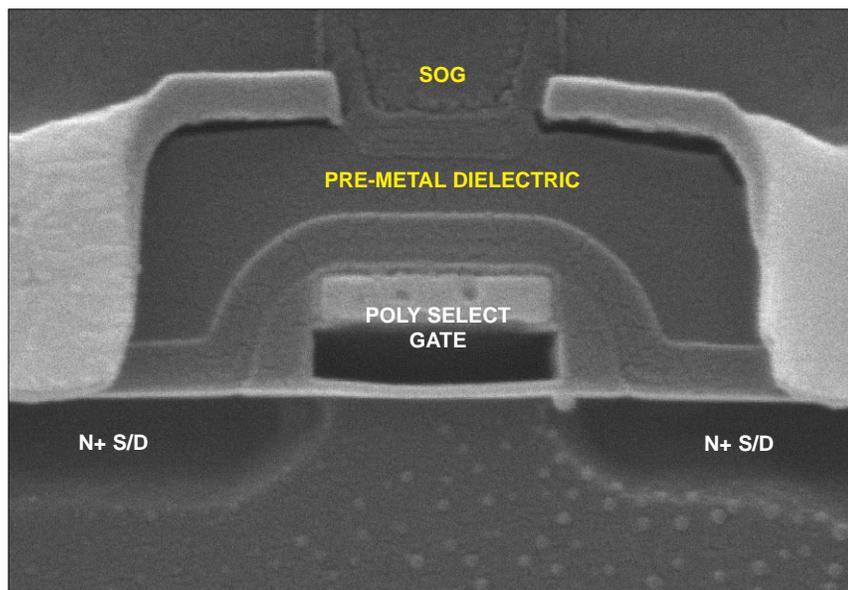
Figure 27. SEM section views of the SRAM cell.

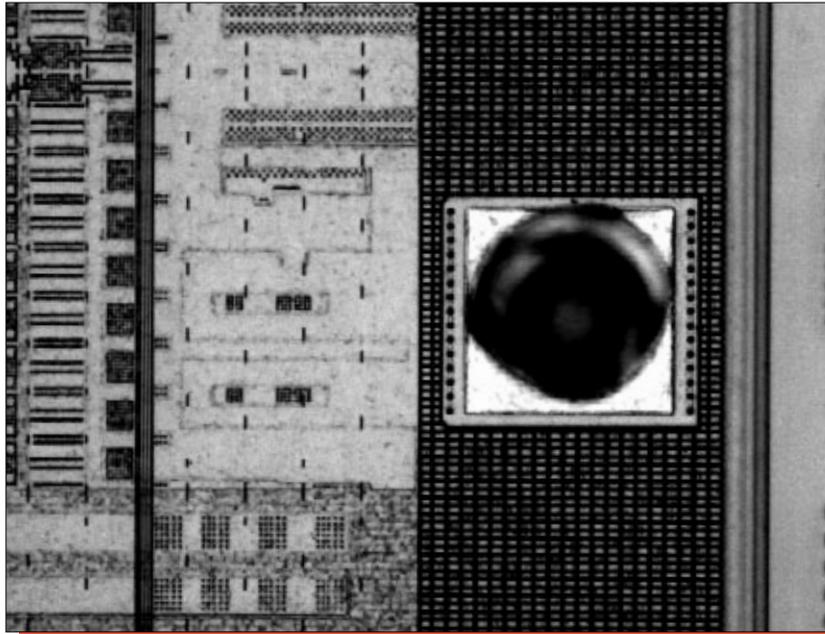
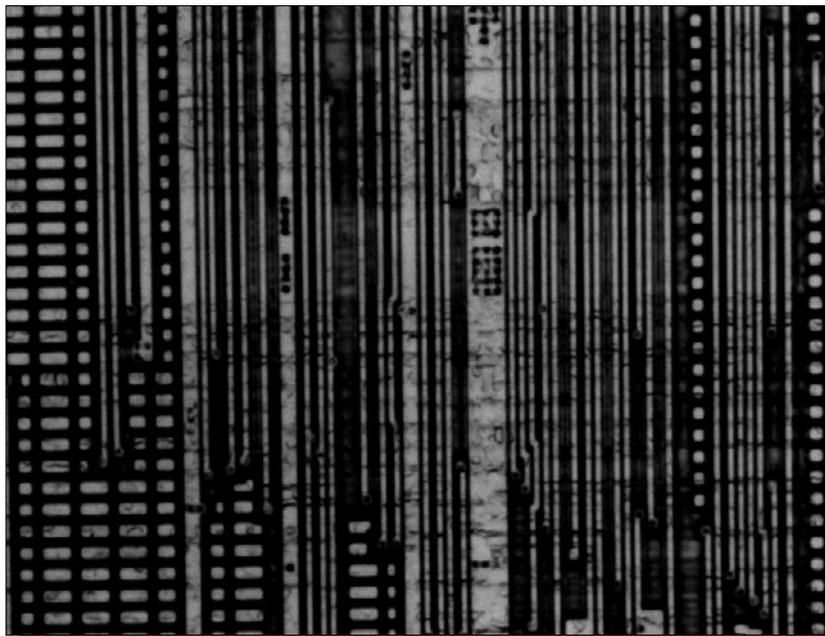
Figure 28. Optical views of the I/O structure and general circuitry.
