Construction Analysis

Motorola PC603R Microprocessor

Report Number: SCA 9709-551

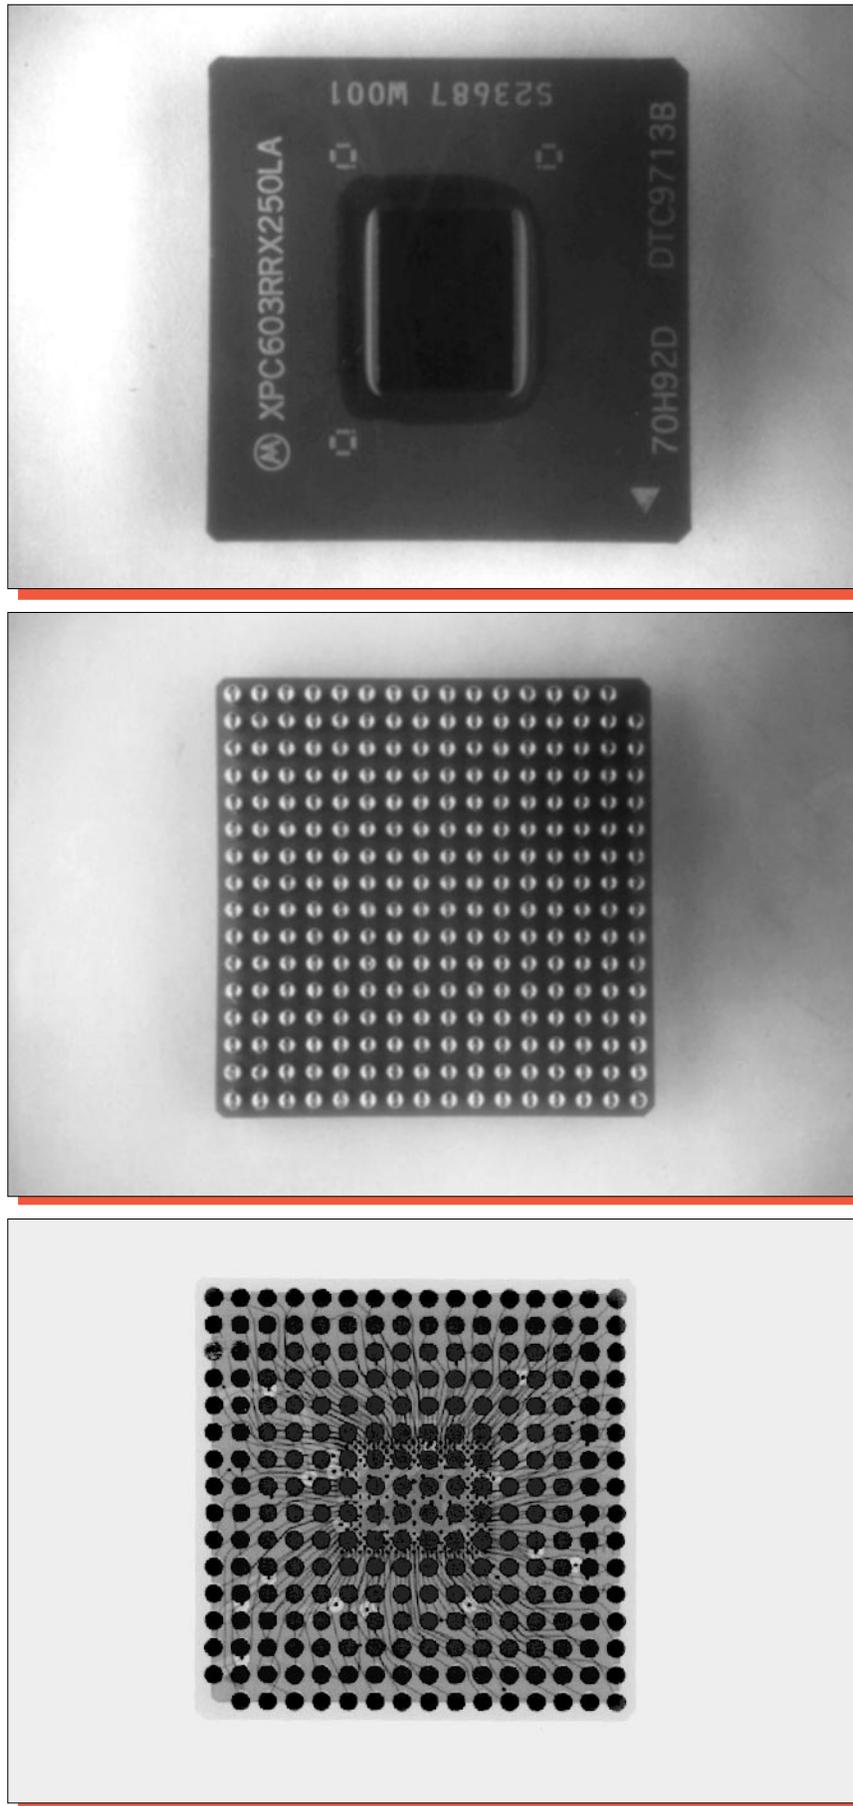
Figure 1. Package photographs and x-ray view of the Motorola PC603R Microprocessor. Mag. 2.8x.

- The devices were packaged in 256-pin (255 actual pins) Ball Grid Arrays (BGAs). The die was mounted surface down on the ceramic substrate (C4 flip-chip assembly).
- A blue colored underfill was present between the die surface and the ceramic substrate.
- Solder balls were employed for all connections to die metallization (C4 flip-chip process). There appeared to be space for standard bond pads around the die perimeter although used for protection diodes (?) in this case (see Figure 6).
- Sawn dicing (full depth).

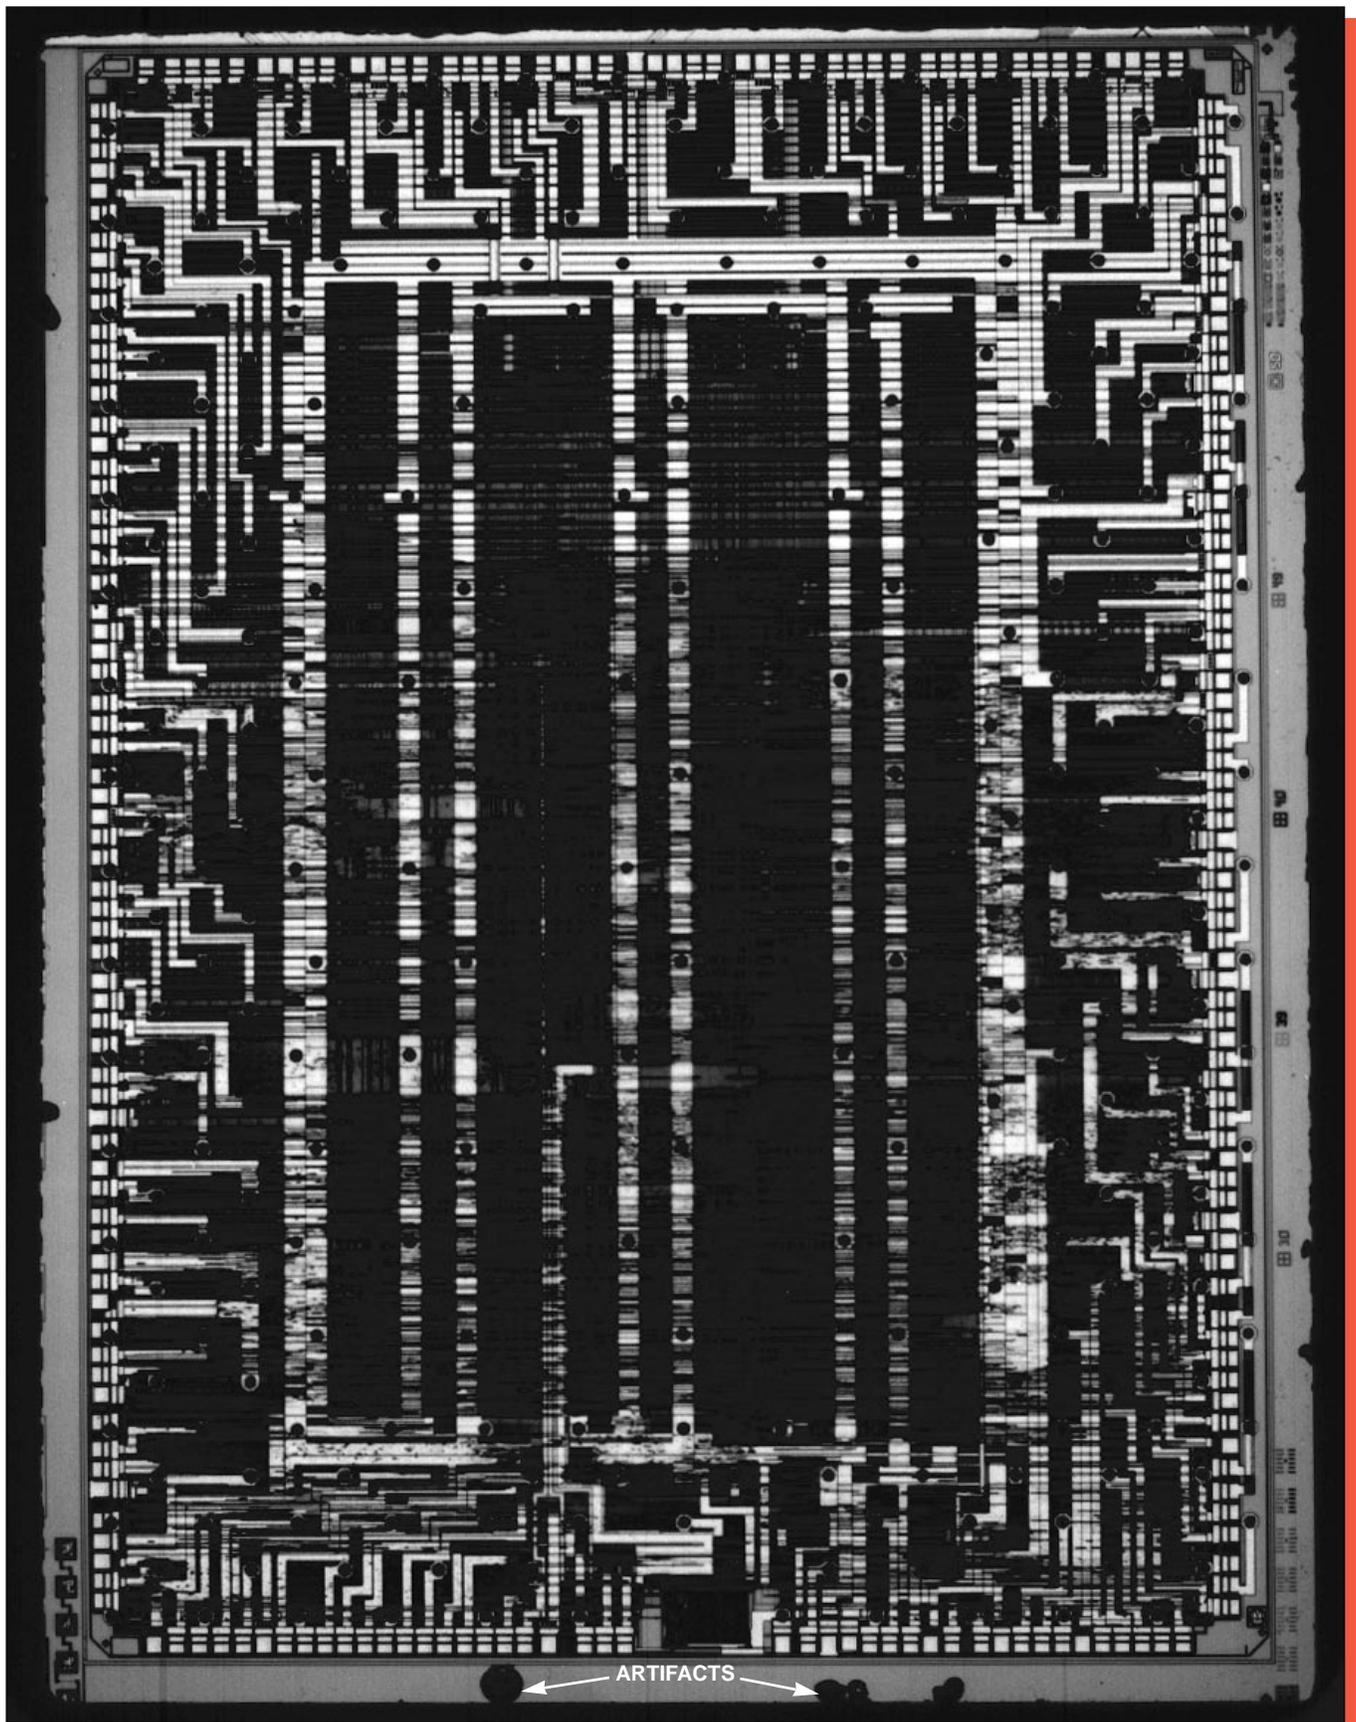
Figure 2. Whole die photograph of the Motorola PC603R Microprocessor. Mag. 28x.

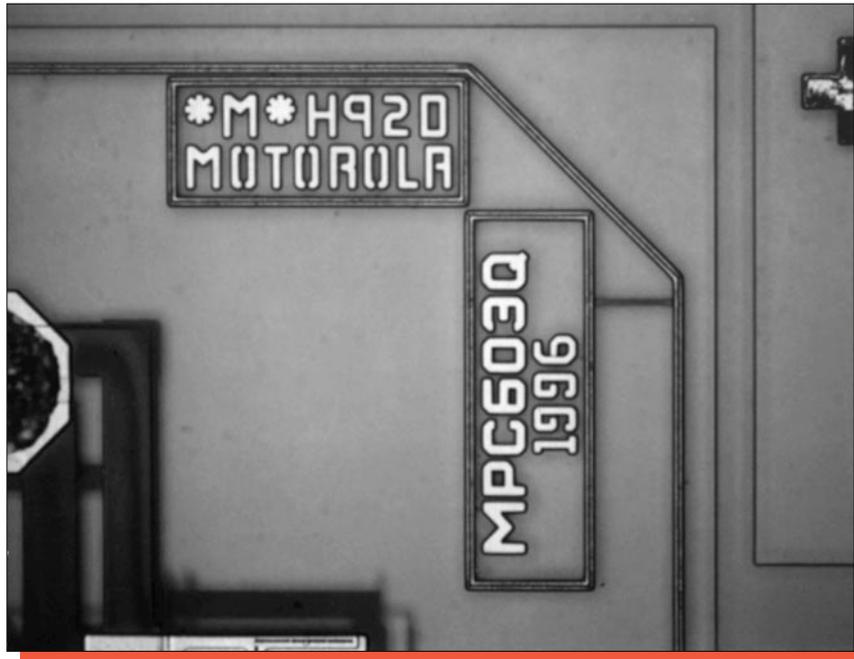
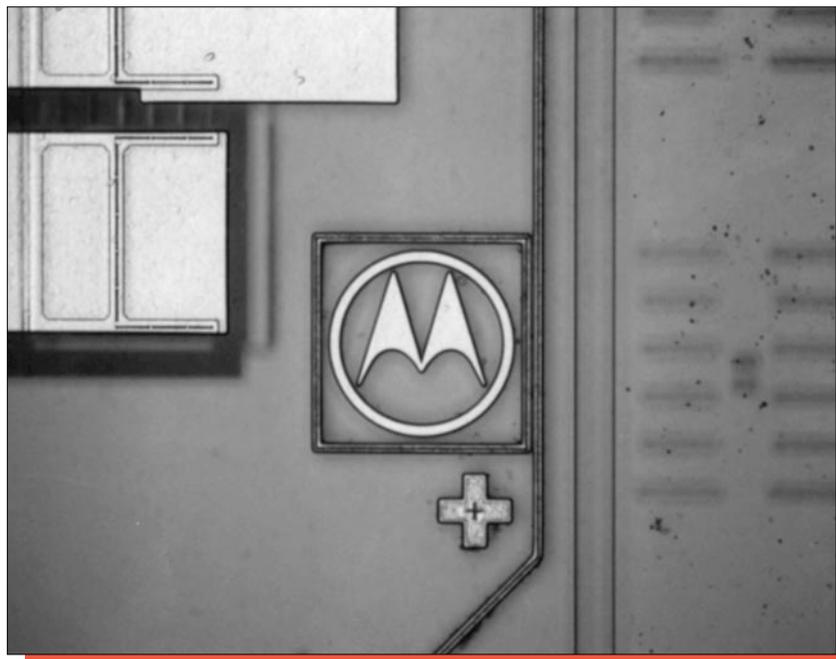
Figure 3. Die markings from the surface. Mag. 320x.

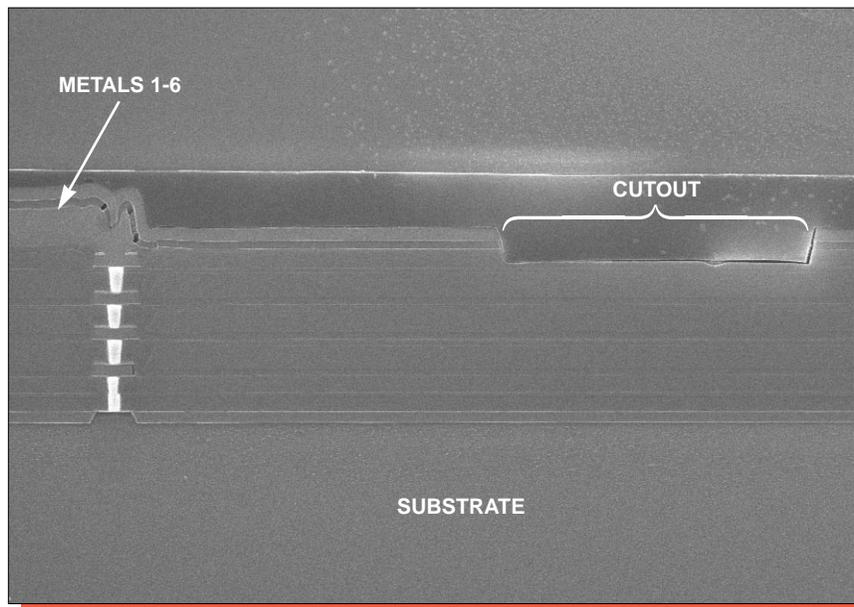
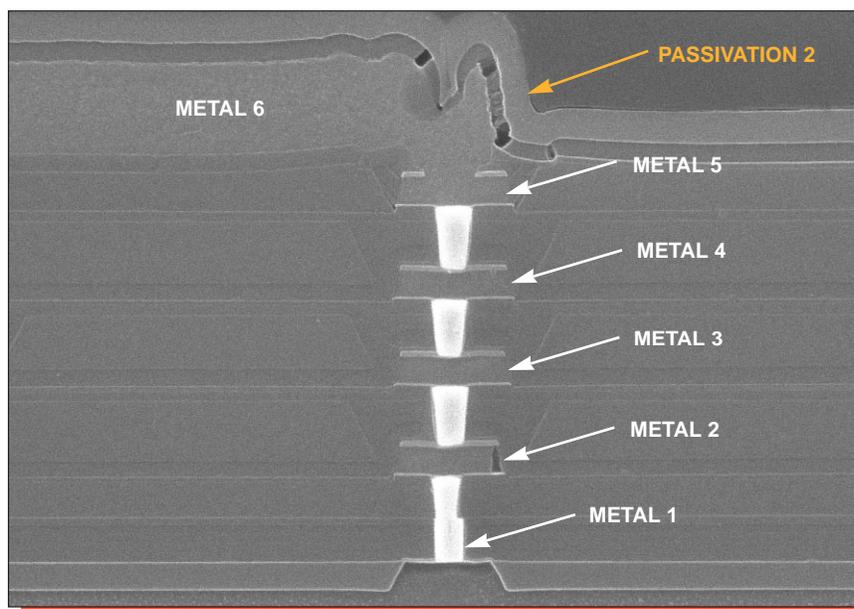
Figure 5. SEM section views of the edge seal structure.

- Final passivation: A layer of nitride over a layer of glass. Coverage was good. Edge seal was also good as the passivation extended to the scribe lane to seal the metallization. A cutout was present in the passivation and ILD 5 around the die perimeter to prevent cracks from radiating over the circuitry.

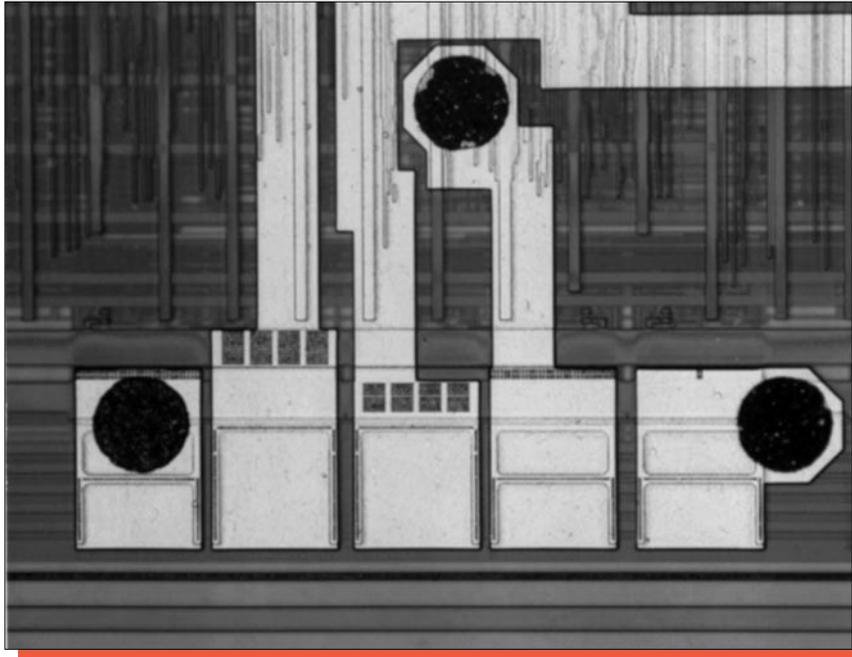
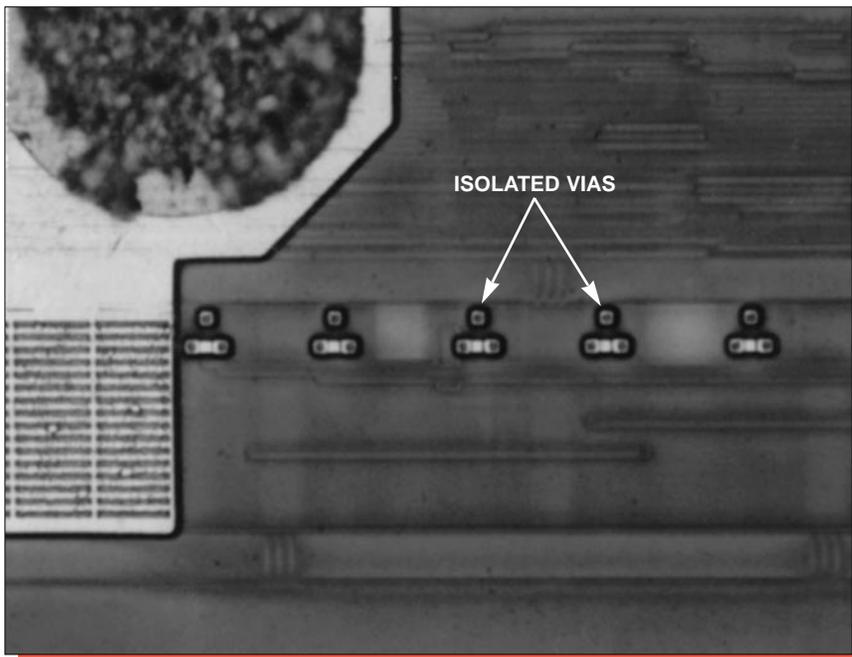
Figure 6. Optical views of layout features.

- Fabrication process: Oxide filled shallow-trench isolation, BiCMOS process employing twin-wells in an apparent P-epi on a P substrate. No problems were found in the process.
- Design implementation: Die layout was clean and efficient. Alignment was adequate at most levels; however, alignment of metals 2 and 4 to their respective underlying plugs was poor. Plug coverage was only 35-to-40 percent at some metal 2 and 4 vias. Some isolated metal 6 vias were noted on the die (see Figure 6).

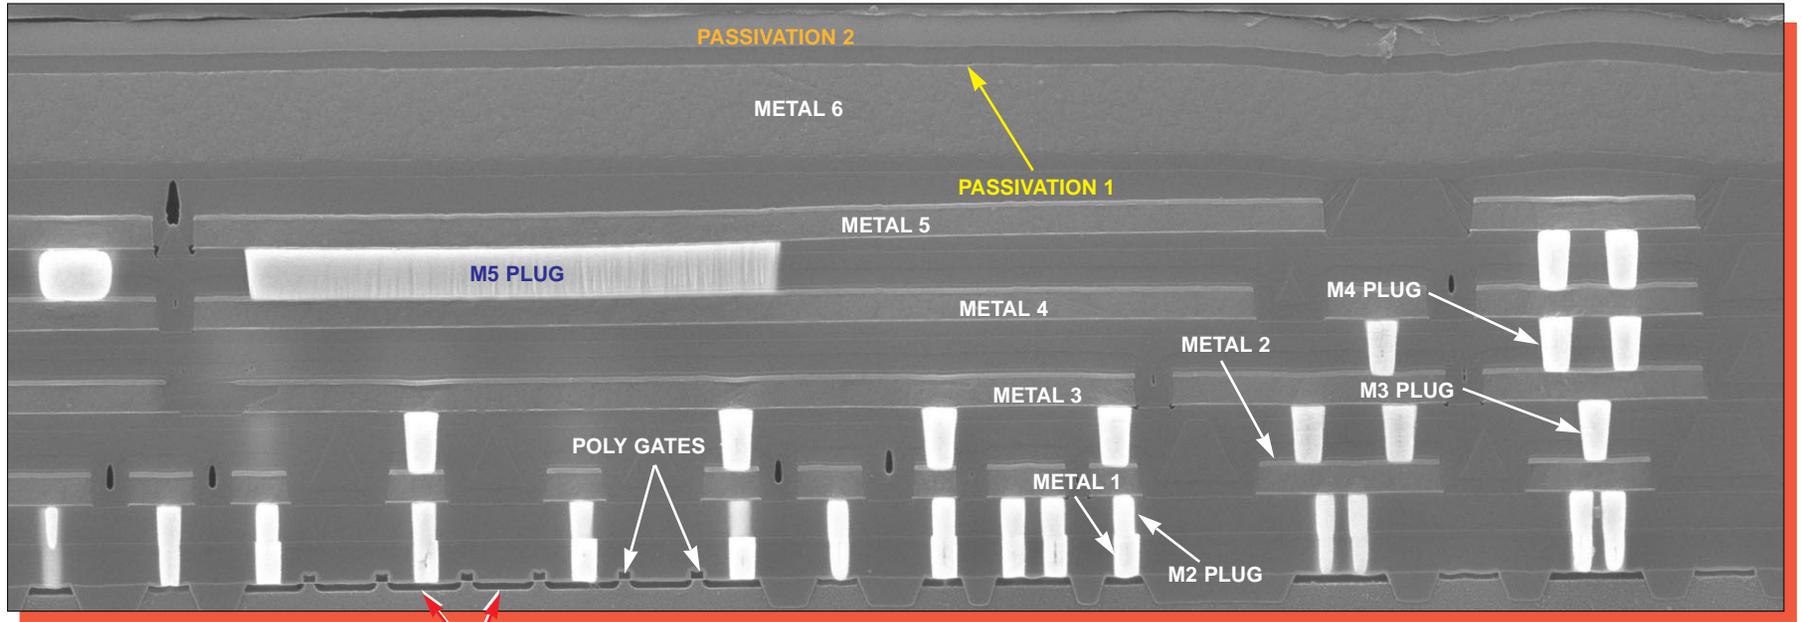
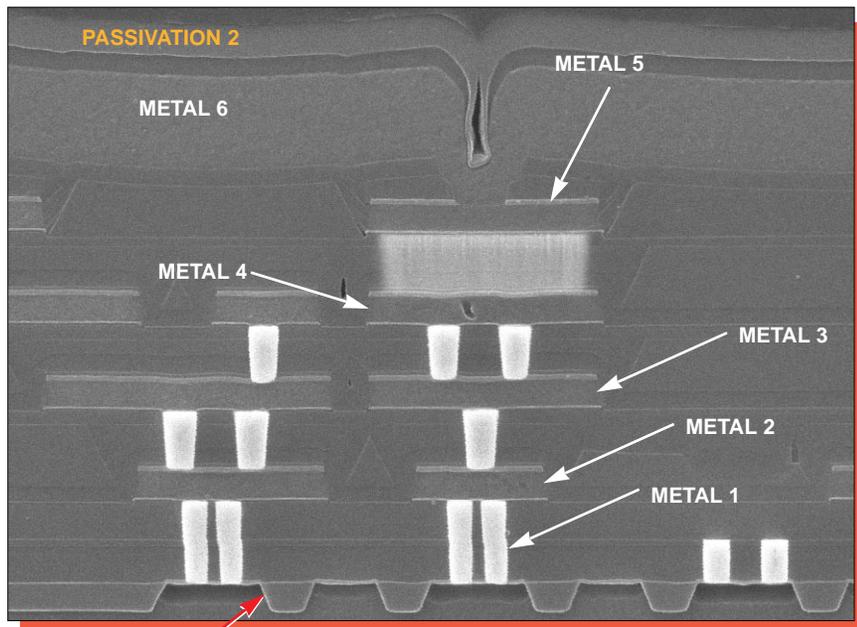
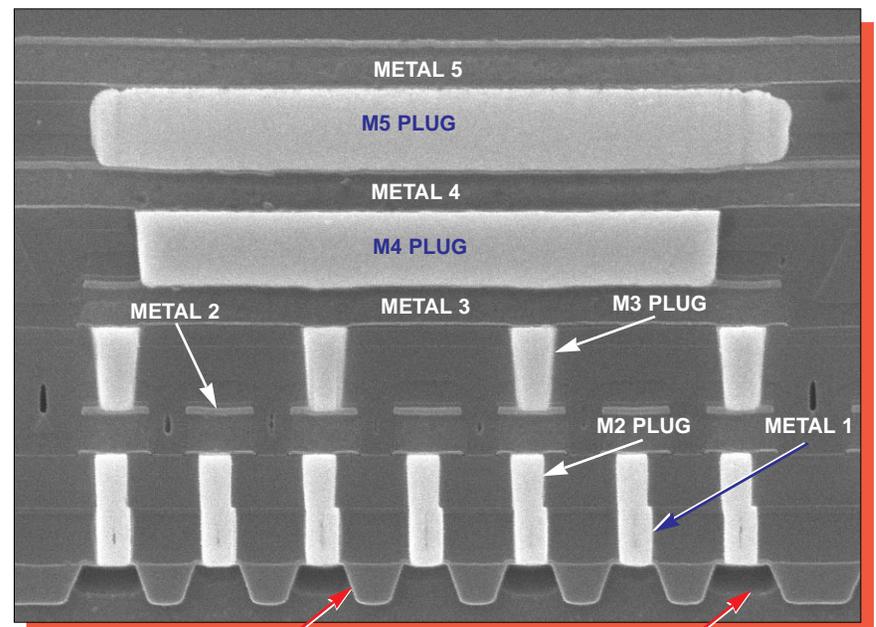
Figure 7. SEM section views of general device structure.

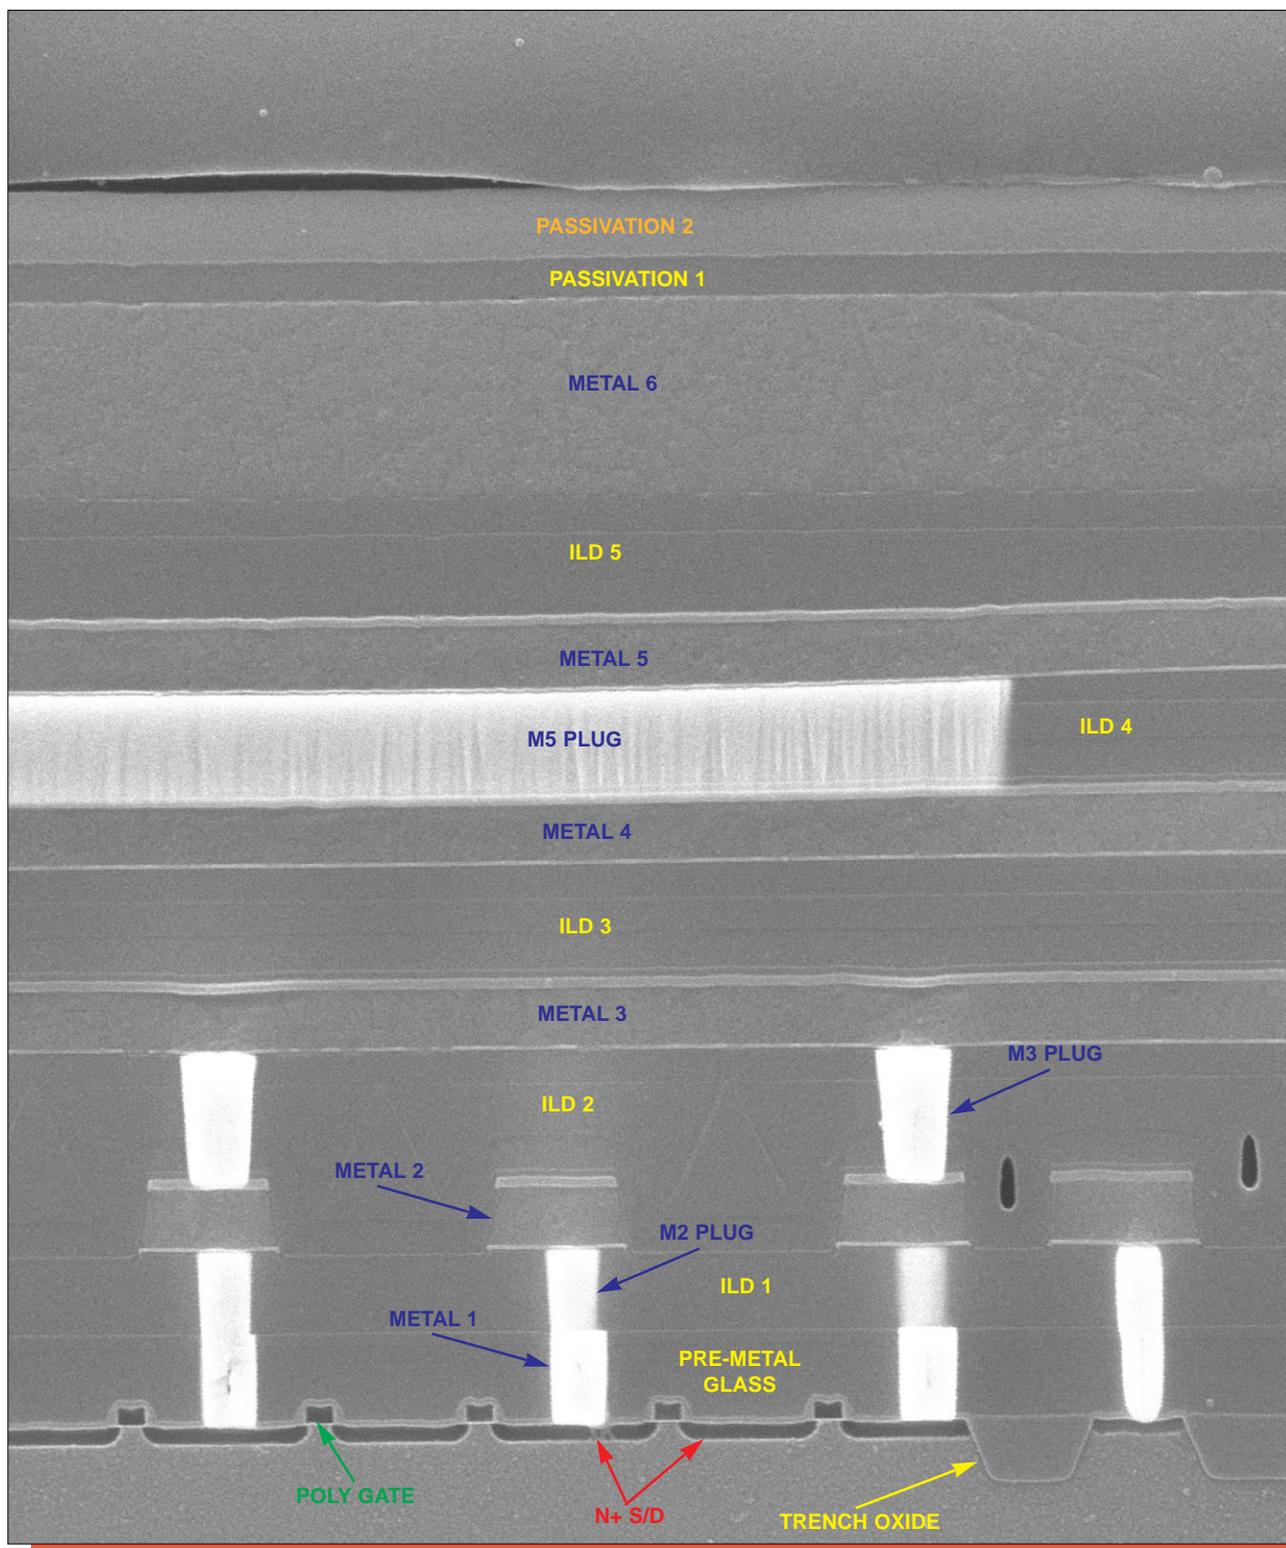
Figure 7a. Detailed SEM section view of general device structure. Mag. 14,300x.

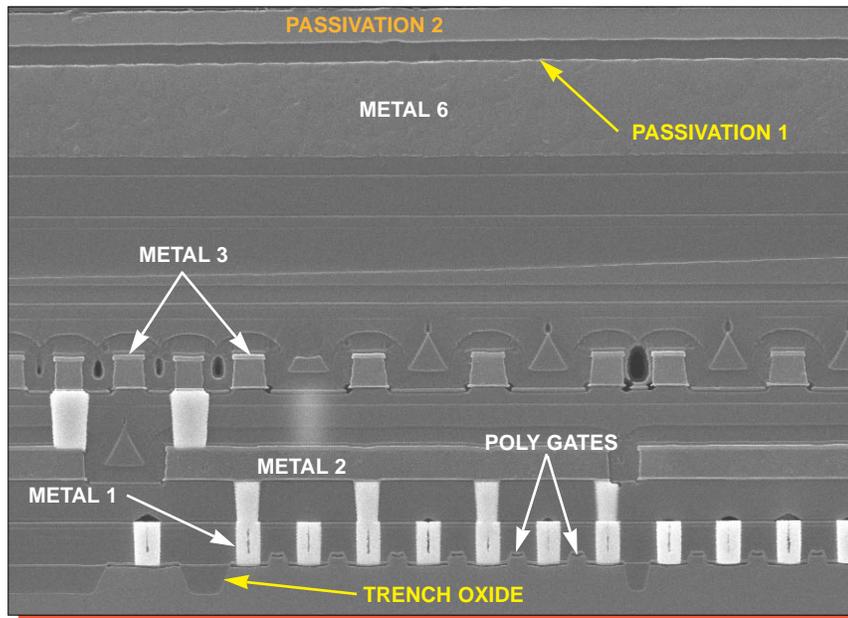
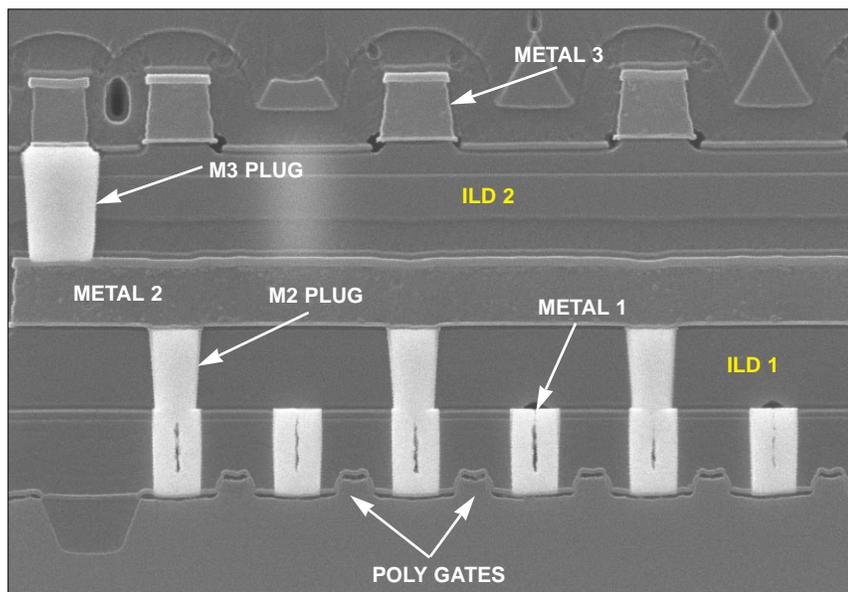
Figure 8. Glass etch section views illustrating general structure.

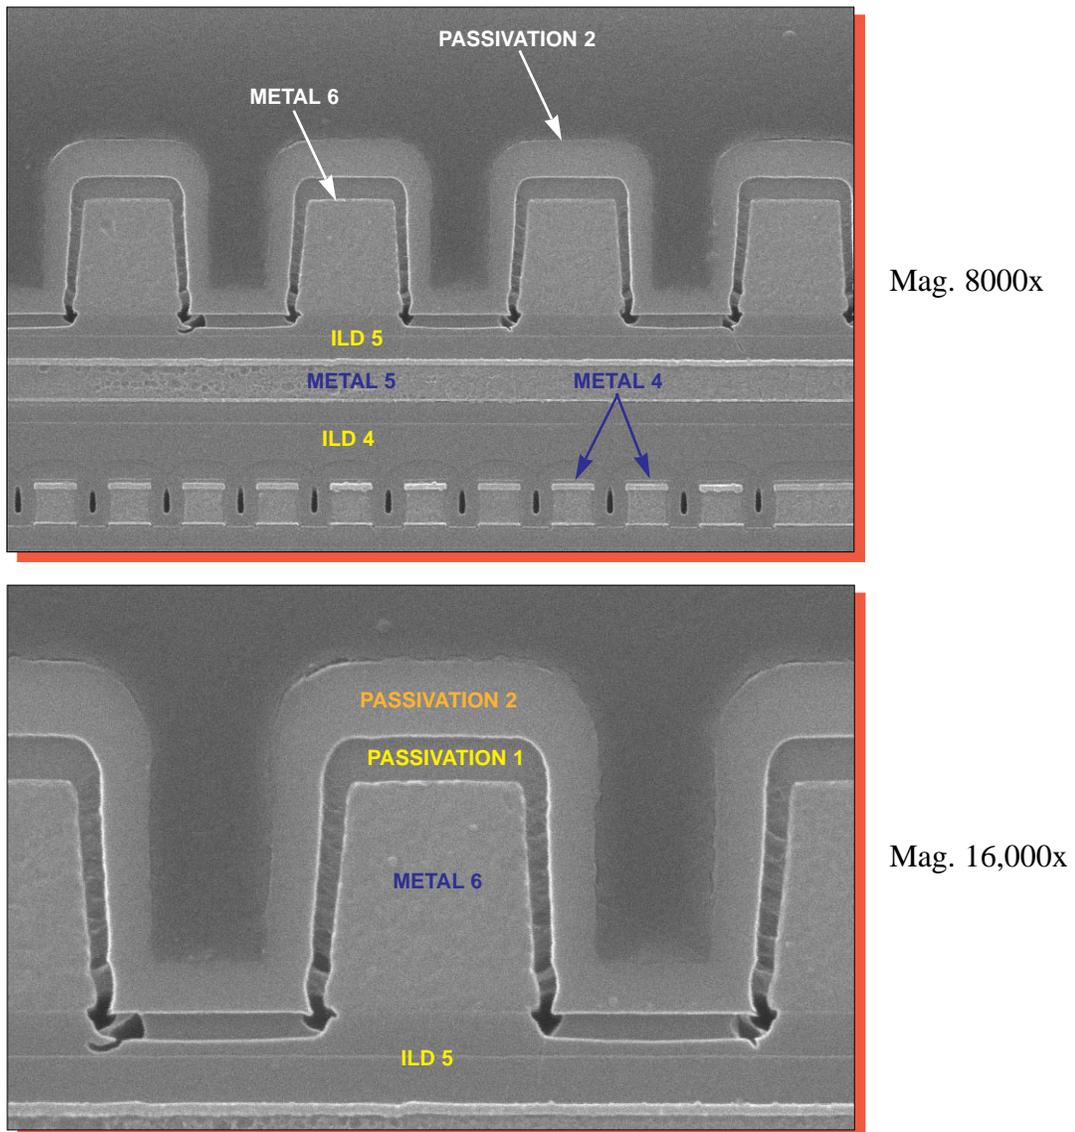
Figure 9. SEM section views of metal 6 line profiles.

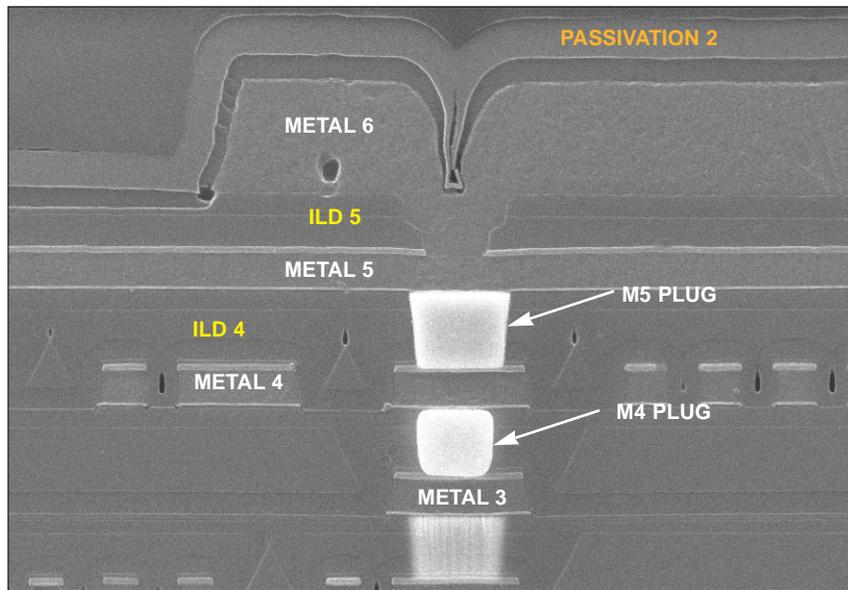
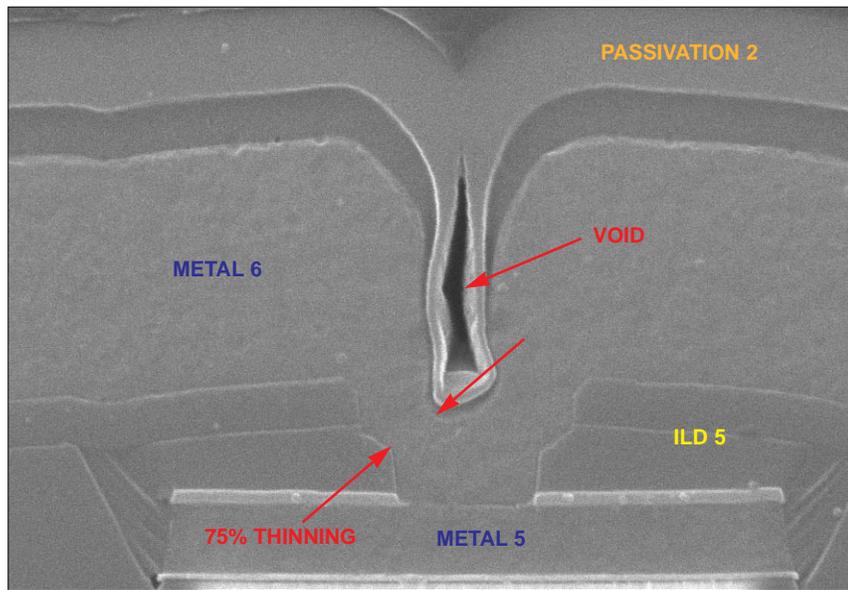
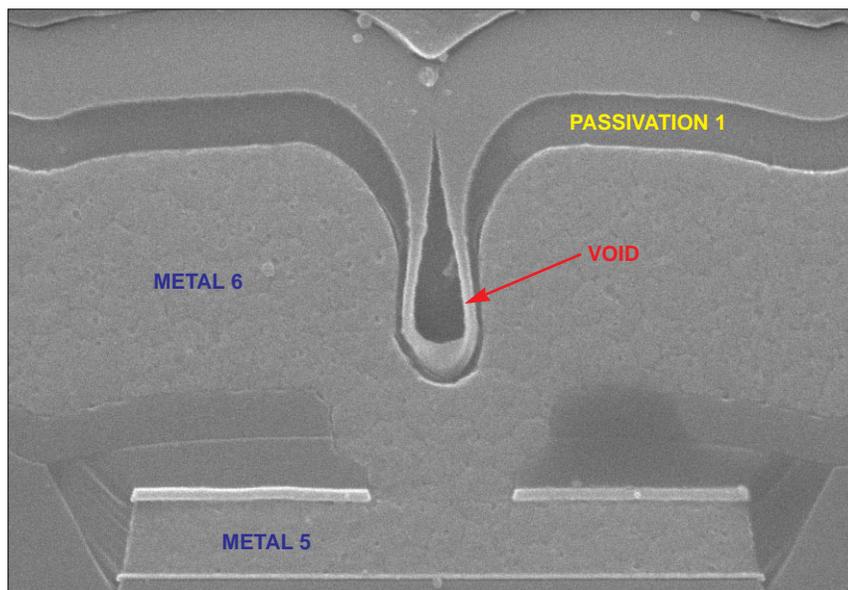
Figure 12. SEM section views of metal 6-to-metal 5 vias.

- Metal step coverage: Metal 6 thinned up to 75 percent at vias. Although the thinning exceeds MIL-STDs (70 percent) it is not considered a reliability concern. No metal thinning was present at the connections to the tungsten via plugs or metal 1. The absence of thinning is due to the good control of plug height and the planarization technique employed.

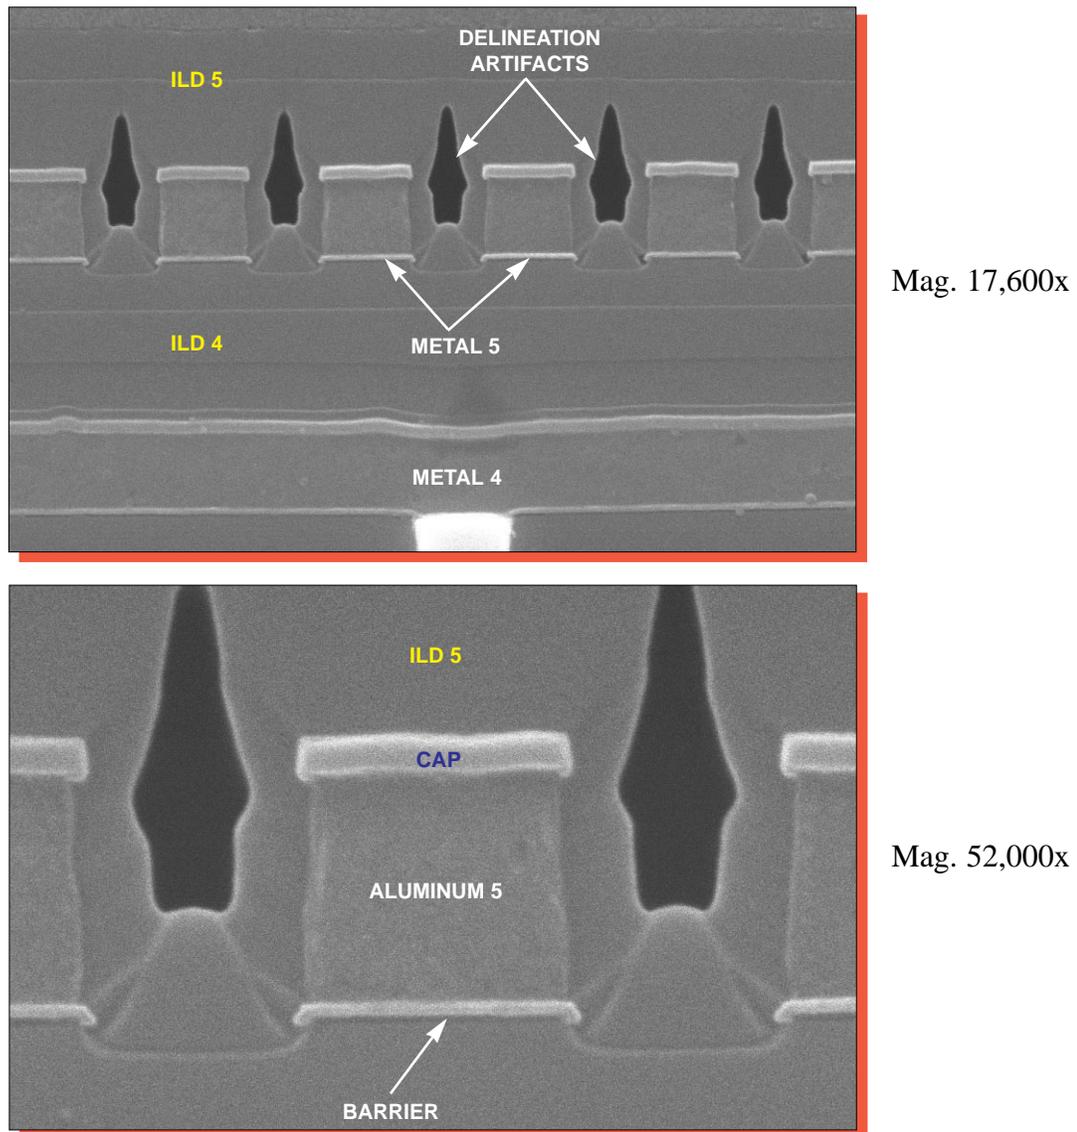
Figure 13. SEM section views of metal 5 line profiles.

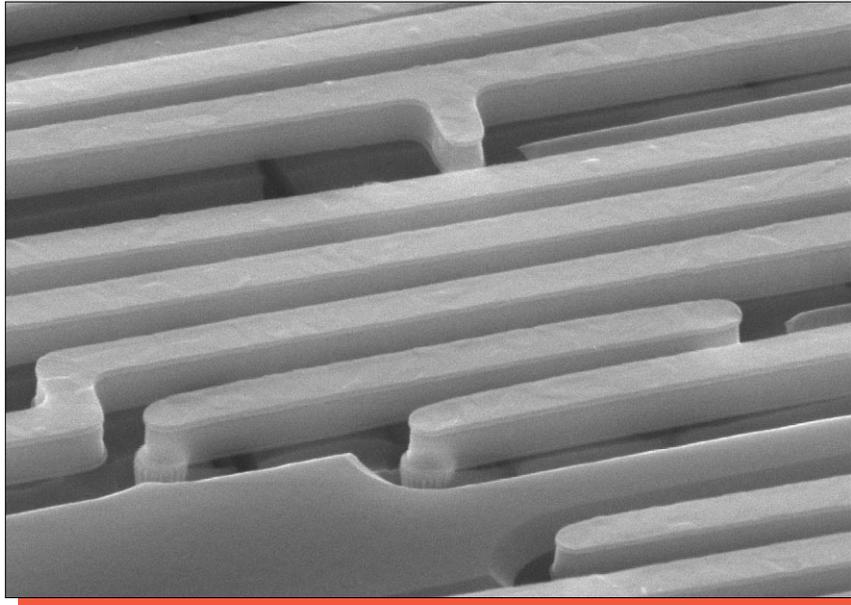
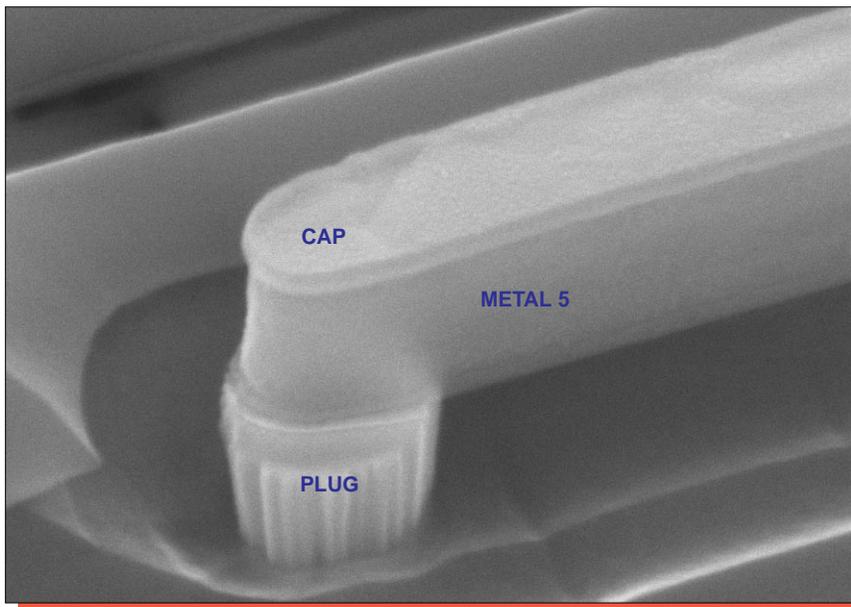
Figure 15. SEM views of general metal 5 integrity. 55°.

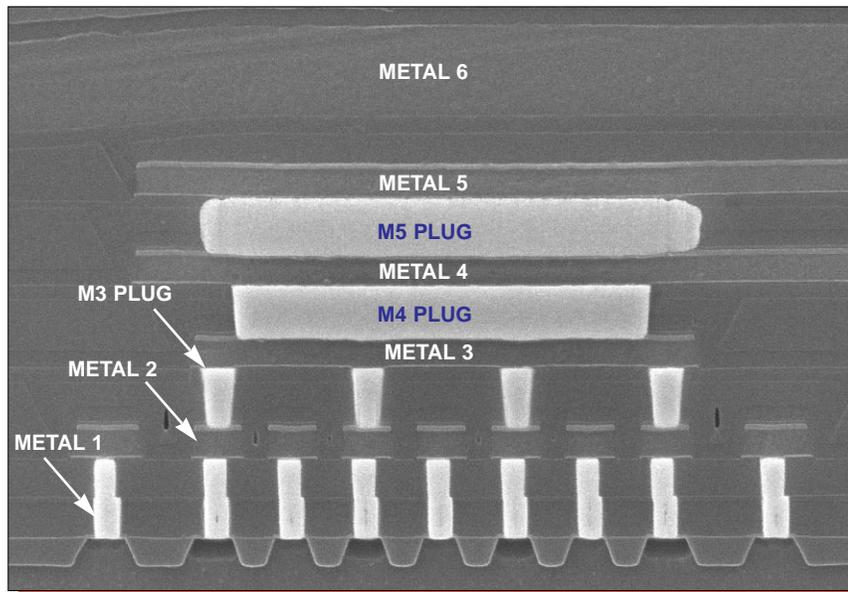
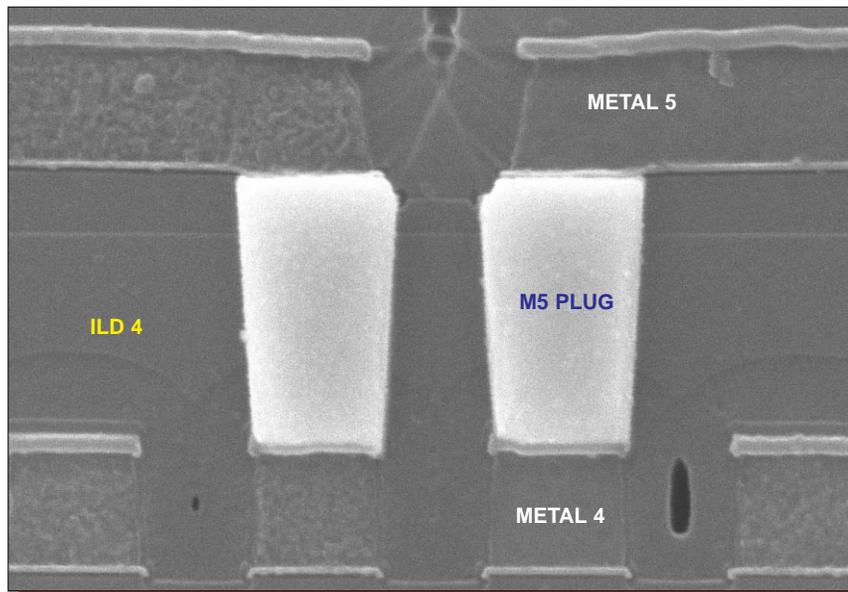
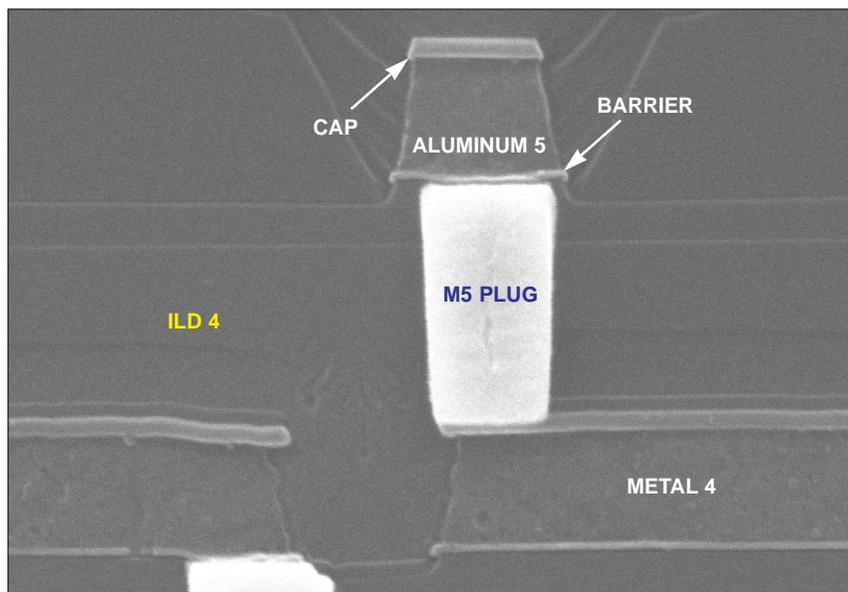
Figure 17. SEM section views of metal 5-to-metal 4 vias.

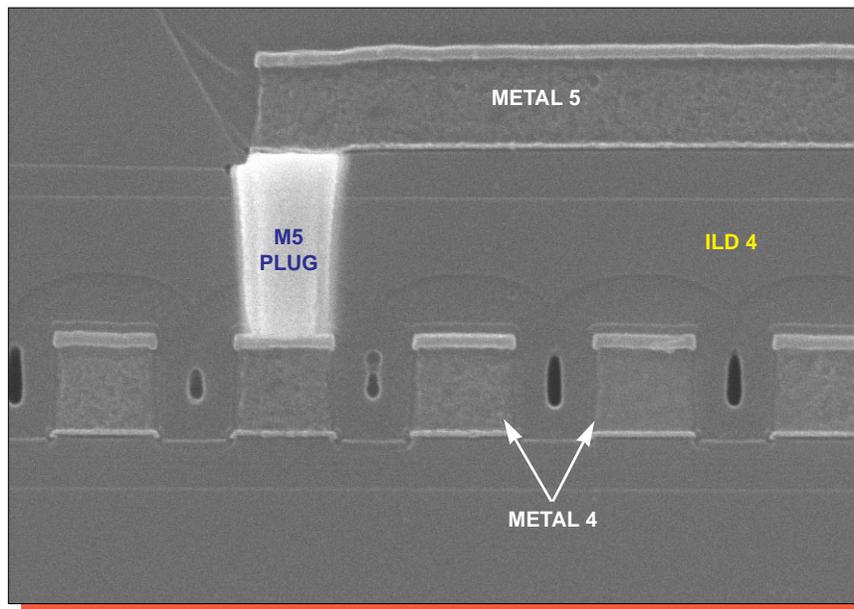
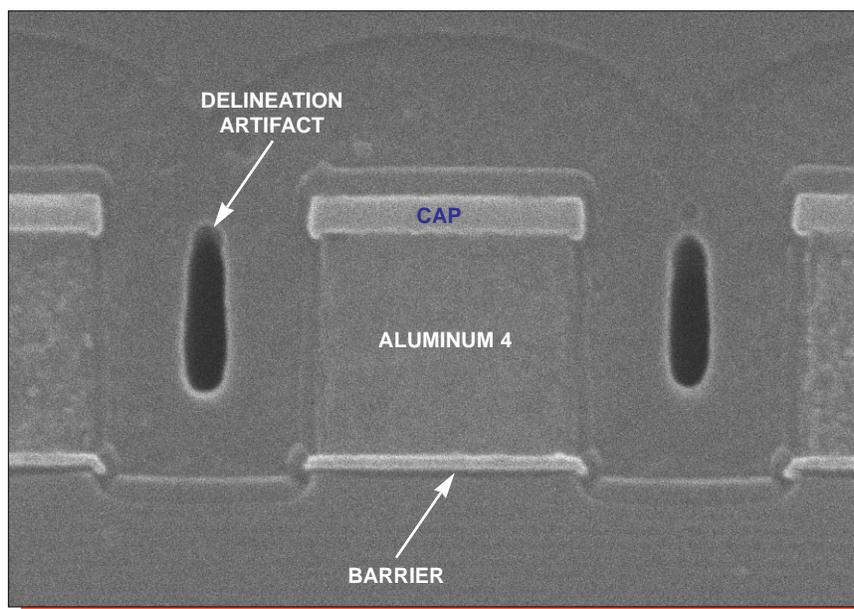
Figure 18. SEM section views of metal 4 line profiles.

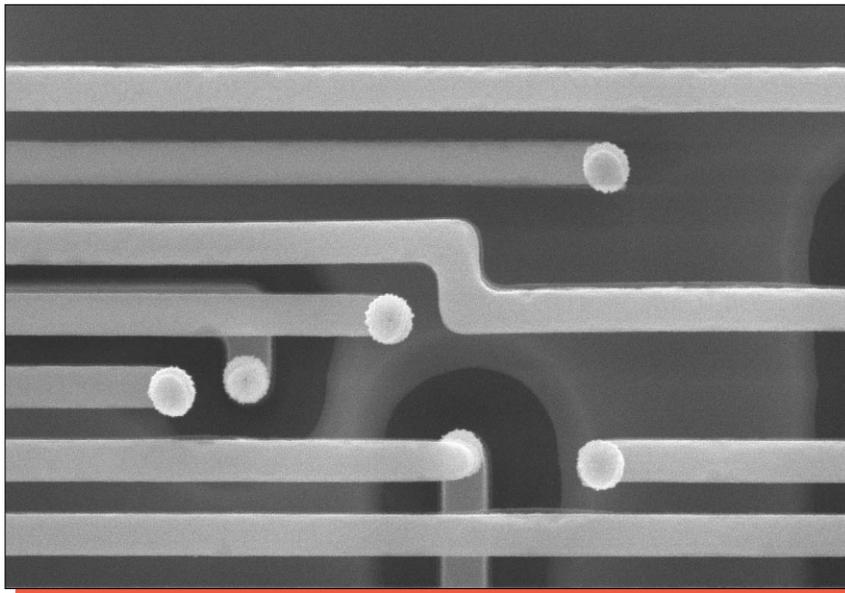
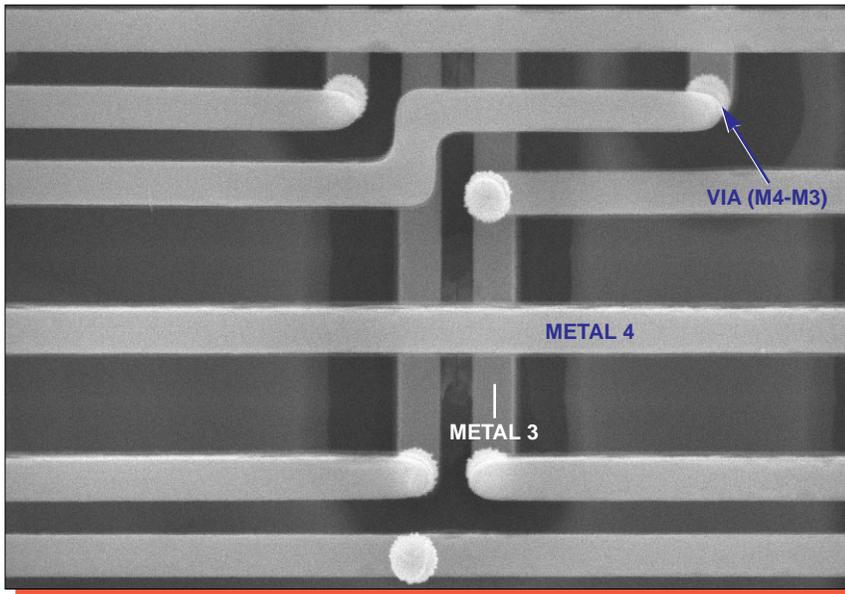
Figure 19. Topological SEM views of metal 4 patterning. 0°.

- Significant misalignment of metal 2 and 4 to the underlying plugs was noted (Figures 19 and 29)

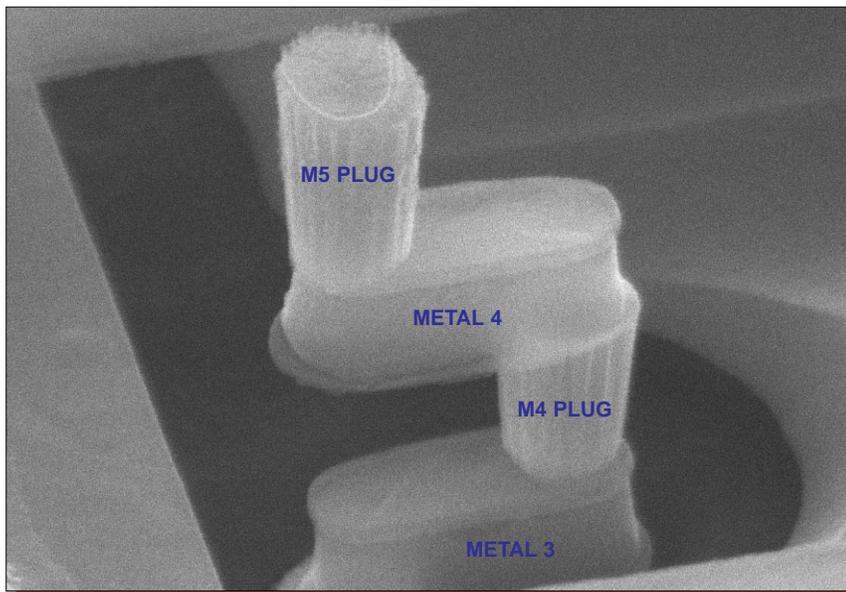
Figure 20. SEM views of general metal 4 integrity. 55°.
