Construction Analysis

Motorola PC603R Microprocessor

Report Number: SCA 9709-551

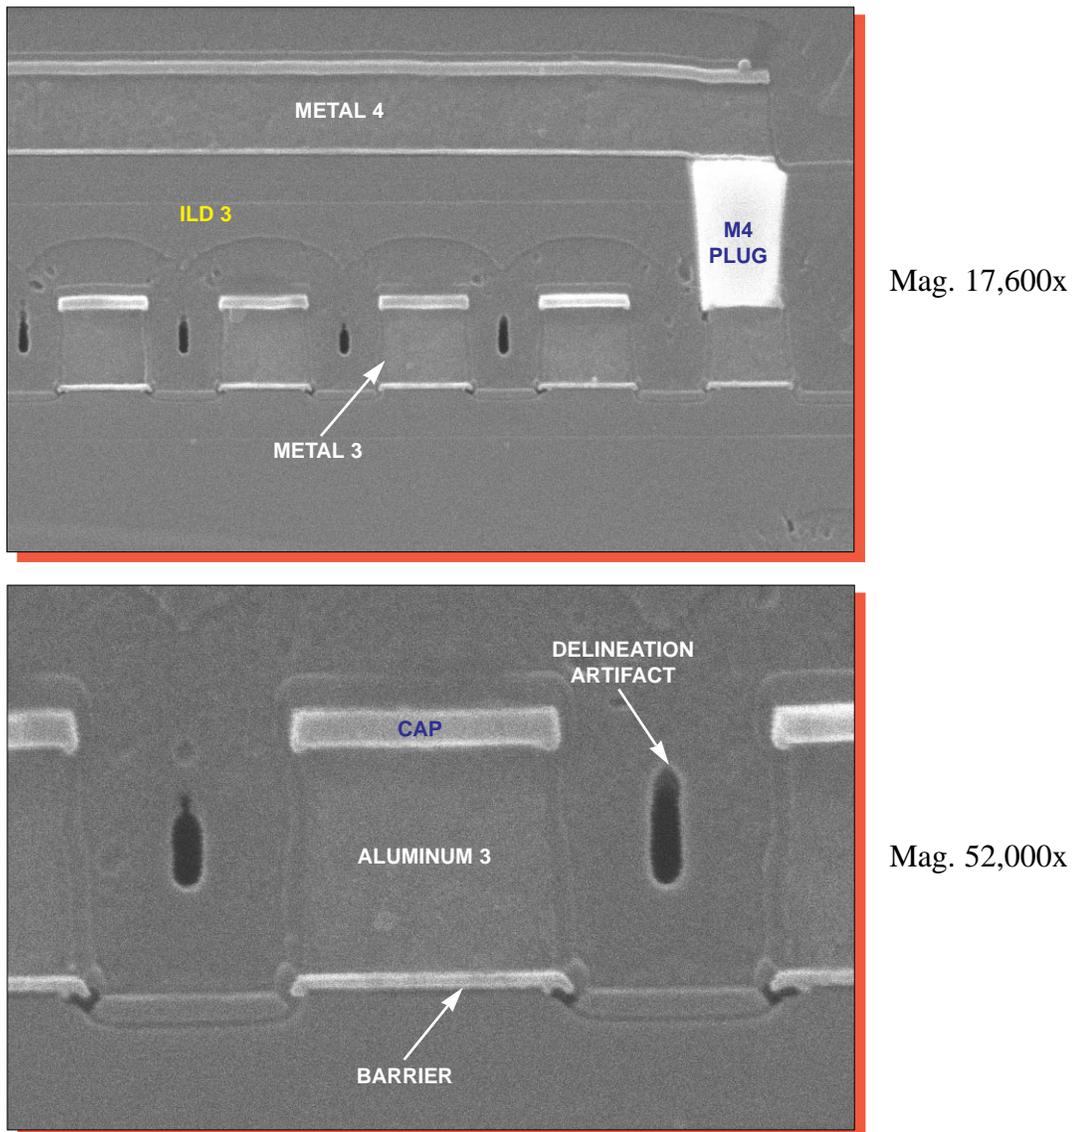
Figure 23. SEM section views of metal 3 line profiles.

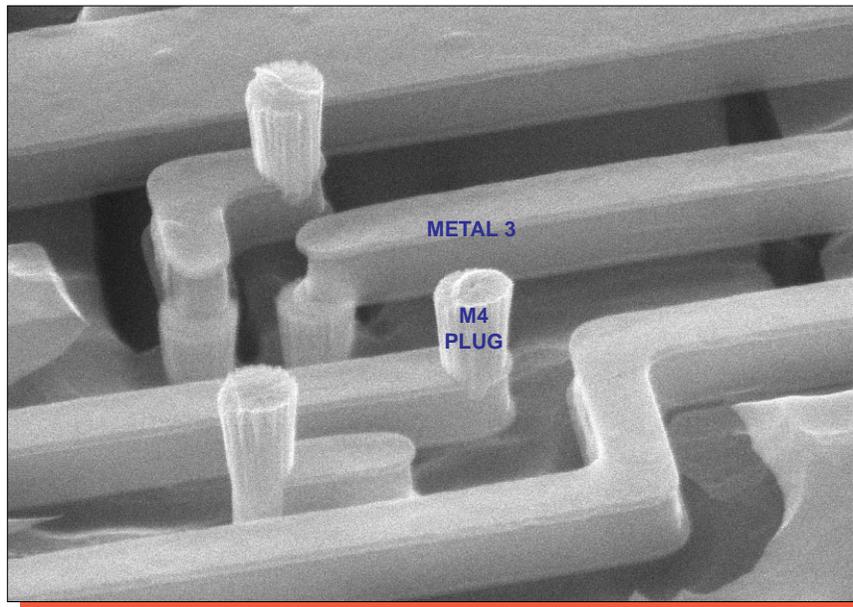
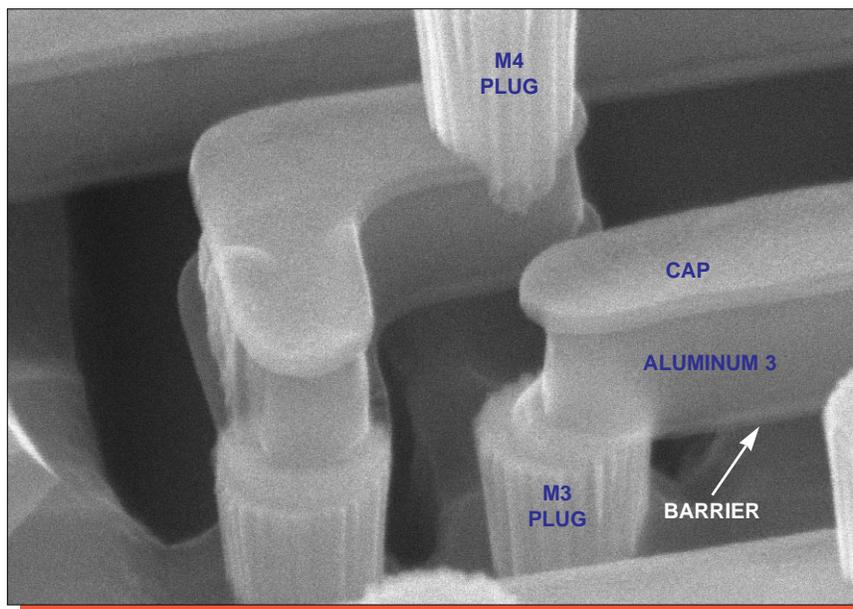
Figure 25. SEM views of general metal 3 integrity. 55°.

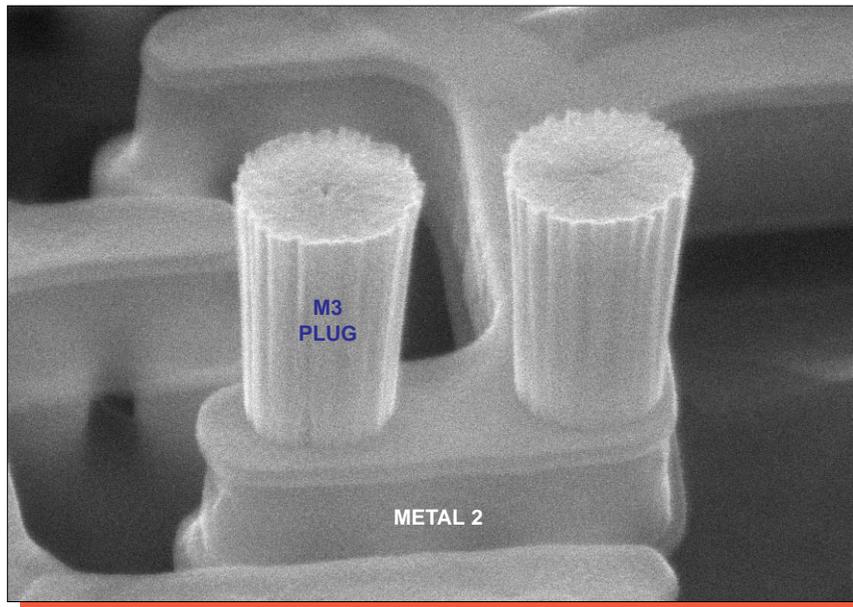
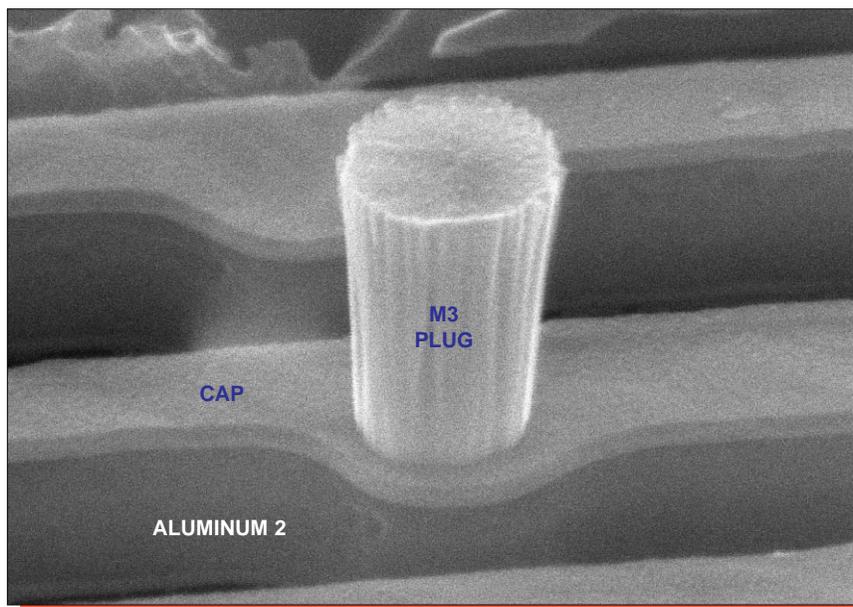
Figure 26. SEM views of metal 3 tungsten plugs. 55°.

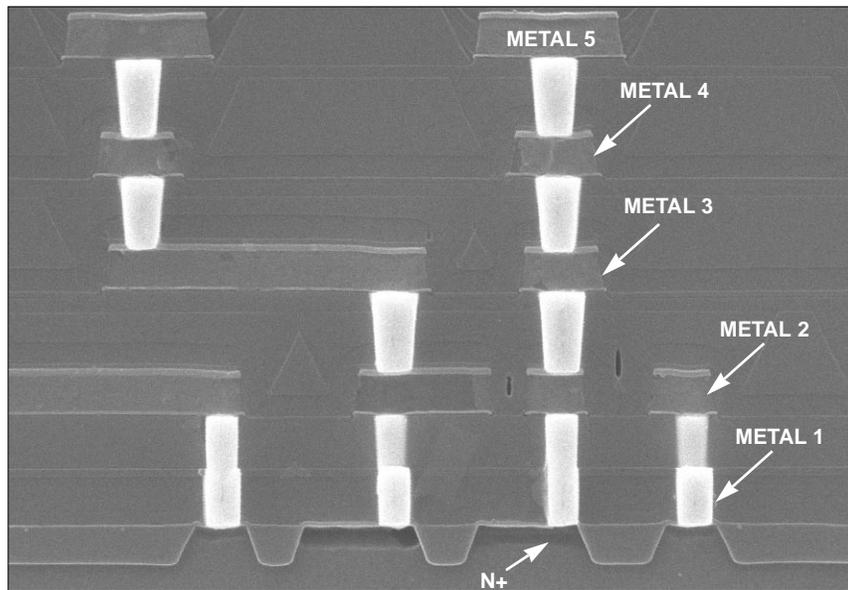
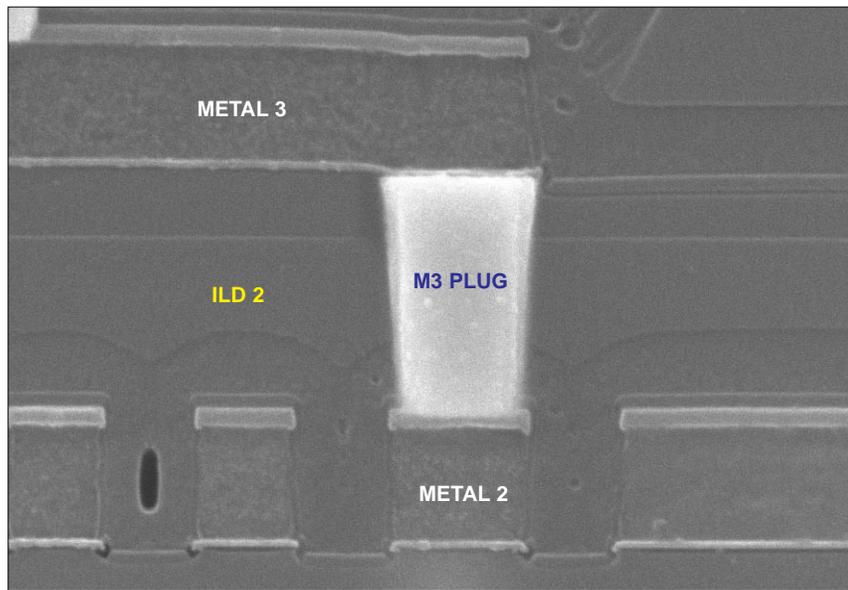
Figure 27. SEM section views of metal 3-to-metal 2 vias.

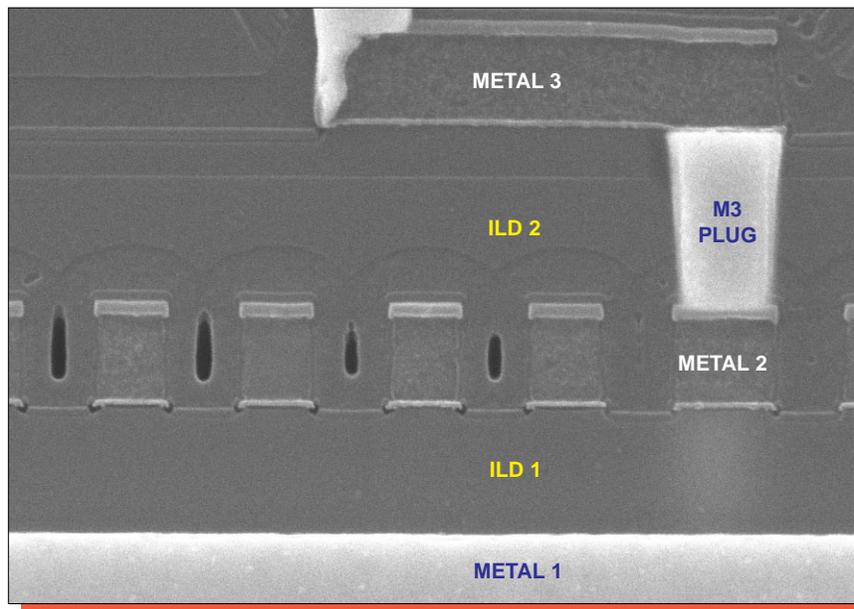
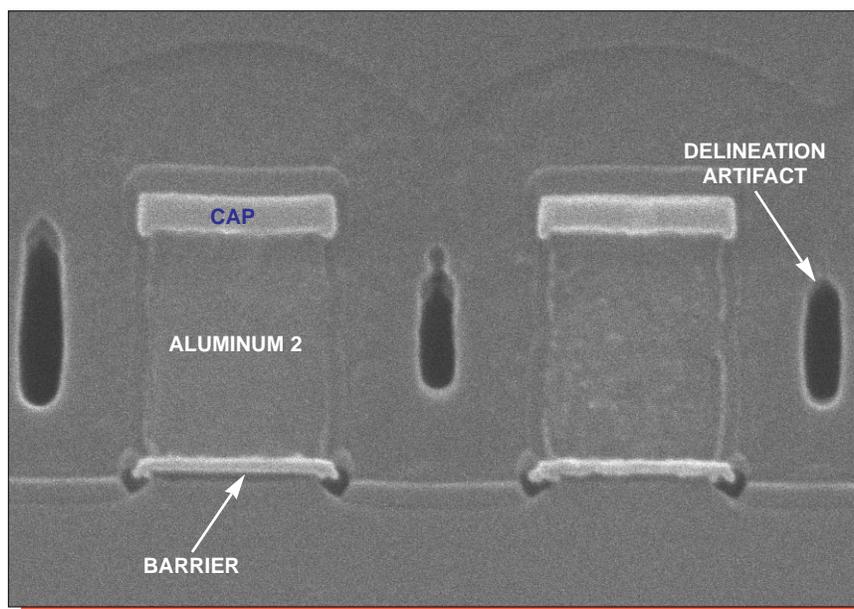
Figure 28. SEM section views of metal 2 line profiles.

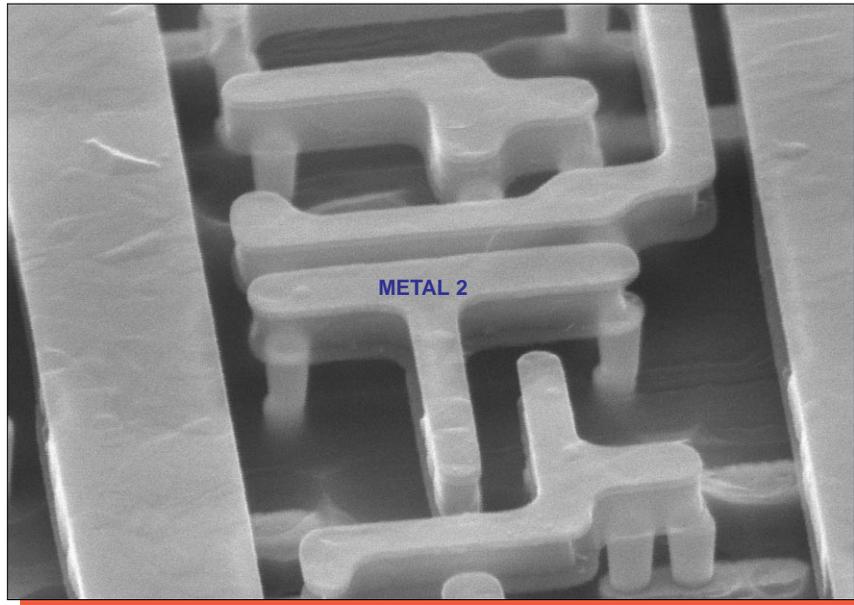
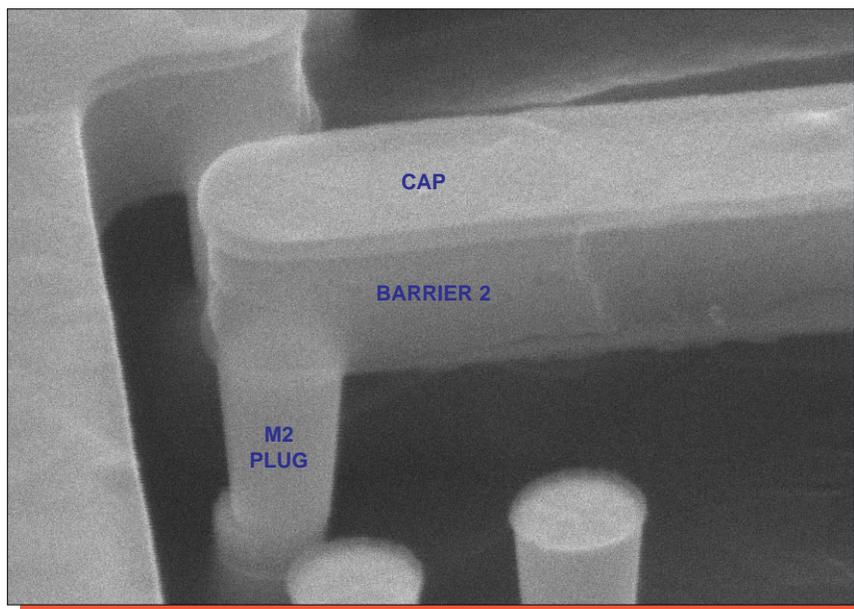
Figure 30. SEM views of general metal 2 integrity. 55°.

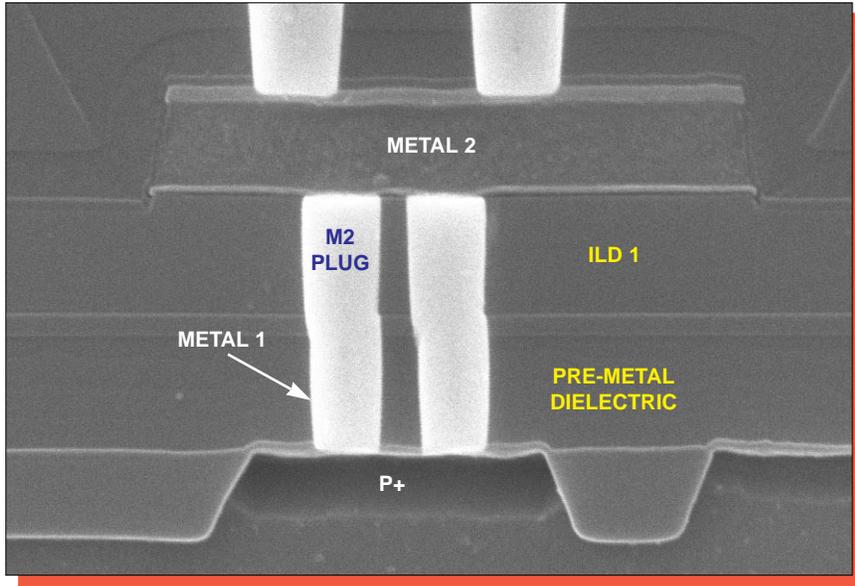
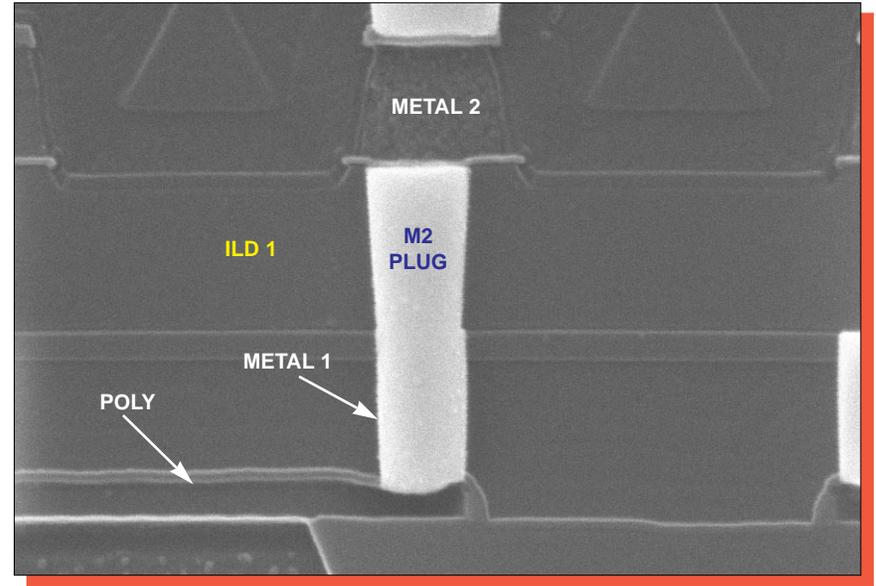
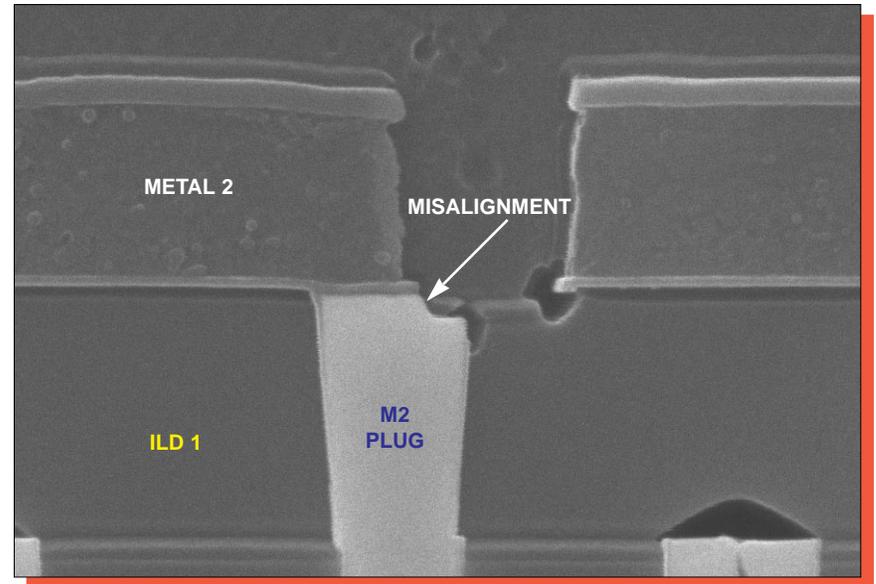
Figure 32. SEM section views of metal 2-to-metal 1 vias.

- Vias and contacts: All via and contact cuts were defined by a dry etch of good quality. Again there was significant misalignment of metal 2 and 4 to their respective plugs. This misalignment reduced metal spacing to adjacent plugs (see Figure 32). Some tungsten plugs “spilled over” one edge of the metal. IBM uses this “borderless” contact technique for improved contact resistance. Vias and contacts were placed directly over one another (stacked vias). No problems were noted.

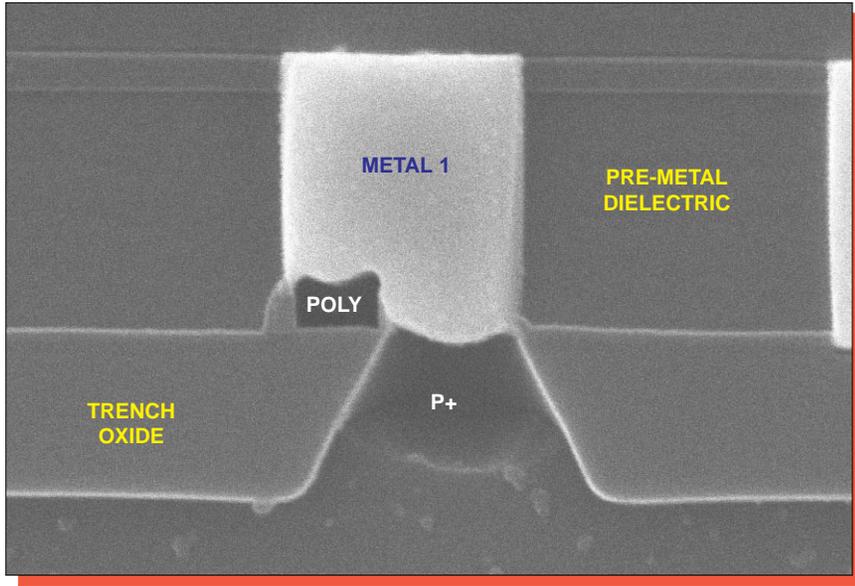
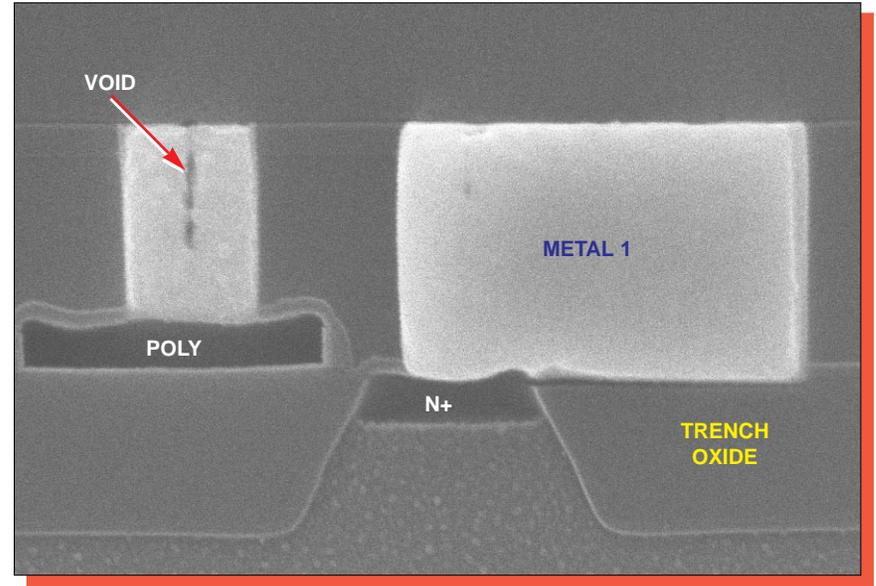
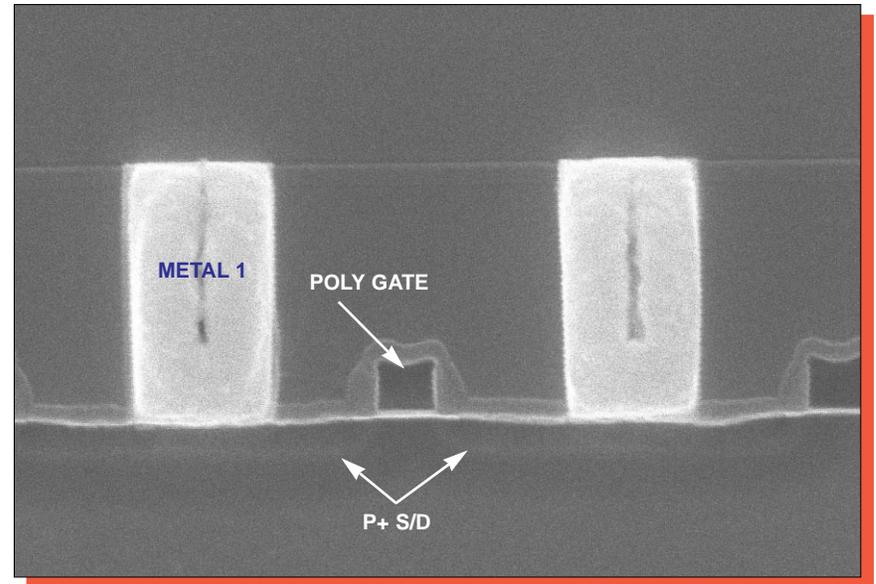
Figure 35. SEM section views of metal 1 contacts.

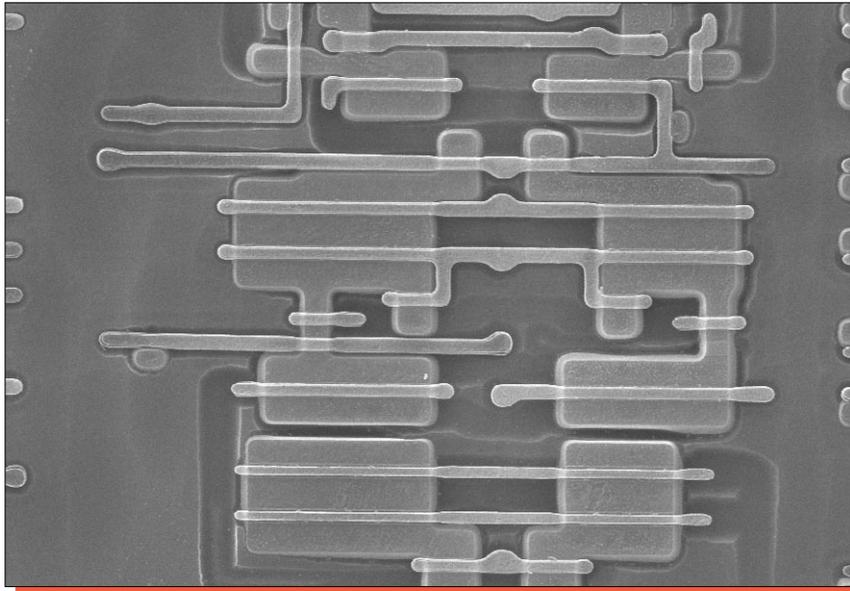
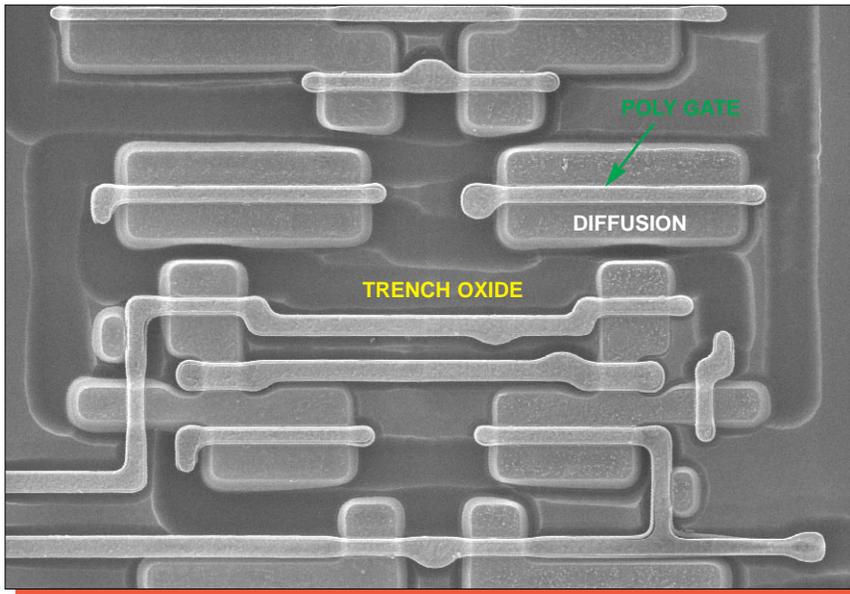
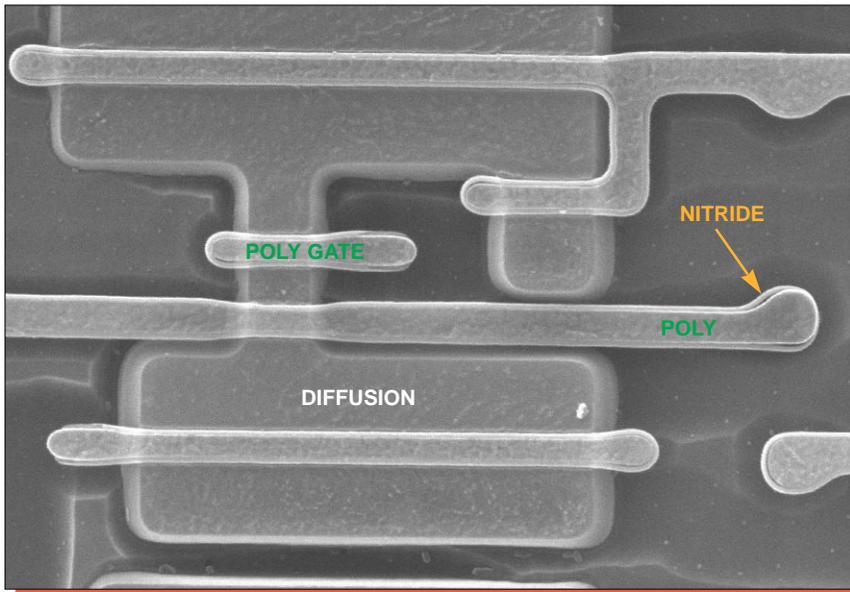
Figure 36. Topological SEM views of poly patterning. 0°.

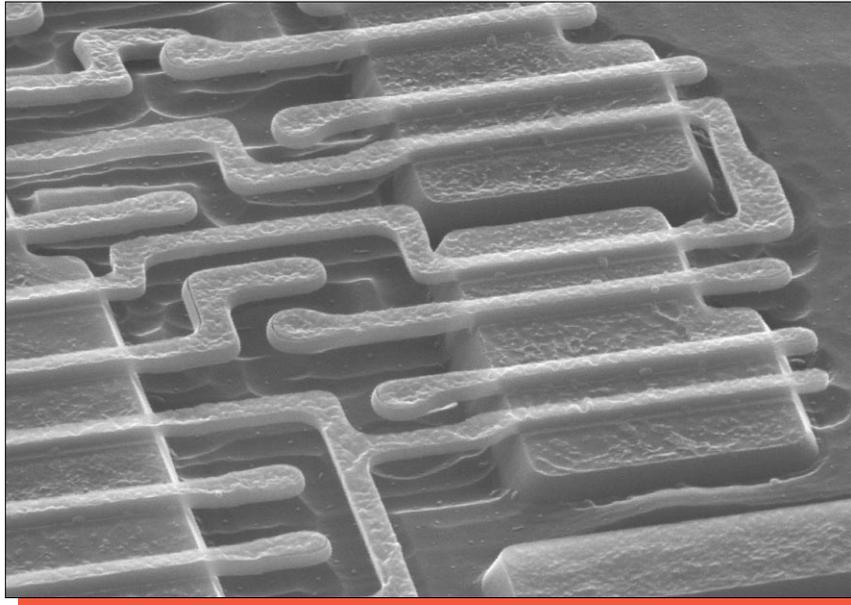
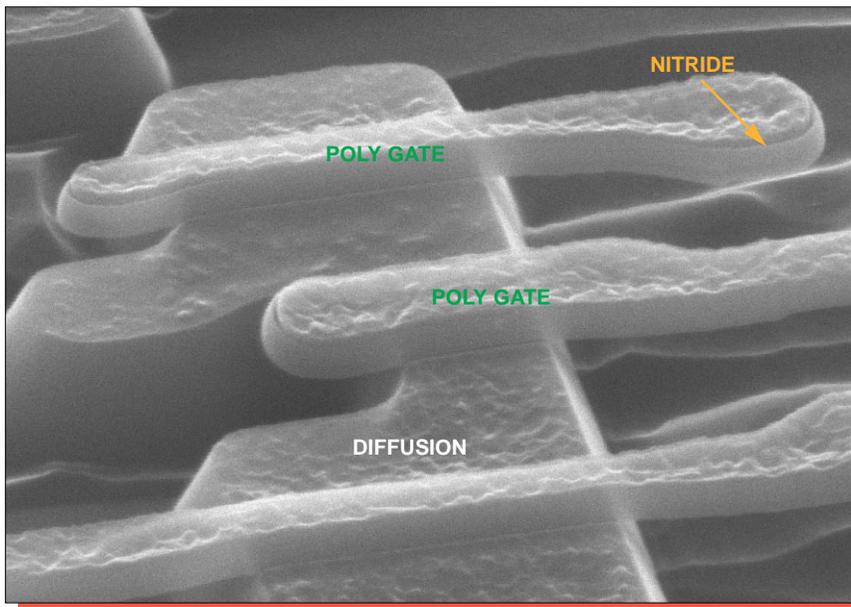
Figure 37. SEM views of general poly coverage. 55°.

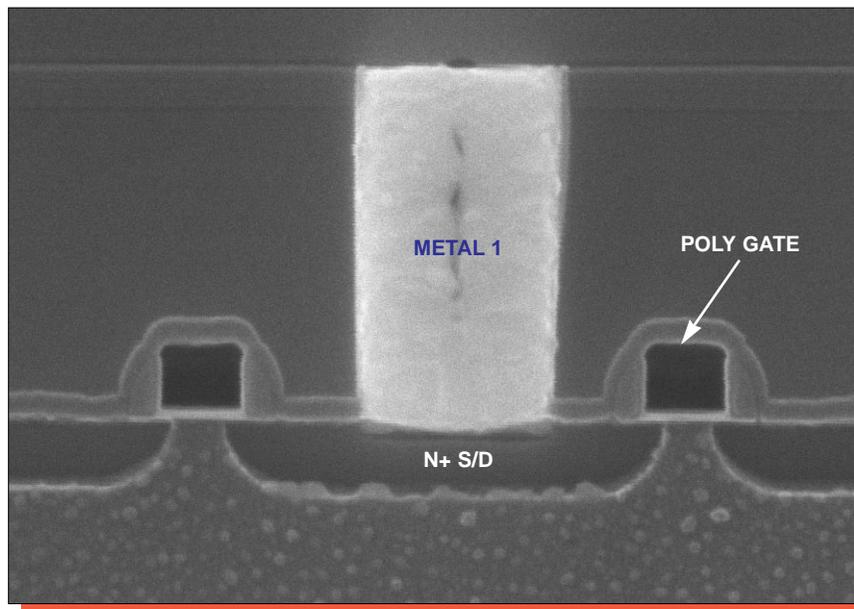
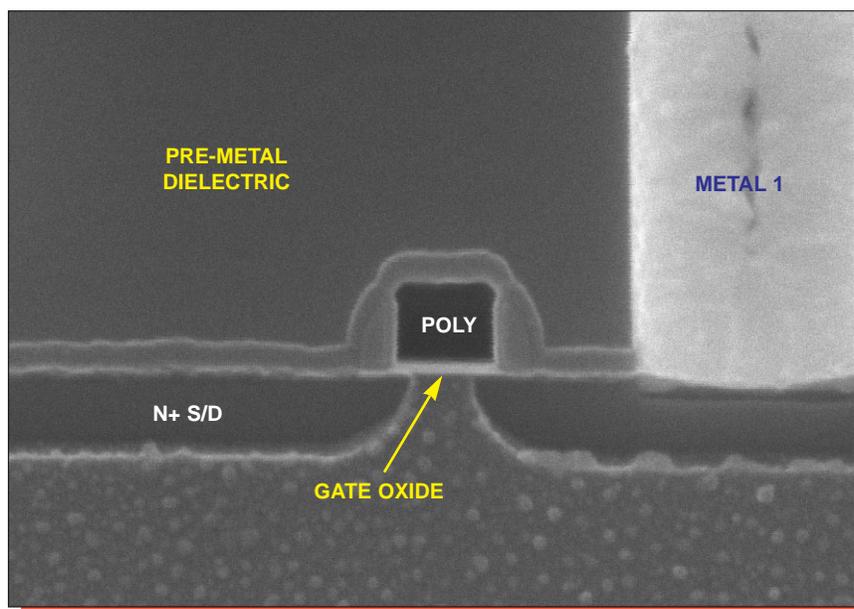
Figure 38. SEM section views of N-channel transistors.

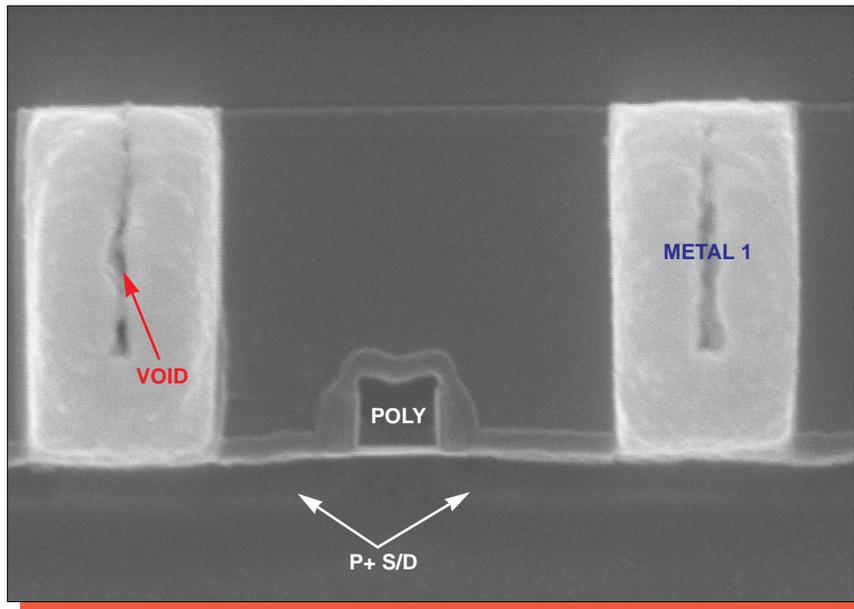
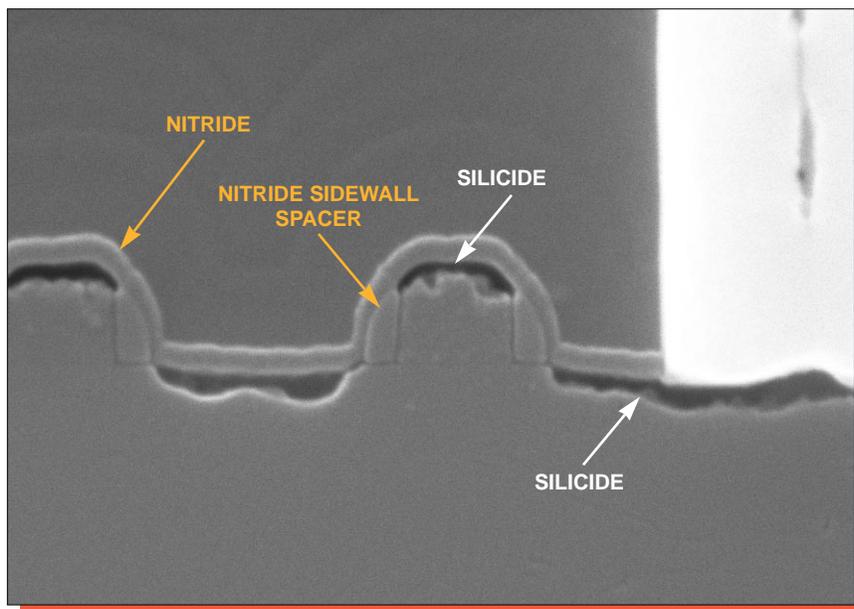
Figure 39. SEM section views of P-channel transistors.

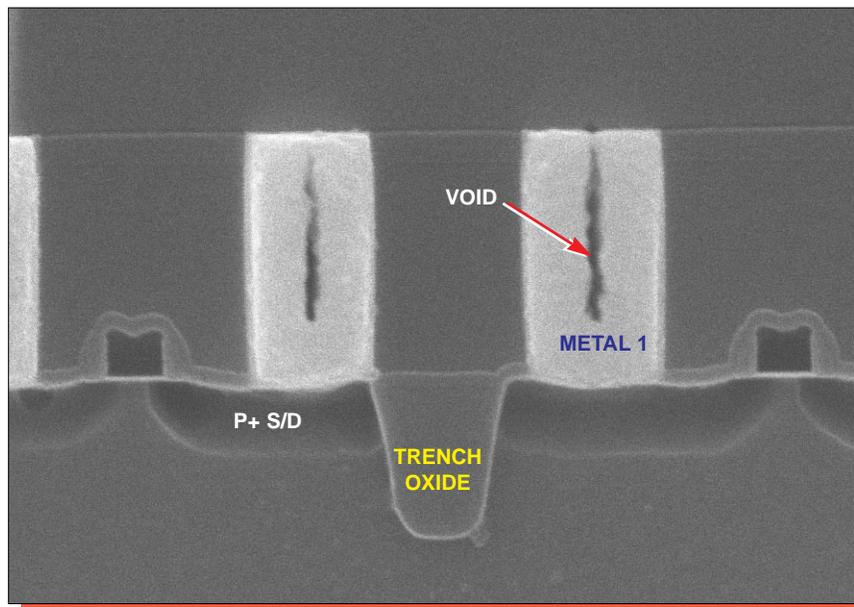
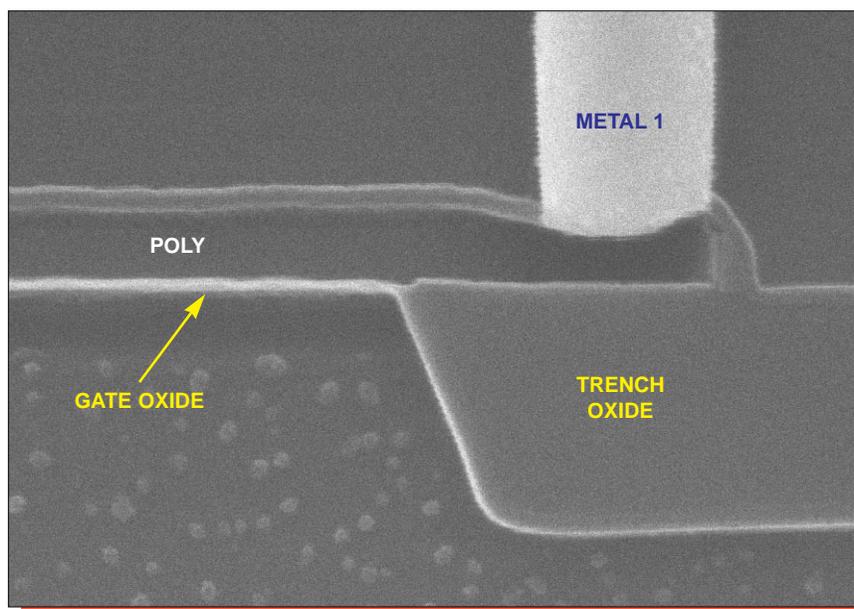
Figure 40. SEM section views of trench oxide structures.

- Isolation: The device used oxide-filled shallow-trench isolation which was quite planar with the silicon surface. A small step was noted on top of the trench oxide at well boundaries. No problems were present.

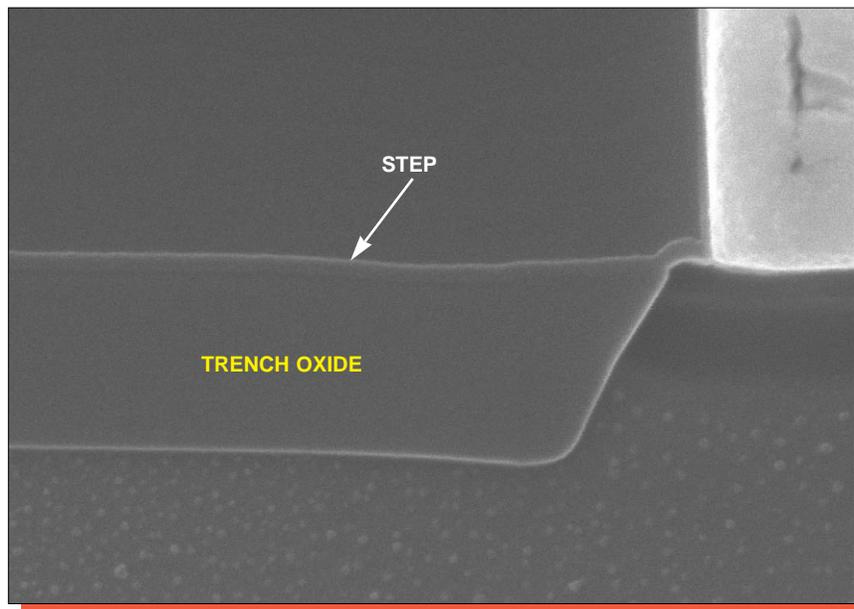
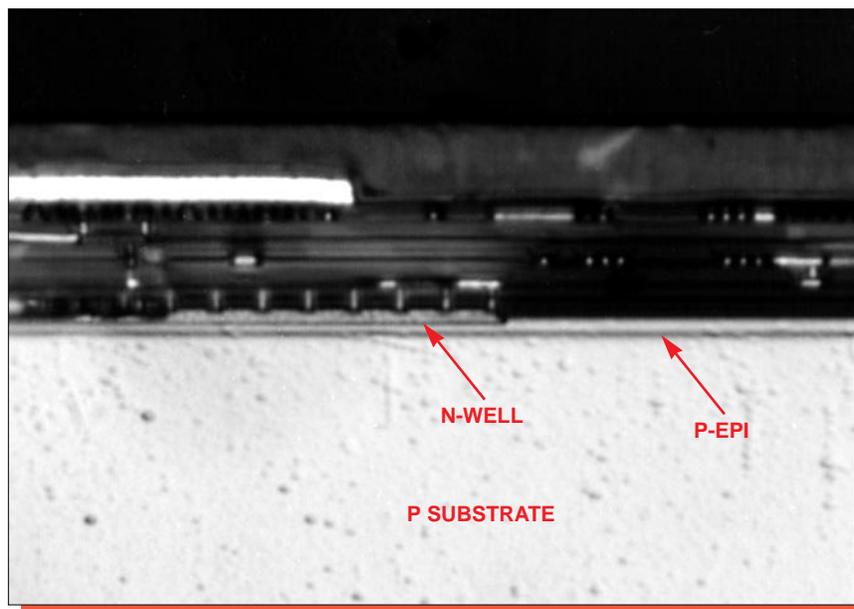
Figure 41. Section views illustrating the well structure.

- Wells: Twin-wells were used in a P-epi on a P substrate. Definition was normal. We could not delineate the P-well in cross-section.
- Buried contacts: Direct poly to diffusion contacts were not used.

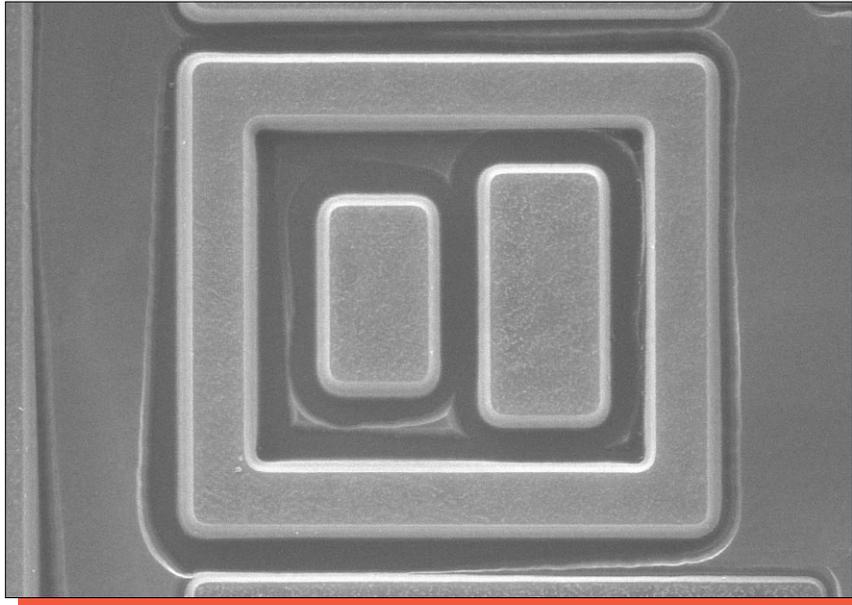
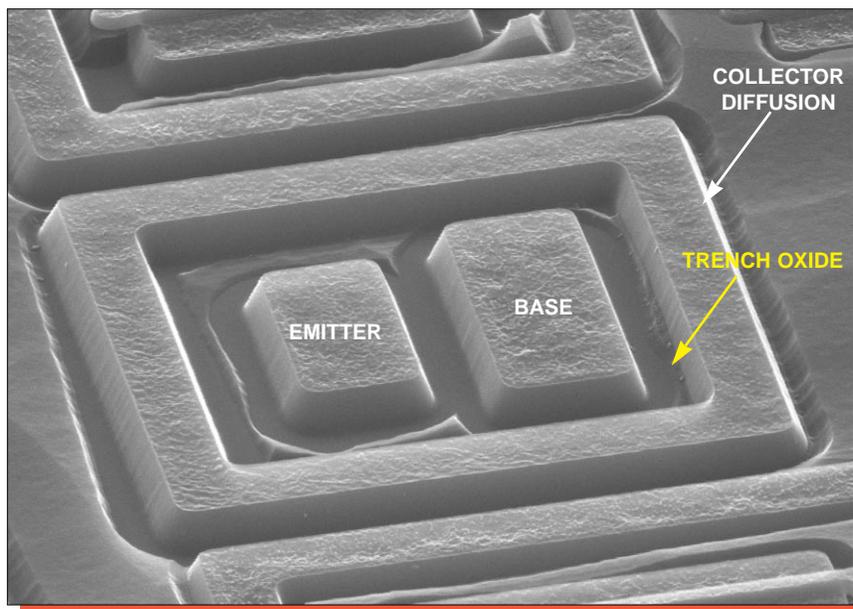
Figure 42. SEM views of a bipolar device.

- There appeared to also be bipolar devices on the die as observed from the surface. Since they could only be seen once the die was delayered we were unsuccessful in obtaining a cross section through one of these devices to observe the sectional structure.
- No redundancy fuses were noted.

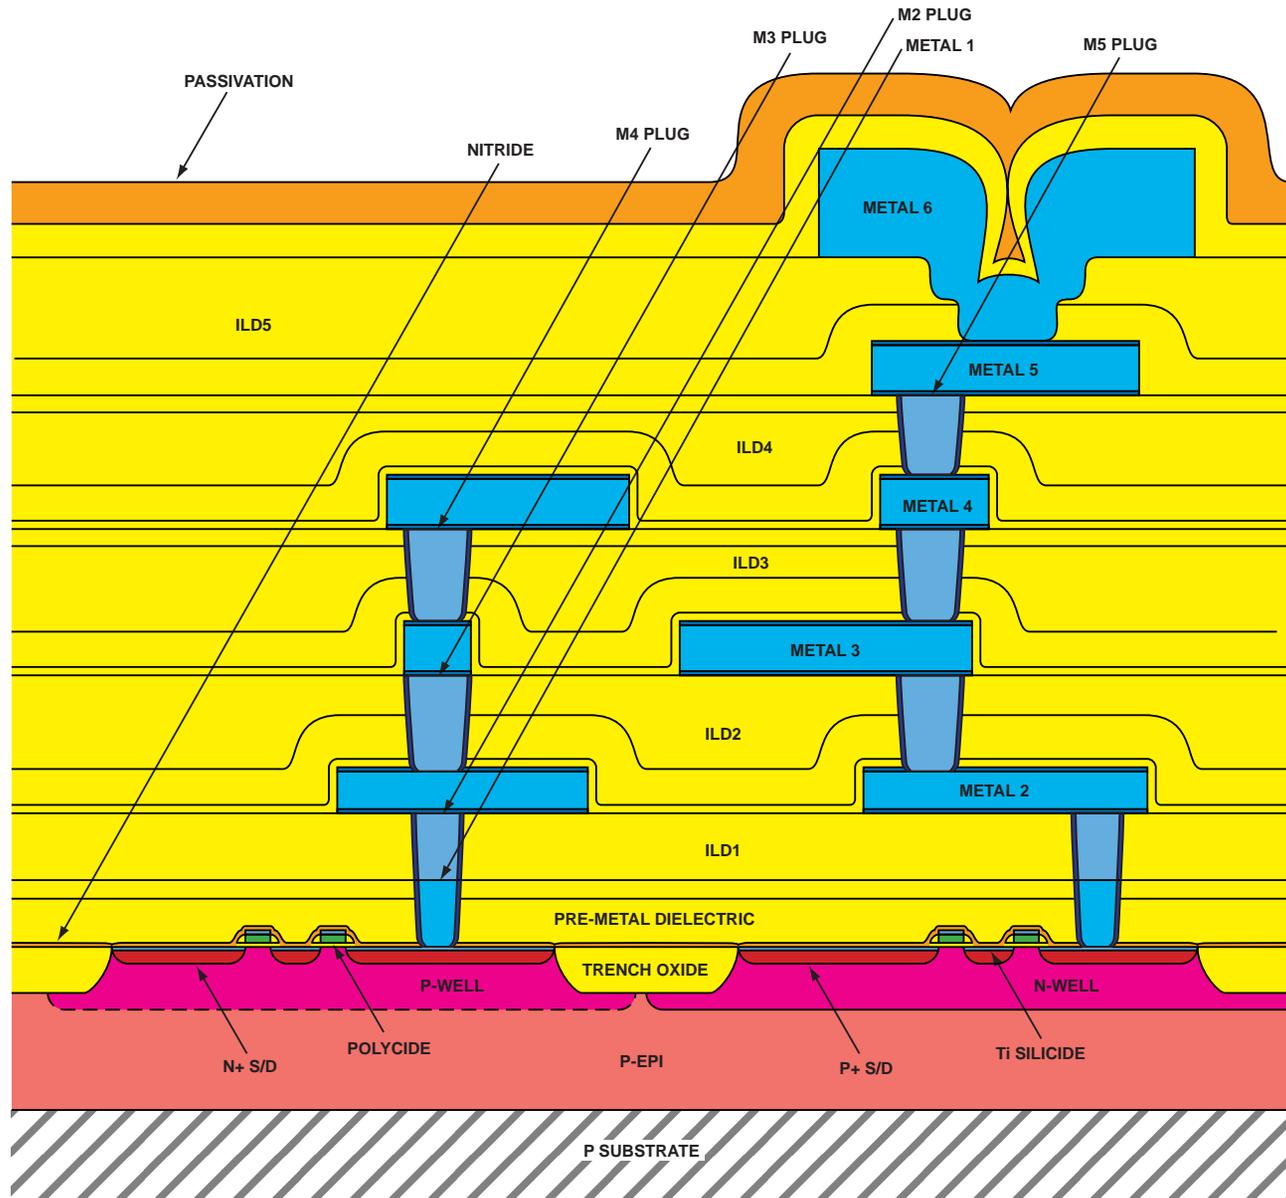
Orange = Nitride, Blue = Metal, Yellow = Oxide, Green = Poly,
 Red = Diffusion, and Gray = Substrate

Figure 43. Color cross section drawing illustrating device structure.

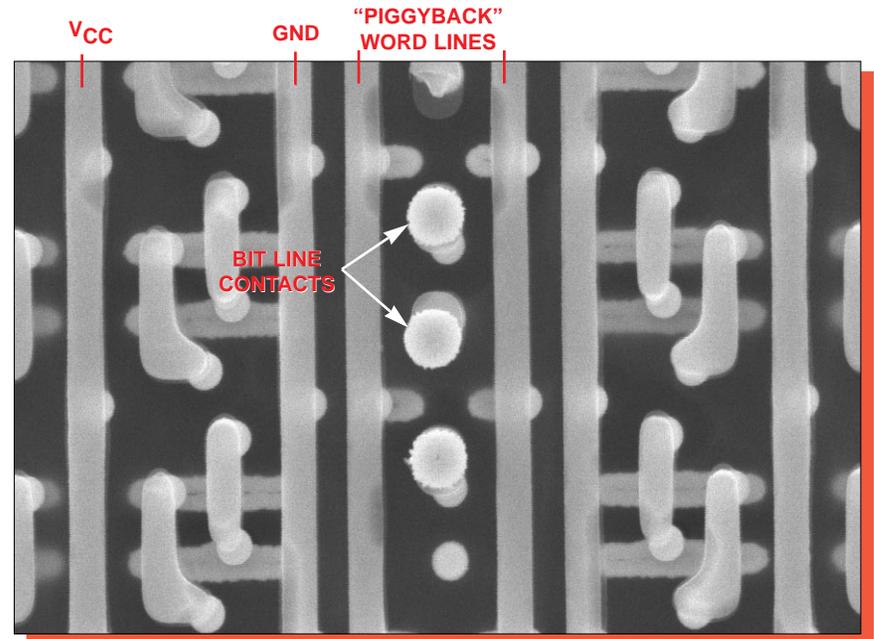
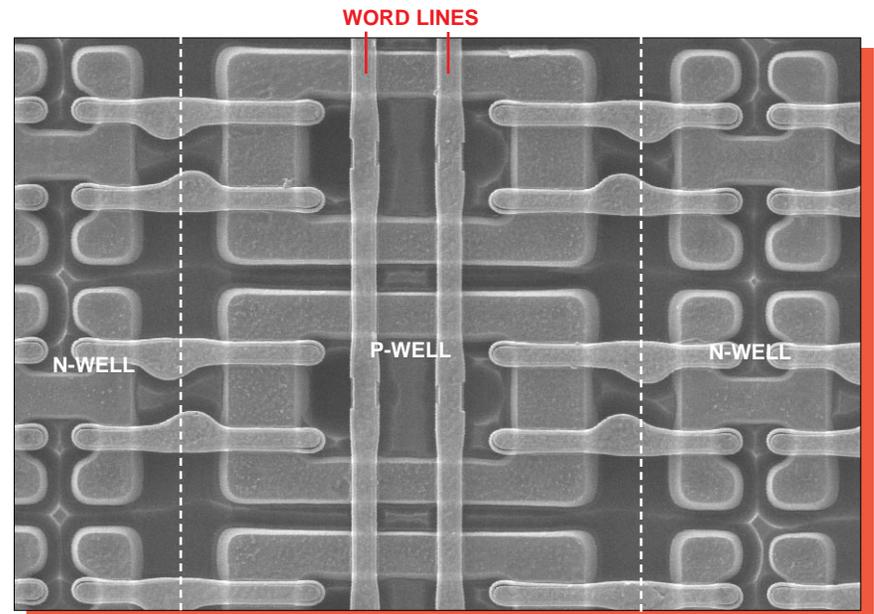
Figure 44. Topological SEM views of the Cache array. Mag. 9000x, 0°.

- SRAM: As mentioned, on-chip cache memory cell arrays were employed on the device. The SRAM cell array used a 6T CMOS SRAM cell design. Metal 3 formed the bit lines. Metal 2 distributed GND and Vcc throughout the cells and was used as “piggyback” word lines and cell interconnect. Metal 1 also provided cell interconnect. Polycide formed the word lines/select and storage gates. Cell pitch was 3.5 x 5.1 microns.

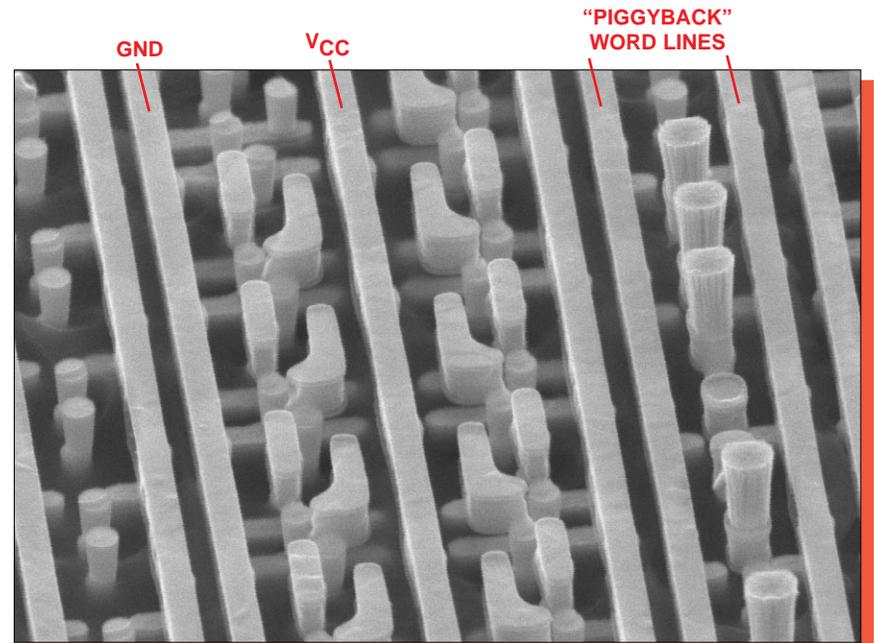
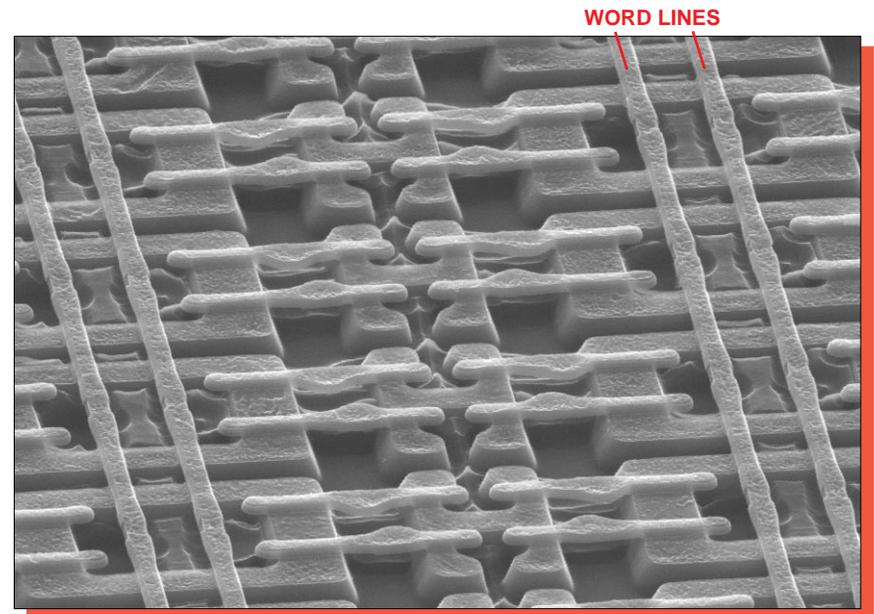
Figure 45. Perspective SEM views of the Cache array. Mag. 8000x, 55°.

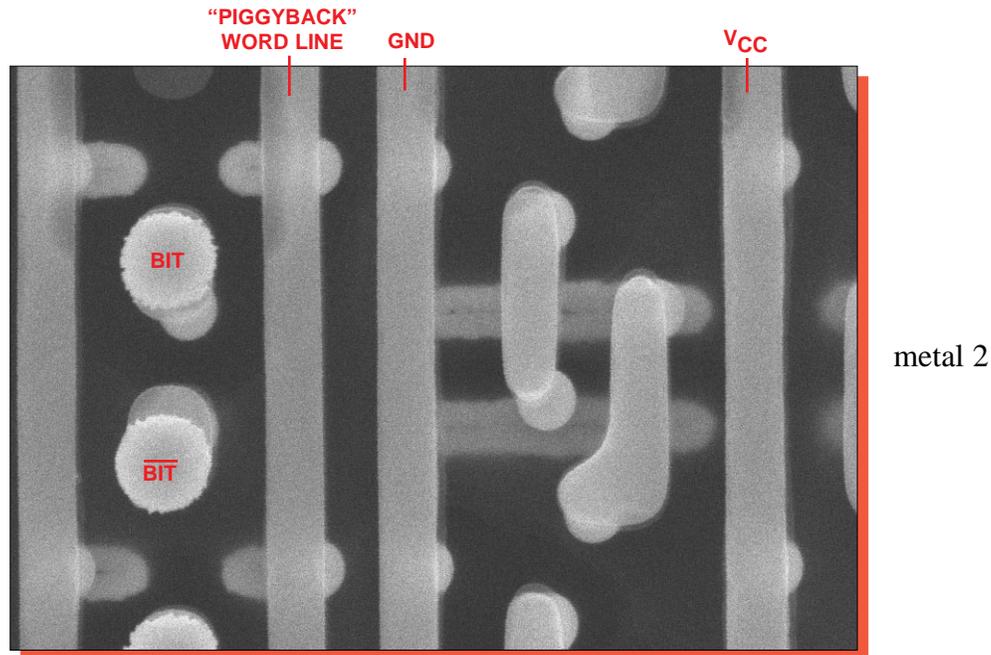
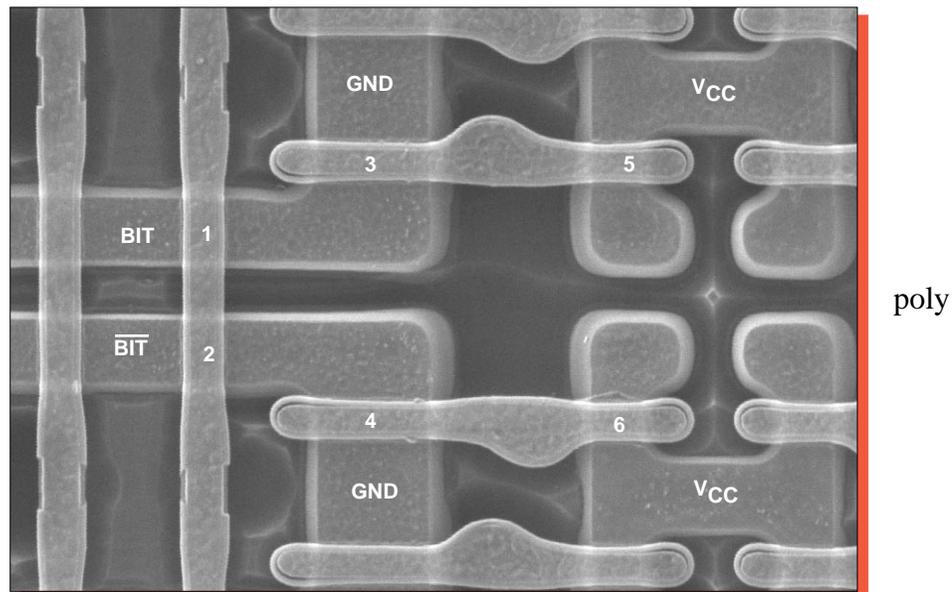
Figure 46. Topological SEM views of a Cache cell with schematic. Mag. 15,000x, 0°.
